**A Compendium of Trout Stream Habitat Improvement
Projects Done by the Wyoming Game and Fish
Department, 1953-1998.**

**N. Allen Binns,
Aquatic Habitat Supervisor**

**Fish Division
Wyoming Game & Fish Department
Cheyenne, Wyoming 82006
April, 1999**

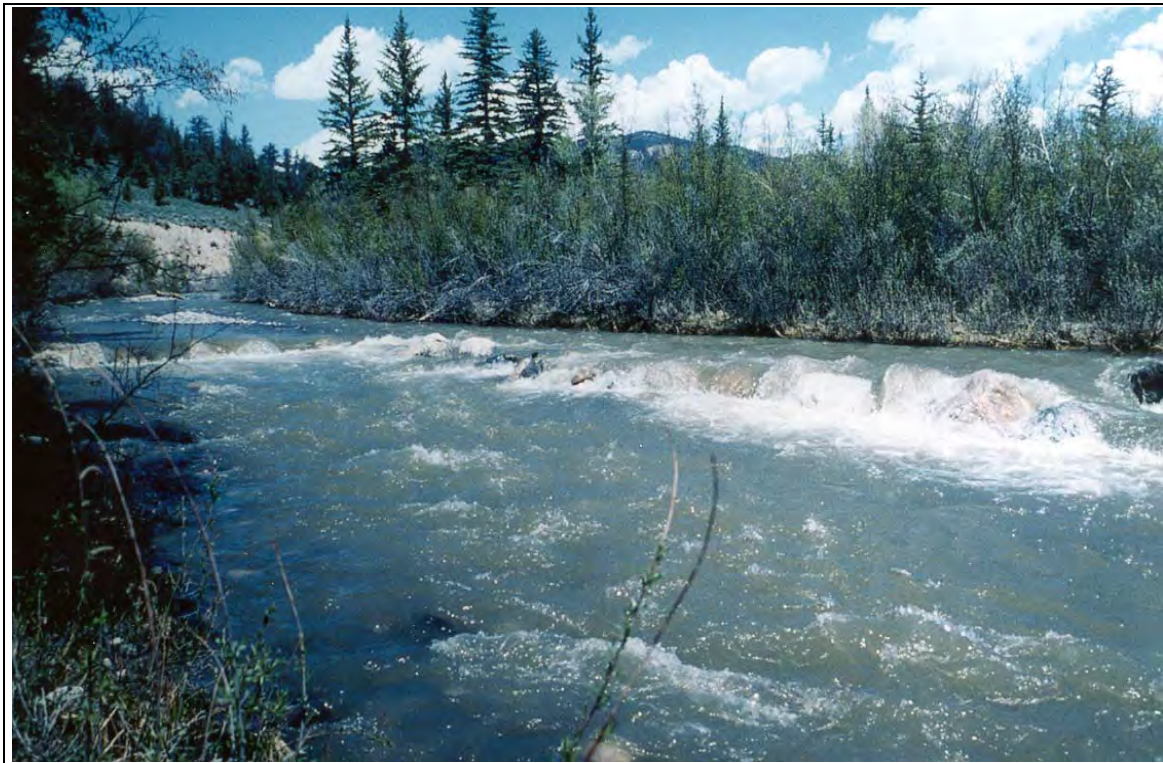
Figure 1-1. A boulder S-dam installed in Bear Creek slows swift spring flows and provides shelter for trout.

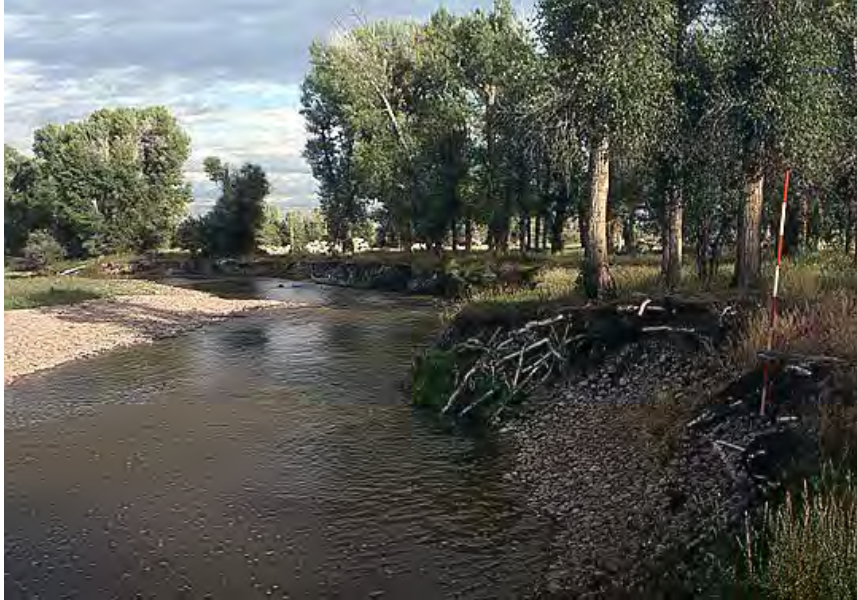
Figure 2-1. An eroding stream bank along the Bear River at the Bear River State Park before bank stabilization.

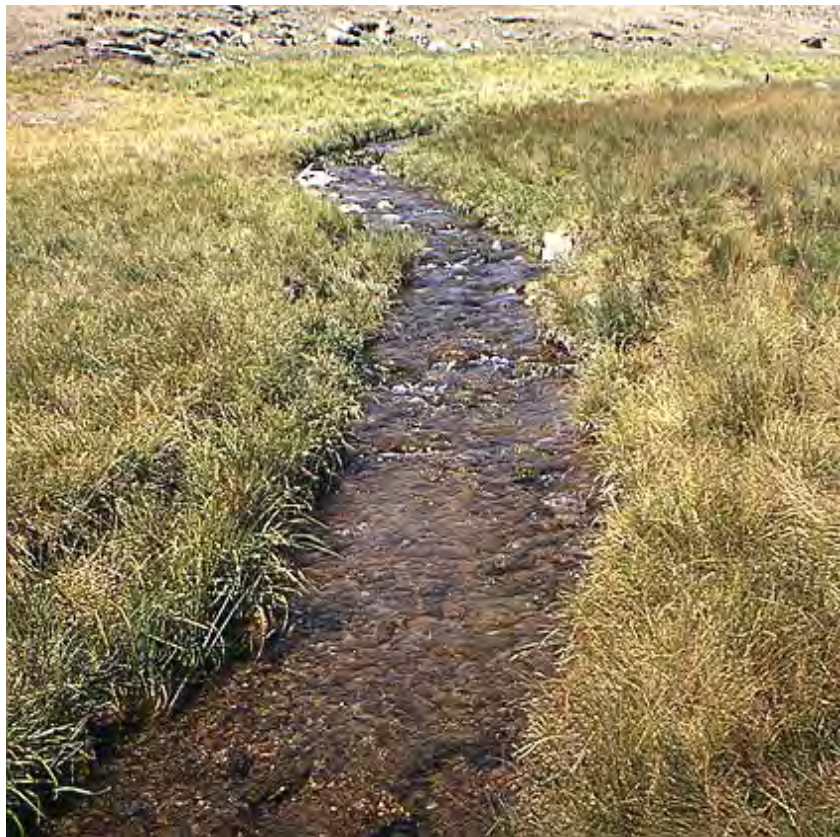
Figure 3-1. Beartrap Creek before habitat improvement was shallow and lacked deep pools.

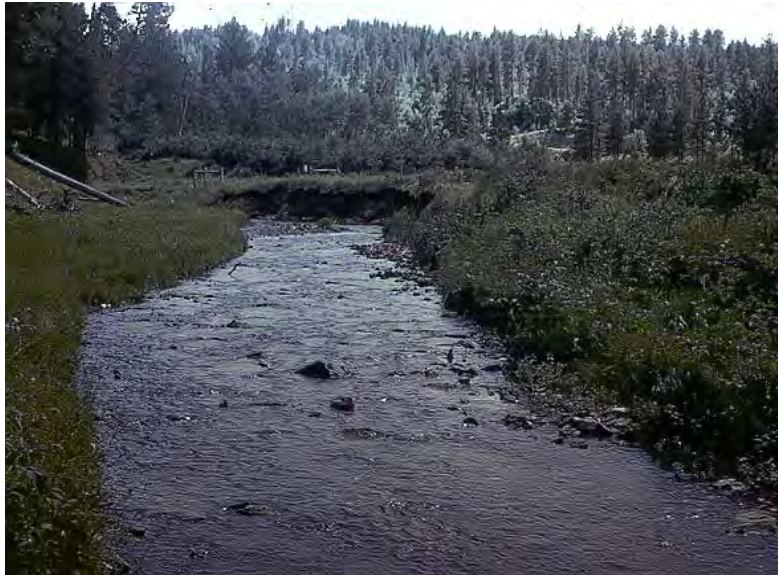
Figure 4-1. Before habitat improvement, Beaver Creek was wide, shallow, and lacked deep pools. Bank erosion was wide spread.

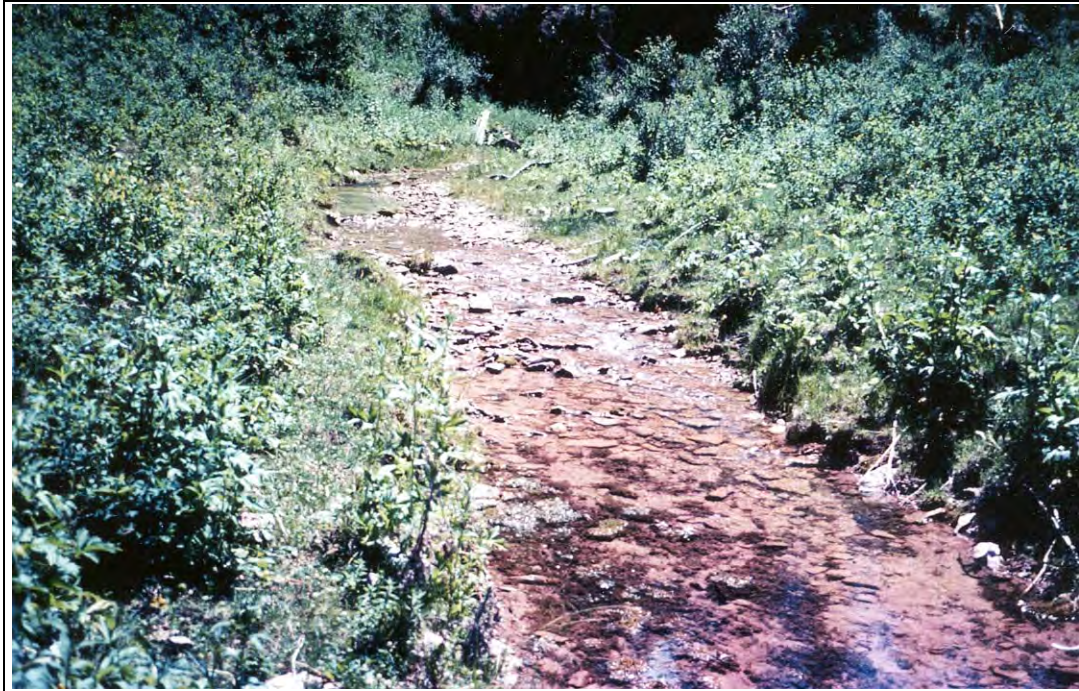
Figure 8-1. Pretreatment, Blacktail Creek was shallow and lacked deep pool habitat for trout.

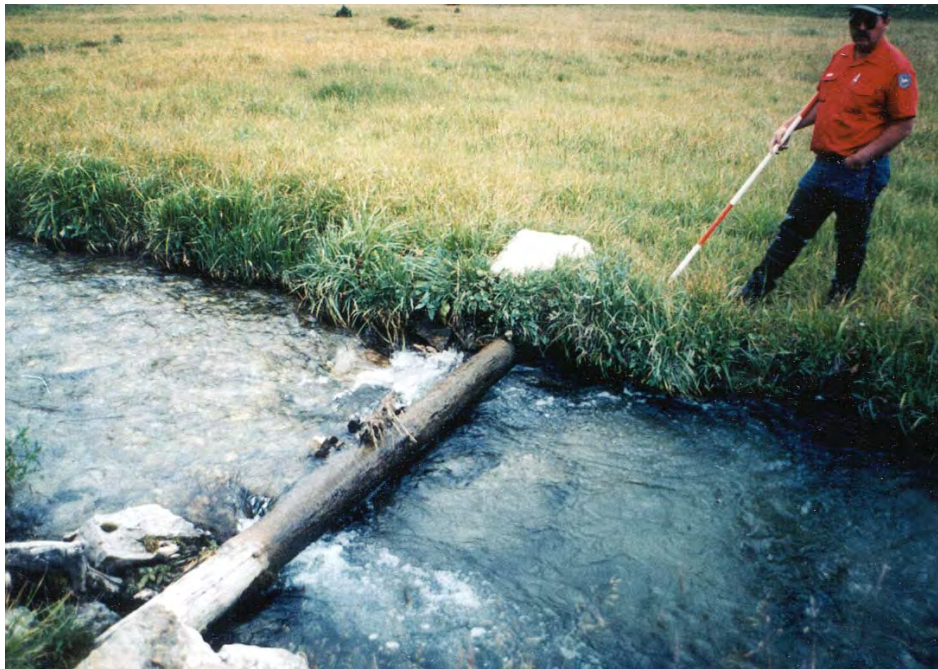
Figure 11-1. Built in 1965, a digger-log was still furnishing pool shelter for trout at the upper meadow on Bull Creek 25 years later.

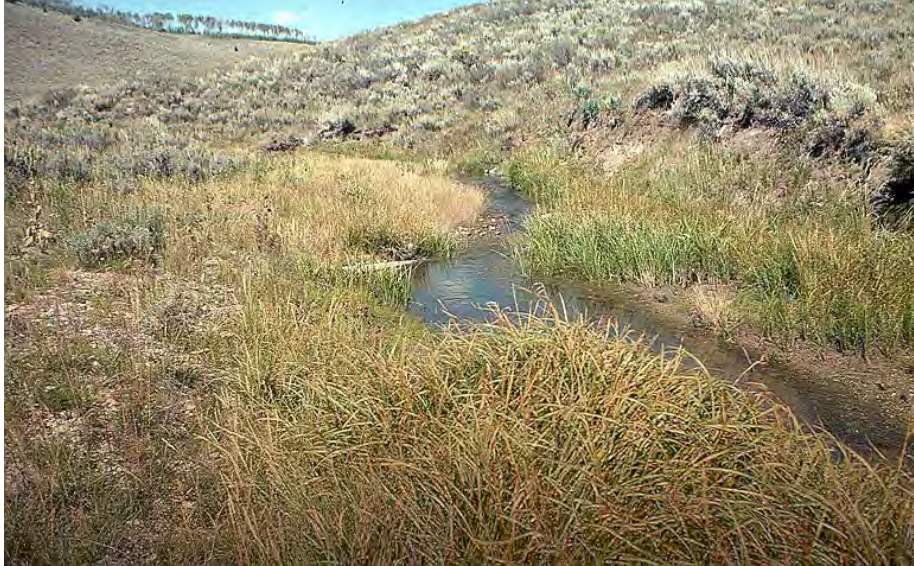
Figure 13-6. Upper Coal Creek within the enclosure after ten years. Due to lack of regular maintenance, the enclosure did not provide complete protection from livestock grazing and vegetation within the fence was grazed sporadically. Even so, the riparian vegetation growth, as seen here, was better in 1989 than it was pretreatment.

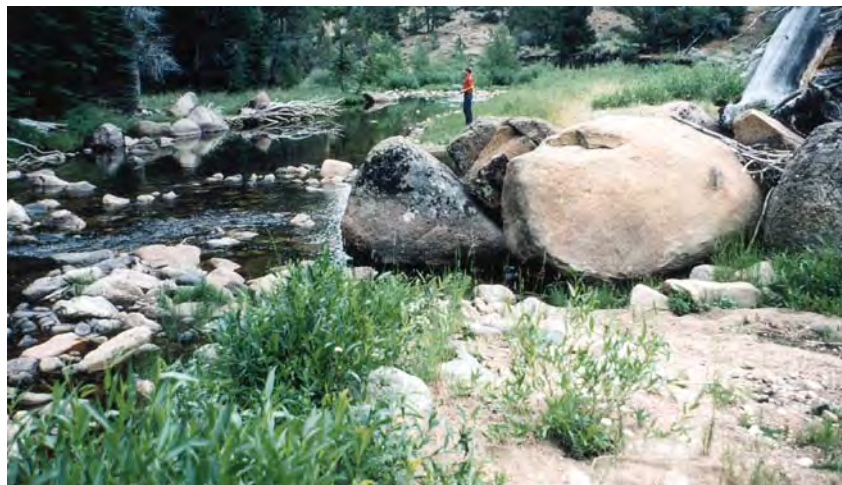
Figure 15-2. Ten years after construction, the boulder deflector is intact and functional, but the tree/rock revetment on the far bank has deteriorated. Good growth of willow and other vegetation has developed on the bar formed upstream and downstream from the deflector.

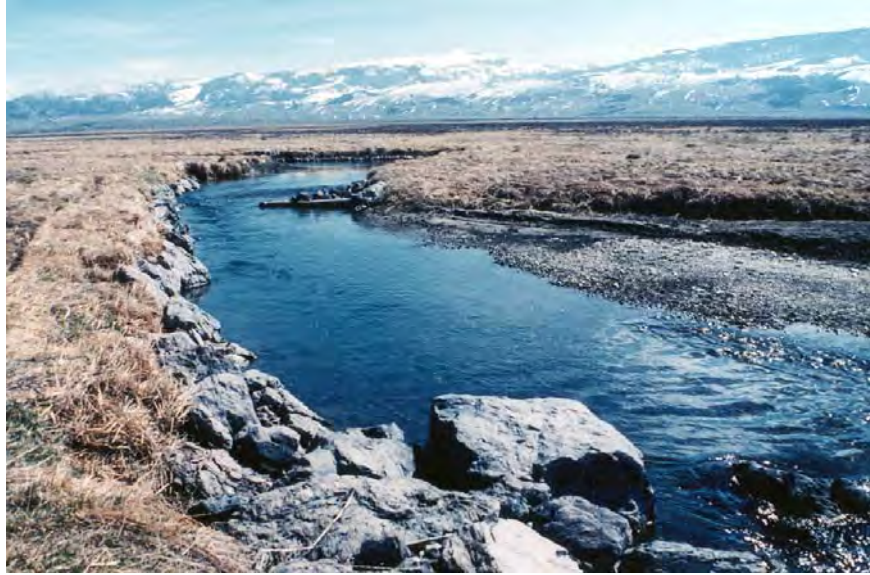
Figure 17-3. Rock riprap was used to stabilize only a few banks at Flat Creek. Five years posttreatment, the rocks retain their original configuration and the wing deflector has caused the low flow channel to narrow as sediment has deposited in a bar downstream from the deflector.

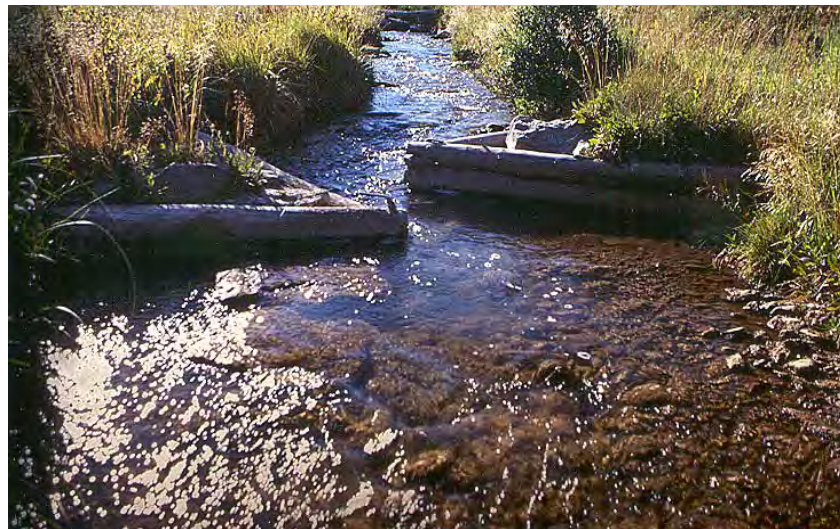
Figure 18-4. Offset double deflectors increased habitat diversity in Fool Creek and provided some overhead cover near deflector tips, but no deep pool shelter formed.

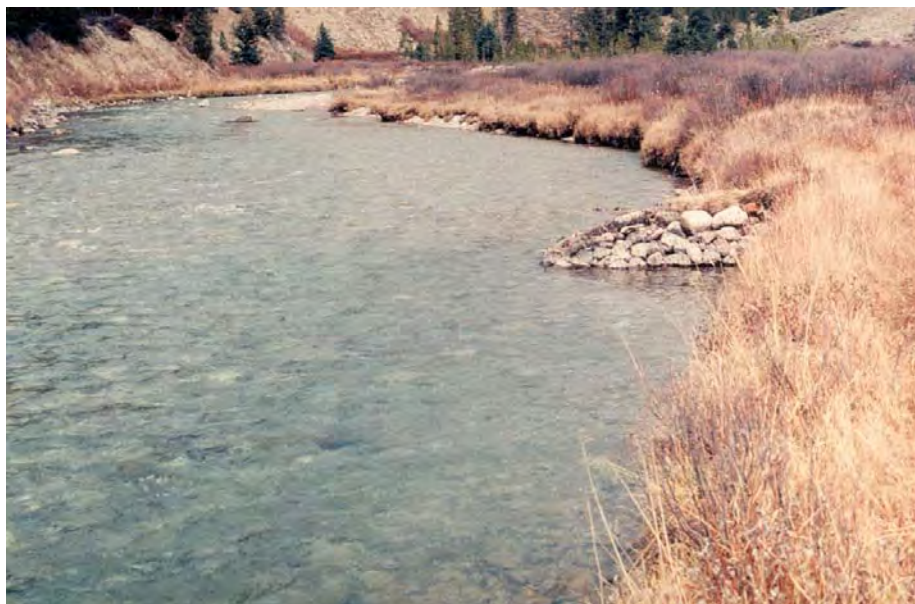
Figure 19-2. A stream-lined wire crib deflector on the south bank of Granite Creek was still largely intact and functional in 1980. A pool/run is present downstream from the point of the device. A similar device on the opposite bank had largely disintegrated by 1980, but the two structures have narrowed the stream at this point. Flow is from top to bottom.

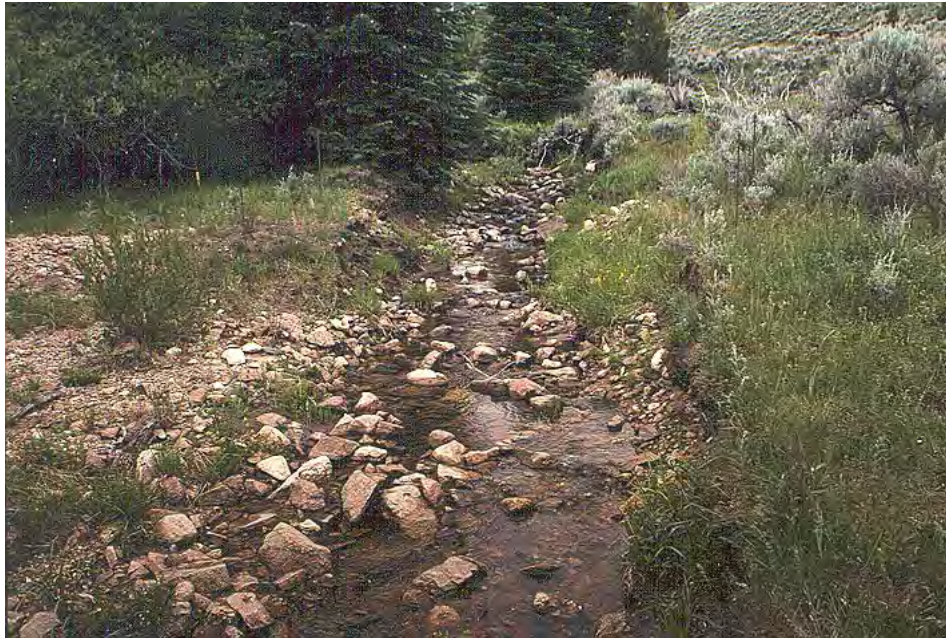
Figure 24-1. Pretreatment, Hall Creek was wide, shallow, and lacked deep pool shelter for trout.

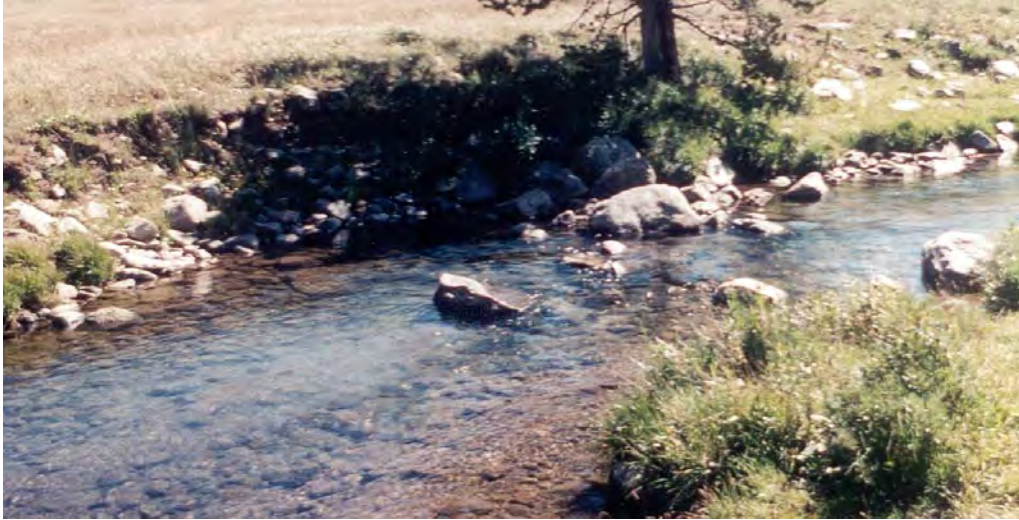
Figure 35-1. Pretreatment, pockets of bank erosion were common and the rocky substrate kept the river from scouring many natural deep pools.

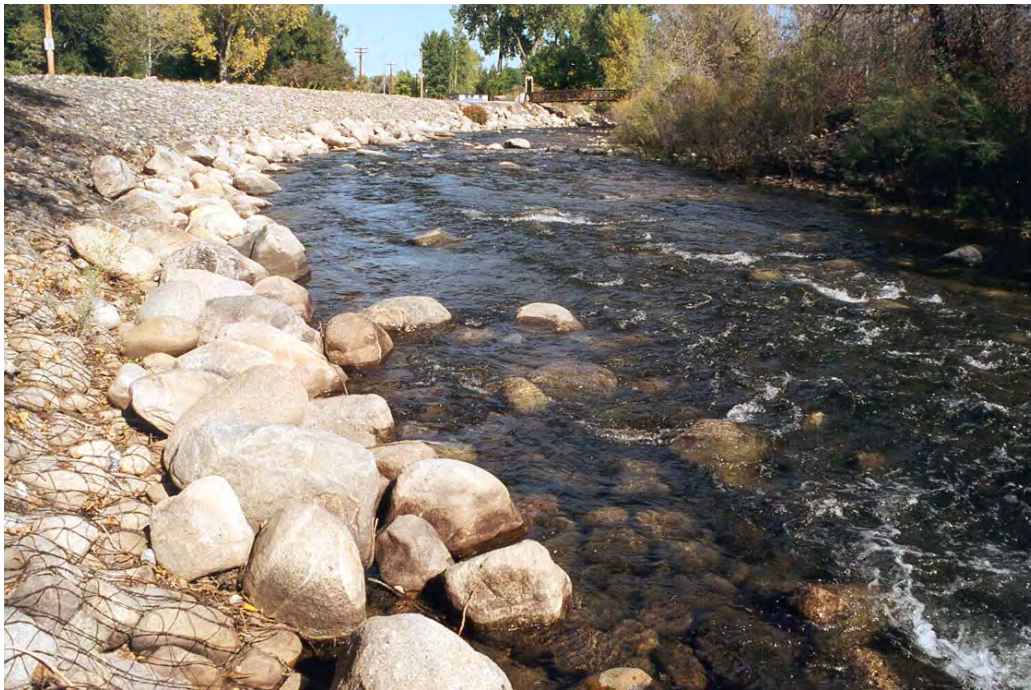
Figure 38-1. Stream banks through City Park had been treated years before by pushing river cobble up along the bank and covering the rocks with common stock fence. Subsequent corrosion of wire at river's edge allowed rocks to be sucked out from under the fencing by pressure differentials (Venturi effect) during high flows. Large boulders placed at the bottom of the riprap have successfully stabilized the banks.

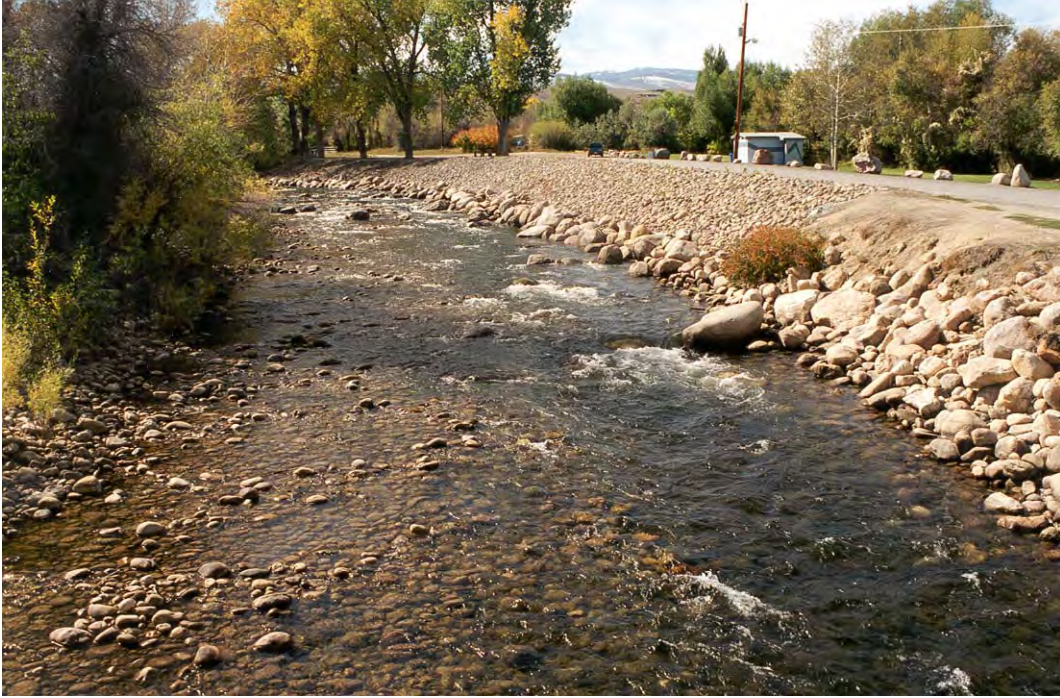
Figure 38-2. Pretreatment, low flows in the Middle Fork were spread shallowly across the riverbed due to previous channelization. Posttreatment, the river has formed a deeper thalweg near the right bank, thus concentrating low flows to aid trout.

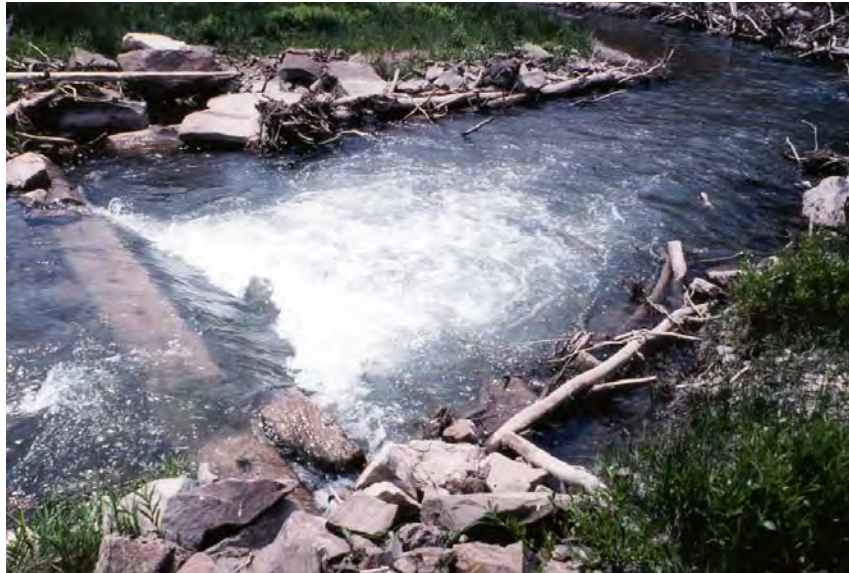
Figure 53-1. A log plunge installed in Salt Creek provided both grade control and shelter for trout. But by 1997, the plunge pool had migrated downstream to form a deep corner pool along the face of the tree/rock revetment (top of picture, right).

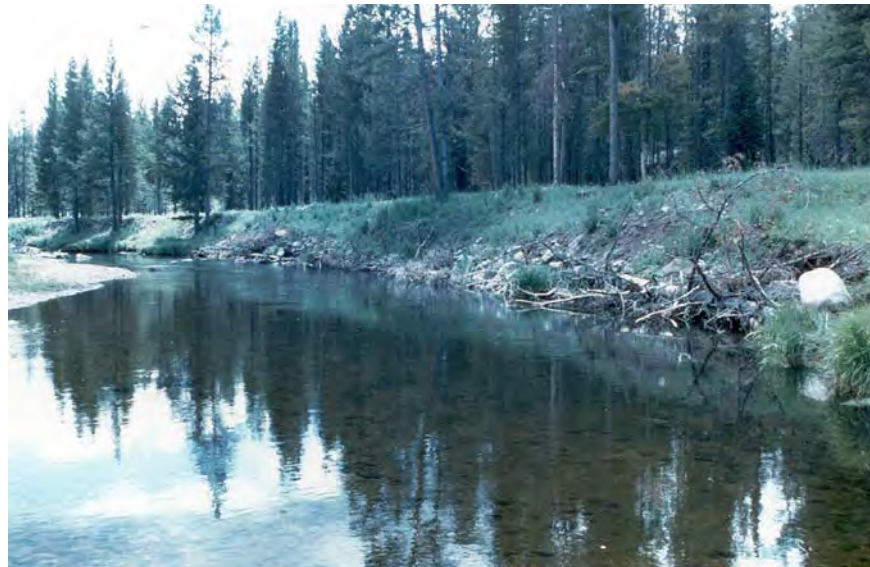
Figure 56-4. Pretreatment, this bank was being severely eroded by the river, but ten years after a tree/rock revetment was installed, the bank is completely healed. When this section is electrofished, many trout are found living in the deep pools and woody debris along the bank.

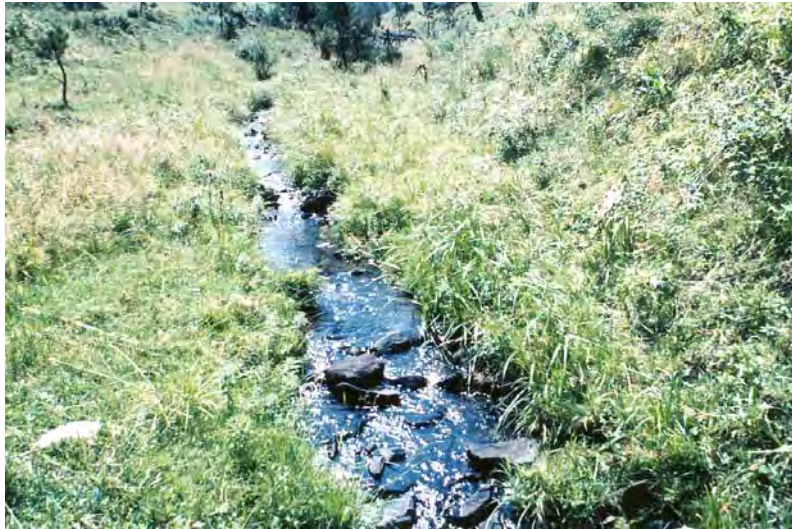
Figure 59-1. Pretreatment, Spotted Tail Creek was shallow and lacked deep pools, as in this view of the control section.

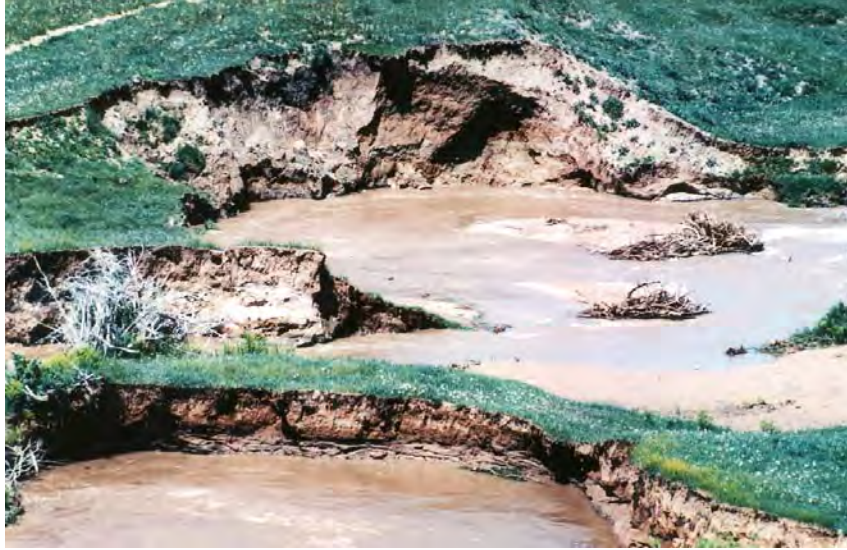
Figure 60-4. Severe bank erosion was rampant in the Squaw Creek drainage before efforts were made to control silt pollution in the watershed. Spring snowmelt floods often carved off large chunks of soil and washed it downstream to bury pools and riffles with silt.

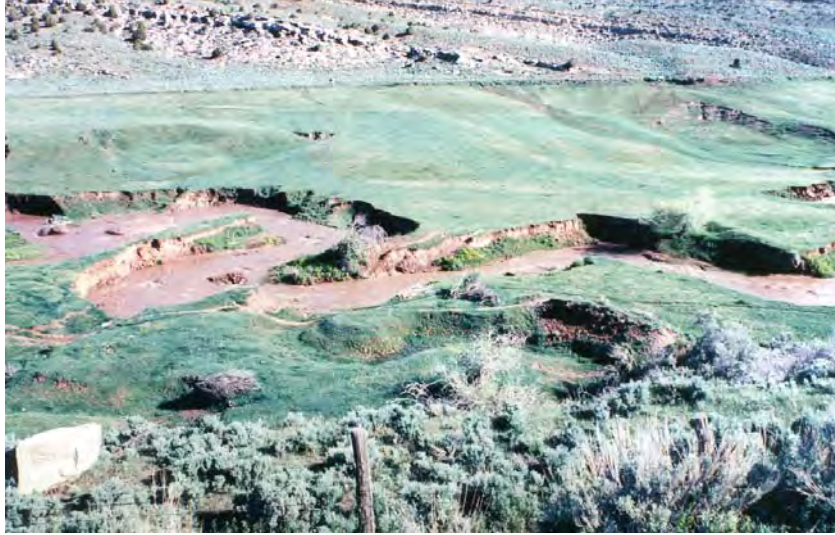
Figure 60-6. Annual spring floods degraded stream banks, caused oxbow cutoffs, and other channel adjustments. At low flow, little cover for trout was contributed by the small amount of riparian vegetation and pools were often choked with silt.

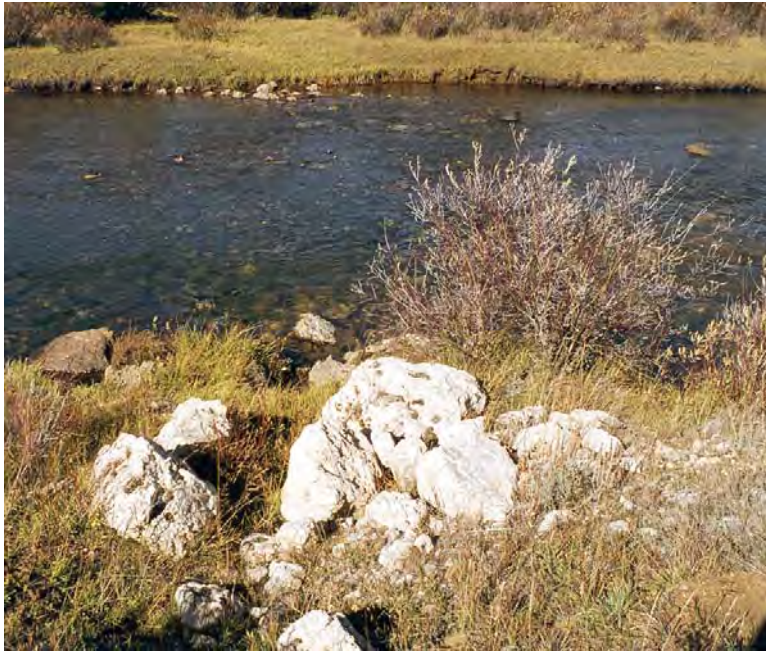
Figure 62-5. A few limestone boulders on the bank are all that remain of a rock weir after 25 years. The stream has presumably buried the instream portion of the weir.
