Volume 14

2020

Fish Management in the Jackson Region

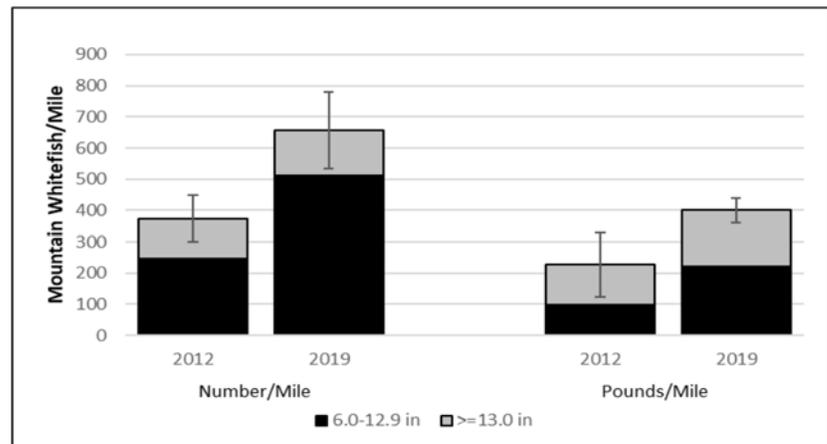
Mountain Whitefish population estimates from 2012 and 2019.

In order to evaluate any changes in the whitefish population over time, the Jackson Region fisheries crew decided to begin revisiting these population estimate sites. In 2019, the site on the Greys River, from the Little Greys River to Squaw Creek was sampled. The population estimate of whitefish from this stretch in 2019 was substantially higher than the estimate from 2012 with a total estimate of 658 whitefish per mile and 400 pounds of whitefish per mile. The increase from 2012 to 2019 is a result of more than twice as many small whitefish (≤ 12.9 inches). The reason for this increase is unknown, but is a good sign of a healthy fishery.

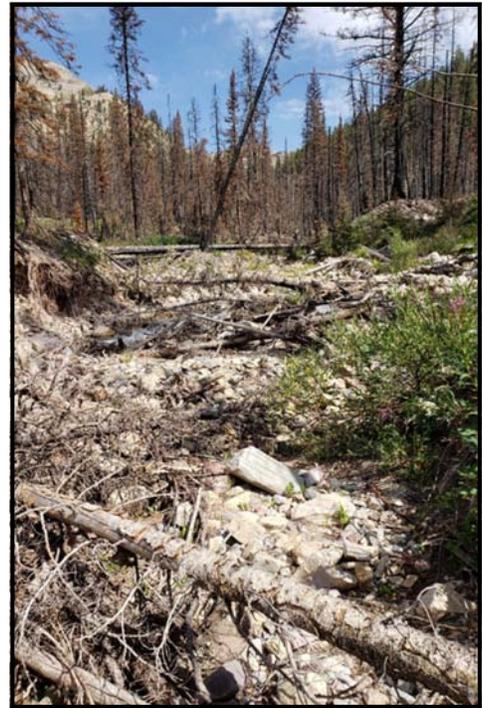
Sampling site on Bare Creek within the Roosevelt Fire burn area.

Habitat assessment of the two sites affected by the 2018, fire Bare Creek (Site 6) and Hoback River (Site 7), revealed both positive and potentially concerning fire impacts. At both sites, the fire burned old floodplain terraces and uplands dominated by conifers (lodge pole pine and subalpine fir), largely leaving the riparian corridor unaffected. Understories burned and conifers were left black and standing. Large sediment and wood inputs to the Hoback River are therefore anticipated in coming years.

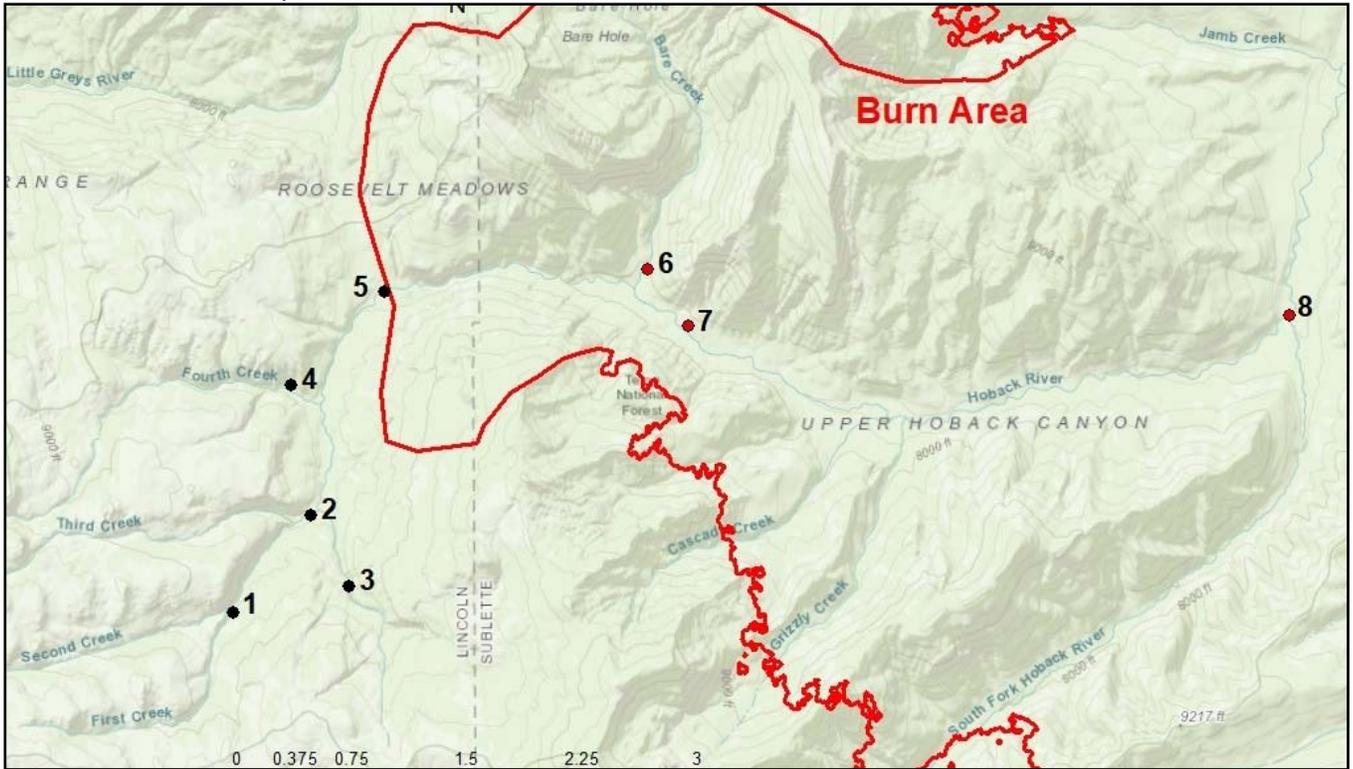
Map of 2012 and 2019 sampling sites in or near the Roosevelt Fire burn area. Black dots indicate sampling locations outside the burn and red dots indicate sampling locations inside the burn.

Hoback River fisheries were evaluated at eight sites (see map on next page). Five sites had been previously sampled in 2012 (1, 4, 5, 6, and 8) and three new sites within the burn area or immediately adjacent to the burn were sampled in 2019 (2, 3, and 7). Two of the previous sampling sites from 2012 were in the burn area (6 and 8) and an additional sampling site was added (7). A site in the highest intensity burn area on the South Fork Hoback River was scheduled for sampling but rain caused the river to blow out and sampling could not be conducted.

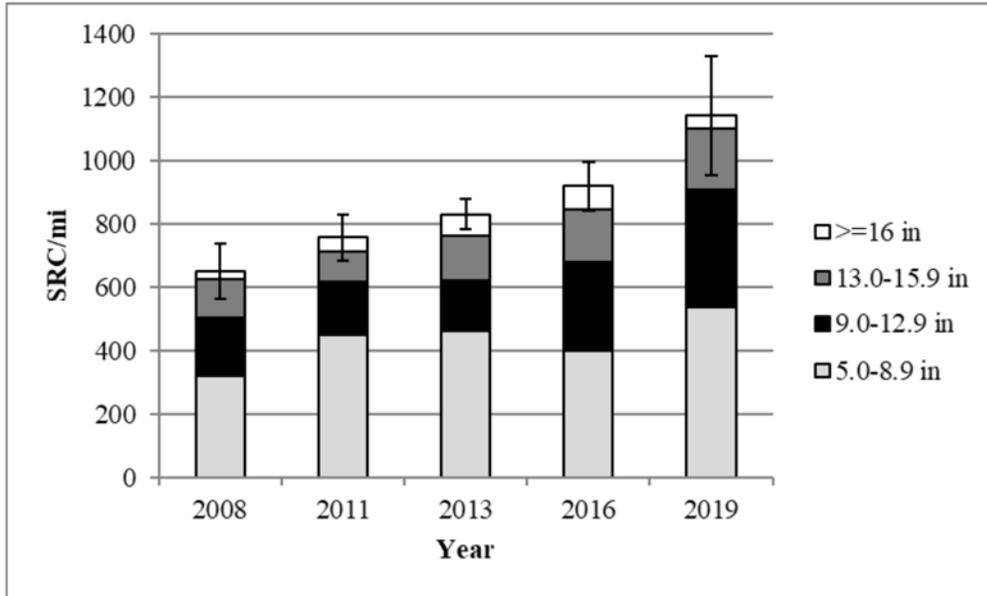
Population estimates for Snake River Cutthroat Trout from a mark-recapture estimate on the Snake River above the Wilson Bridge from 2008 to 2019. Error bars depict standard error (±) for Snake River Cutthroat Trout ≥ 5.0 in.

One of three sections of the Snake River are sampled each year. In 2019, a 5.1 mile section above Wilson Bridge was sampled on October 7, 8, and 11. Typically we try to conduct a population estimate on Snake River Cutthroat Trout every three years on a given section. Our management objective above Wilson Bridge is to have at least 250 Snake River Cutthroat over nine inches per mile. In 2019, this estimate was 604 fish, which is slightly higher than 522 in 2016.

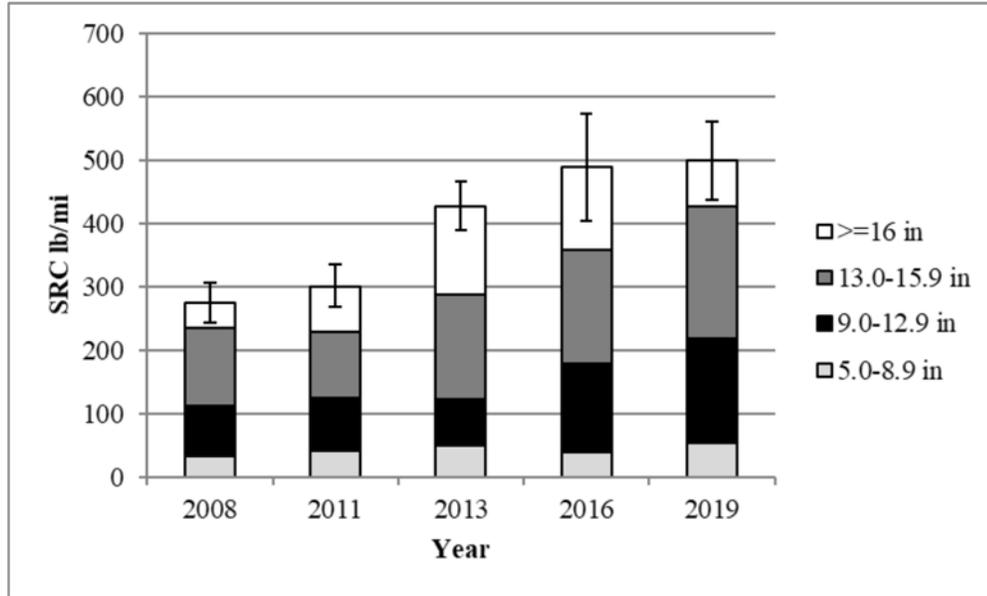
Pounds of fish per mile estimates for Snake River Cutthroat Trout from a mark-recapture estimate for on the Snake River above Wilson Bridge from 2008 to 2019. Error bars depict standard error (±) for Snake River Cutthroat Trout ≥ 5.0 in.

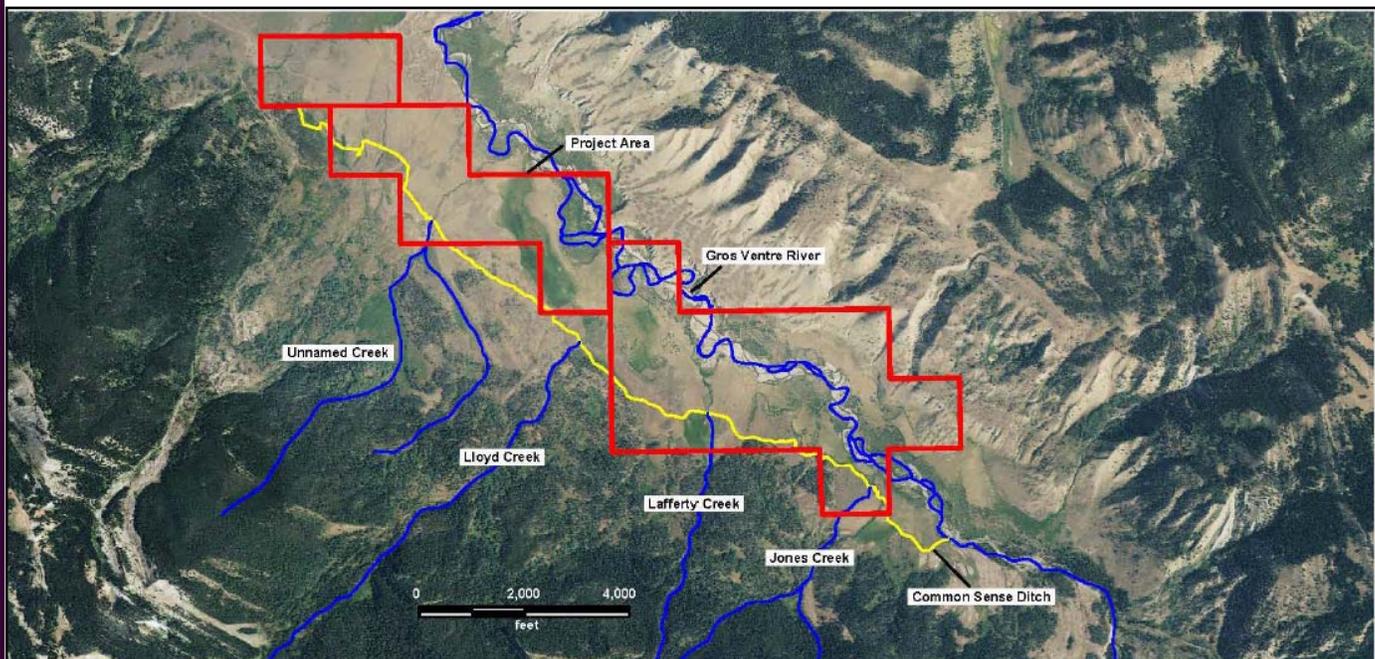
Map of the project implementation area located approximately 25 miles upstream from Lower Slide Lake in the Gros Ventre River drainage.

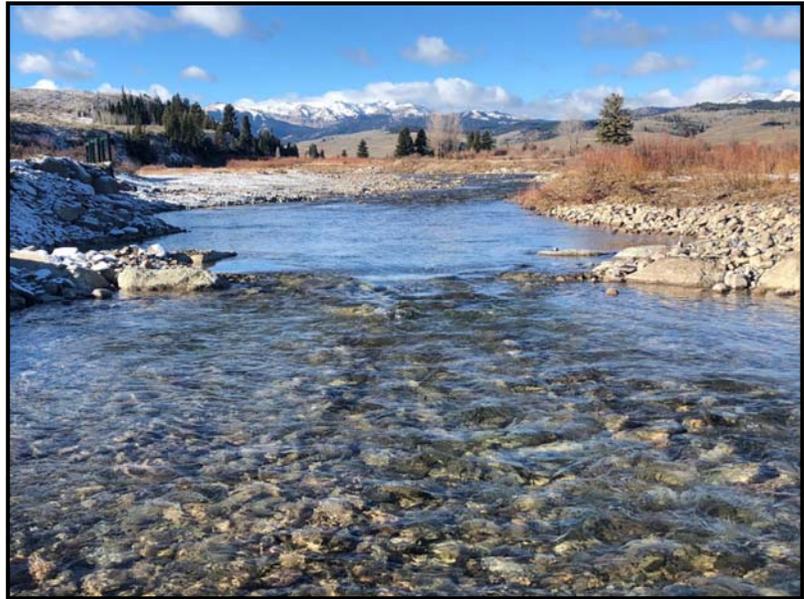
Looking upstream at the newly-constructed, stable cross vane diversion structure. Each rock measures 5-7 feet in diameter!

The gravel push-up dam was replaced with a permanent rock cross vane and the irrigation ditch was outfitted with headgates (photo above). These upgrades should prevent the need for future push-up dam construction. The cross vane is constructed to allow for fish to move up and downstream, transport the river's cobble bed load, and also provide the necessary head to feed the irrigation ditch. This design has been used in rivers throughout Wyoming, from the Green to the Encampment, with great success. We are excited to have a stable, fish-friendly irrigation diversion on the map in the Hoback drainage and hope that the successes at this site translate to future projects throughout the region.

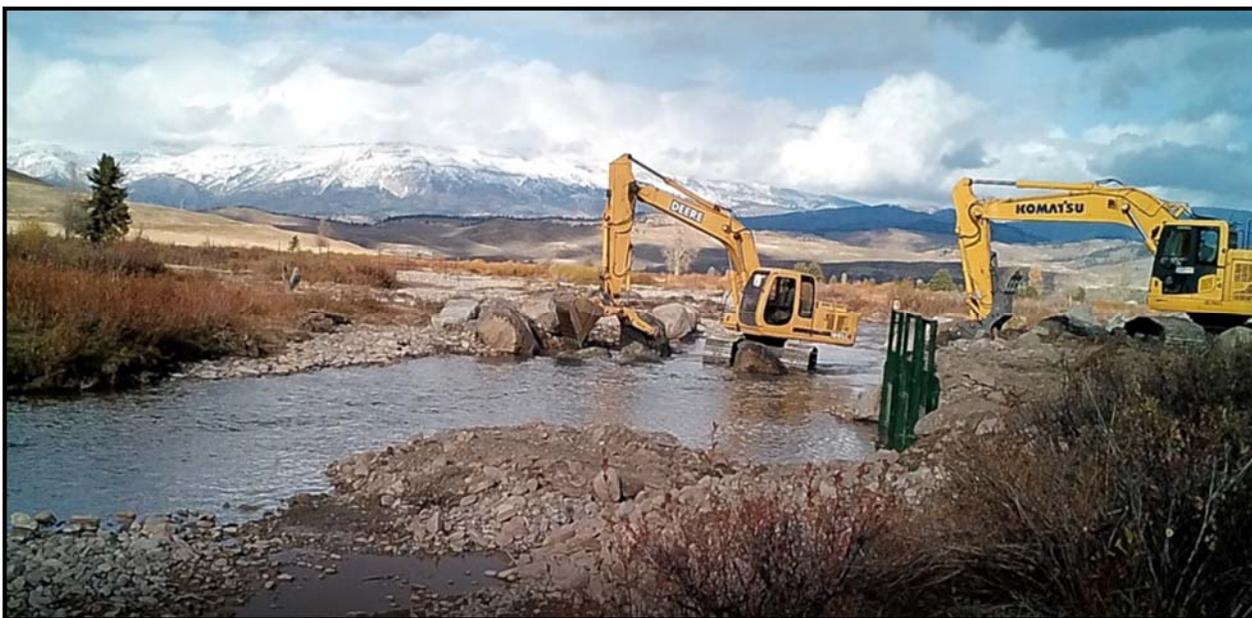
Construction of the McNeel elk feedground irrigation diversion.

Construction was completed on the Upper Hoback River on McNeel elk feedground in October 2018. Equipment mobilized the day after the Roosevelt fire travel ban lifted and construction took less than two weeks (photo below). A gravel push-up dam had historically been constructed each irrigation season using heavy equipment in the channel to manipulate flows. These structures cause downstream bank erosion and can be barriers to upstream fish movements. The Hoback River is an important Snake River Cutthroat Trout spawning system and so connectivity for fish to move from spawning and rearing habitats to holding habitats is extremely important.

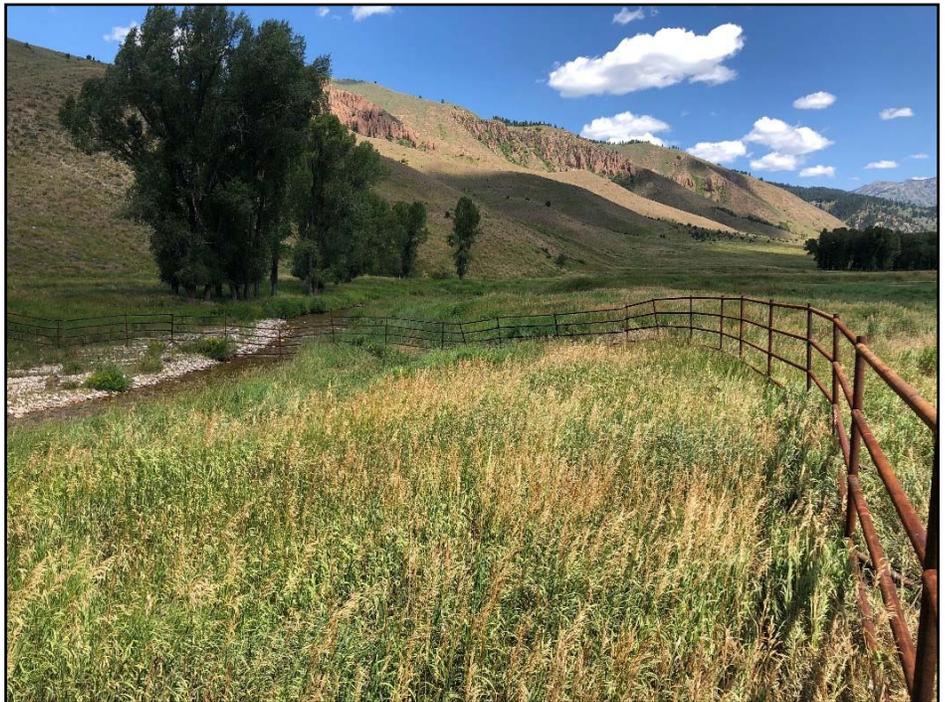
Steel jack fence installed at the Horse Creek WHMA to eliminate ungulate browse and allow the stream channel and riparian vegetation community to heal.

In August of 2019, approximately 1,200 feet of modular, 6 foot high fence was built around a section of Horse Creek on the WGFD Wildlife Habitat Management Area and elk feedground. Volunteers from Trout Unlimited, Backcountry Hunters and Anglers, the USFS, and the Jackson community pitched in to complete this project which will have benefits for aquatic and terrestrial critters. The fence, which is made of recycled oil field drill stem pipe, is necessary to reduce the amount of time elk spend in the river bottom during the winter and to encourage the native riparian vegetation to recover. Many factors have worked together to cause severe bank erosion and channel shifting at the downstream extent of Horse Creek on the WGFD property. Reestablishment of deep-rooted vegetation will go a long way toward healing the erosive banks, along with some hands-on grading and planting to give the system a jump on its natural recovery potential.

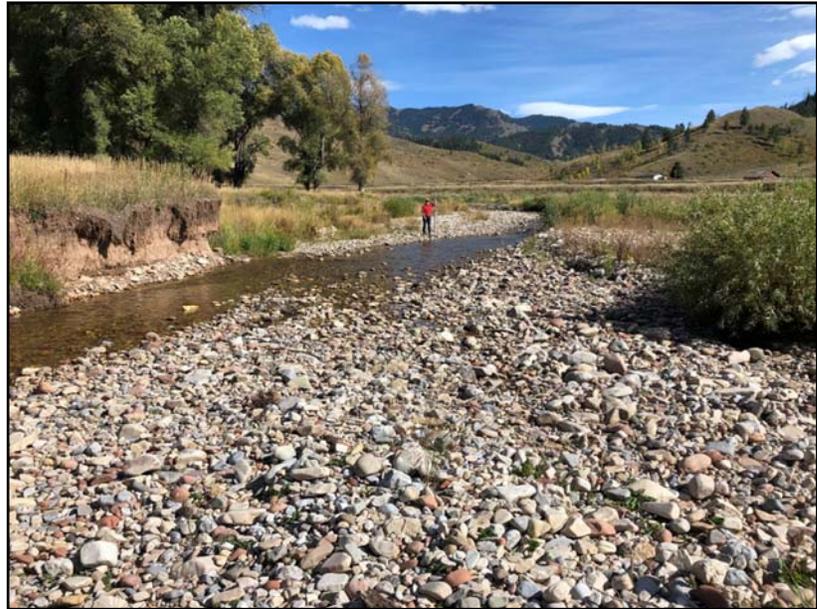
A high eroding bank on Horse Creek with upland pasture grasses growing adjacent to the stream channel offering little stability.

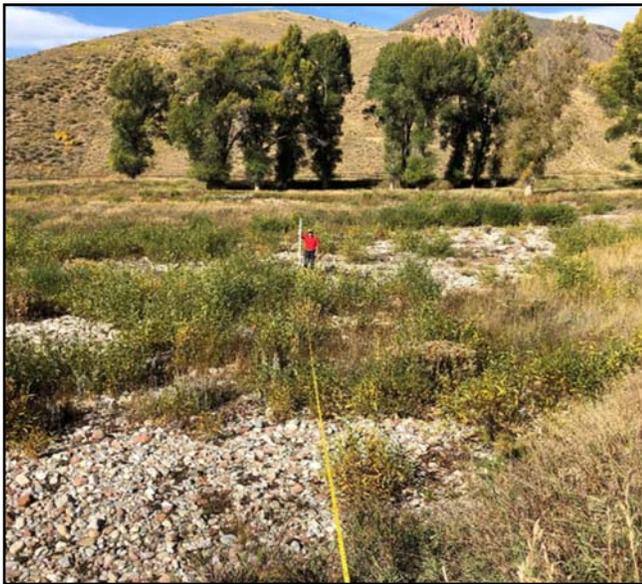
Estimating woody species cover across the Horse Creek floodplain.

Right now, Horse Creek willows show limited recruitment and cottonwoods show none. As plants increase in density and height, the amount of cover, or shade, they provide also increases. Estimating the percentage of cover provided by woody species across a belt transect is an indication of habitat quality and, of course, relates to stream bank stability. Woody species cover across the Horse Creek floodplain is estimated to be about 20%. We anticipate a much larger number in coming years.

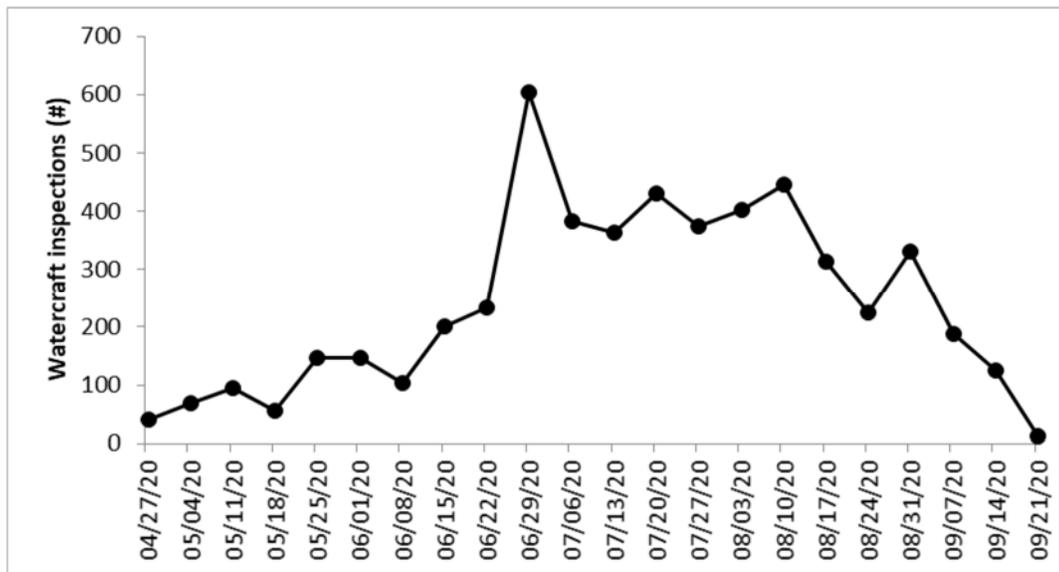
Weekly watercraft inspection totals in the region during the 2019 check station season.

The Jackson/Pinedale AIS program experienced a busy year in 2019. The crew conducted 5,313 inspections over the course of the boating season. Of these inspections, 198 (3.7% of the total) were deemed high risk for transporting invasive species due to the waters they had last boated on during the previous 30 days. The crew performed 16 watercraft decontaminations to neutralize the potential threat these watercraft posed to our local fisheries and water resources. The AIS program continues to stress to boaters the importance of adopting “Clean, Drain, Dry” practices. Watercraft that are clean of mud and debris and contain no standing water pose no risk of transmitting AIS into our state waters.
