CASPER REGION

CASPER REGION HIGHLIGHTS

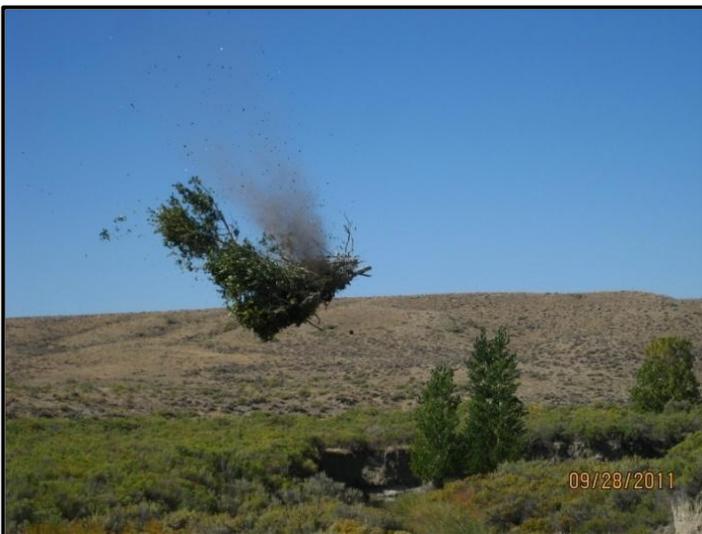
Figure 1. Aspen bundle dropped into Bolton Creek.

In the fall of 2011, we aerially deposited 296 bundles of aspen that ranged in weight from 250 to 900 pounds each (Figure 1). Using an average weight of 575 pounds per bundle, we airlifted 170,200 pounds of aspen trees into existing beaver dam complexes on Bolton Creek, which is more than double the 82,000 pounds airlifted in 2010. This was accomplished using 29 hours of helicopter flight time over a two week period. Field observations on November 9, 2011 showed beaver continue to use the aspen for dam building activities, which accounts for 12 new dams with other dam building activity occurring along the creek. In addition to airlifting aspen, we live trapped and relocated four beaver into the area where we have focused the aspen drops (Figure 2). Nearly 100 hours of time was spent planning and coordinating with the private landowner, the helicopter pilot and WGFD personnel on this project this year.

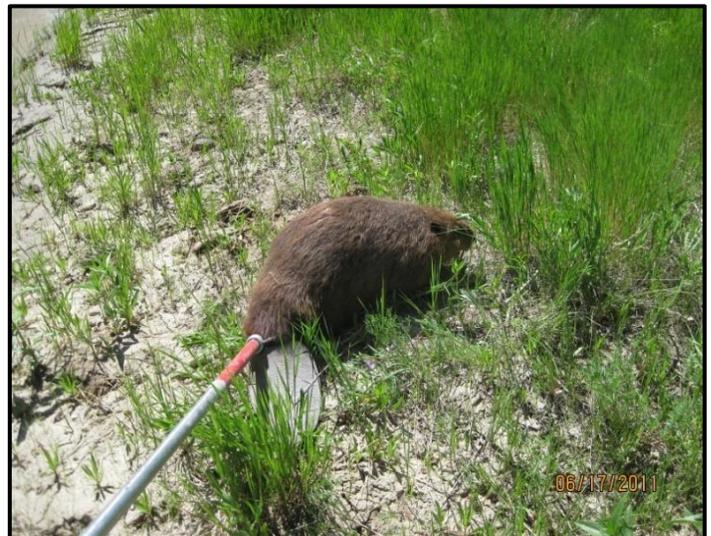
Figure 2. Beaver being relocated into Bolton Creek.

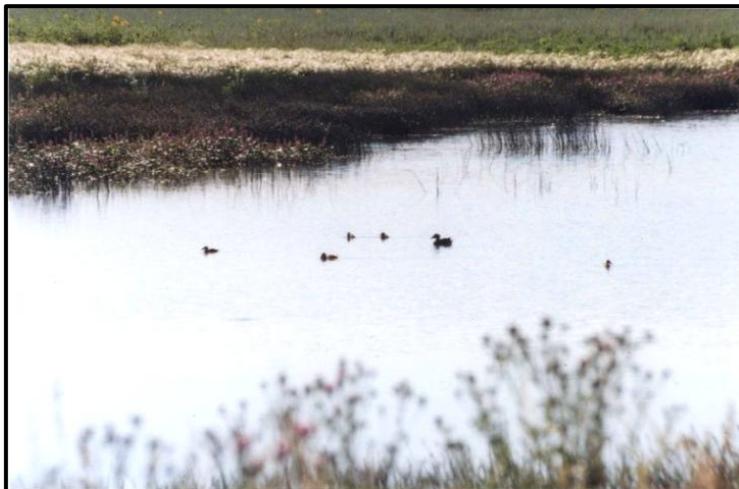
Figure 3. Waterfowl monitoring on SAFE CRP land.

Wildlife monitoring was conducted several times this year on SAFE CRP to assess the effectiveness of converting cropland to perennial grassland (Figure 3). Technical assistance on further seedings and mid-contract management plans were provided on SAFE CRP and general CRP lands. These projects aim to benefit a variety of wildlife by increasing forage and cover.

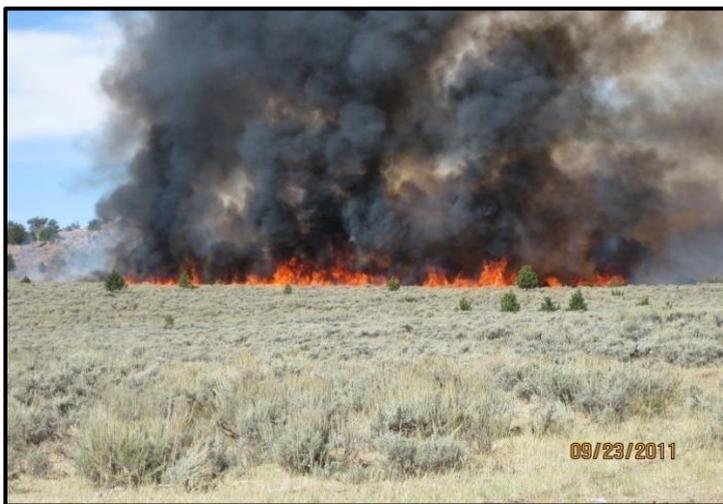
Figure 4. Mountain big sagebrush prescribed burn.

During 2011, we prescribed burned 499 acres of mountain big sagebrush within the Bates Creek watershed (Figure 4). Since the start of this project, we have prescribed burned 2,380 acres of big sagebrush and aspen stands. Wyoming Helicopters applied Plateau® herbicide to control 7,024 acres of cheatgrass-infested big sagebrush communities (Figure 5). This was a continuation of the 7,071

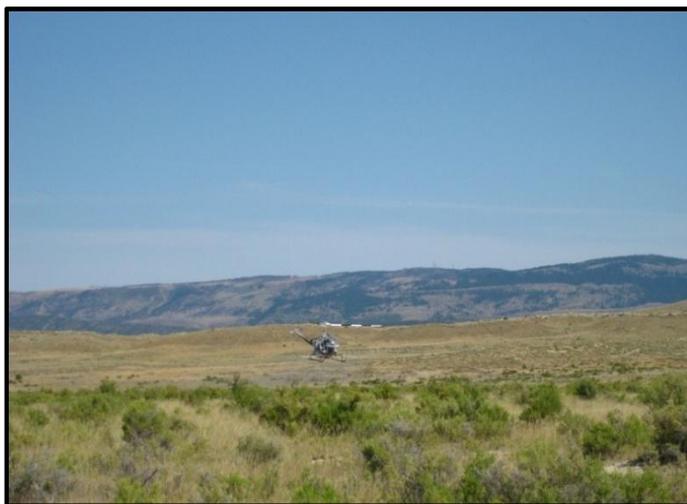
Figure 5. Wyoming Helicopters, LLC applying Plateau® herbicide.

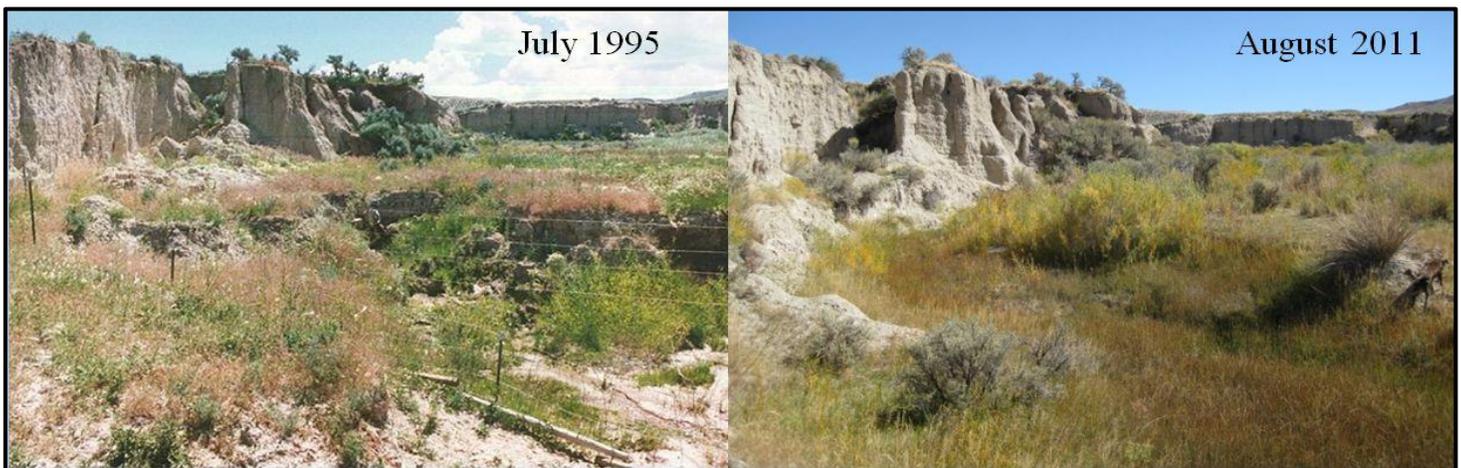
Figure 7. Lawn Creek in July 1995 (five years pre-treatment) and August 2011 (eleven years post-treatment).

This nearby watershed had similar sheet piling structures installed and experienced spectacular gains in riparian vegetation and water retention. In 1995, five years before channel structures were completed, the channel bed was dry and poorly vegetated. When photo documentation was collected in 2011, a diverse and robust riparian community of sedges, rushes and willows were evident and resulted in few exposed banks and definitive water retention.

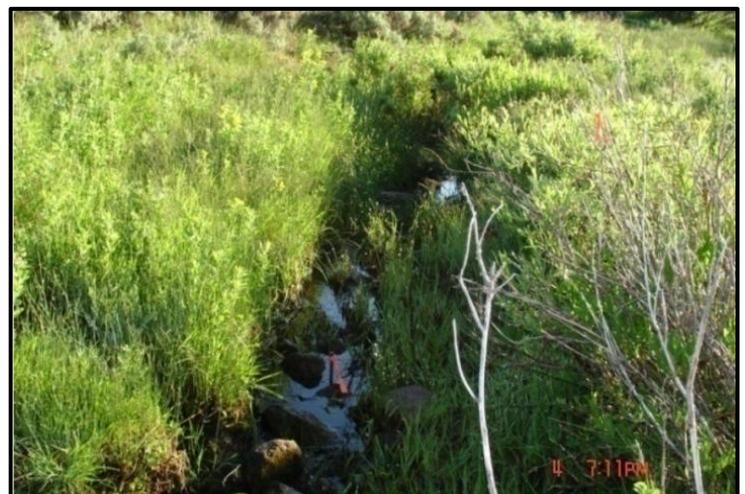
Figure 9. Stream flows were measured at several locations in the Bates Creek Watershed by UW researchers to attempt to relate changes in vegetation to water yield. The location of a pressure transducer is marked with orange ribbon and rebar.

In 2008, UW collaborated with the WGFD to implement a measurement and monitoring program quantifying hydrologic changes related to the vegetation treatments. This study encompassed two graduate projects and involved measuring stream flows and groundwater and tracking vegetation land-use management impacts on watershed response (Figure 9).

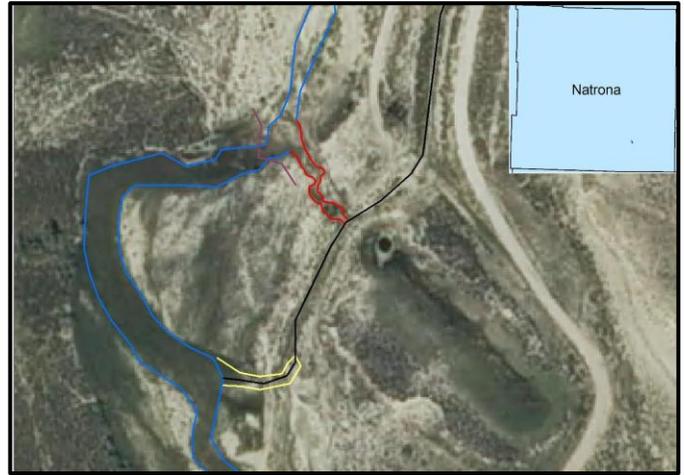
Figure 10. Project schematic and map indicating Stinking Creek (blue outline) and the existing return channel (red outline) to be filled in via the proposed project. The new diversion (yellow) will include structures to minimize the sediment entering the pipe (black). A grade control structure to be installed is shown in purple.

A water return structure along Stinking Creek that returns excess irrigation water back to the creek channel is at risk of failure (Figures 10 and 11). If this structure fails, it risks sending a channel incision up the irrigation channel and will contribute excessive sediment to the watershed.

The intent of the project being developed is to work with the landowner to return the creek to its original channel, eliminate the return structure and develop a superior method of delivering irrigation water. This might include converting the landowner's irrigation method from flood to center pivot. A new irrigation diversion structure that will allow the landowner to efficiently pipe water to the irrigation fields, potentially conserving water in the creek, is being planned with the landowner and NRCS.

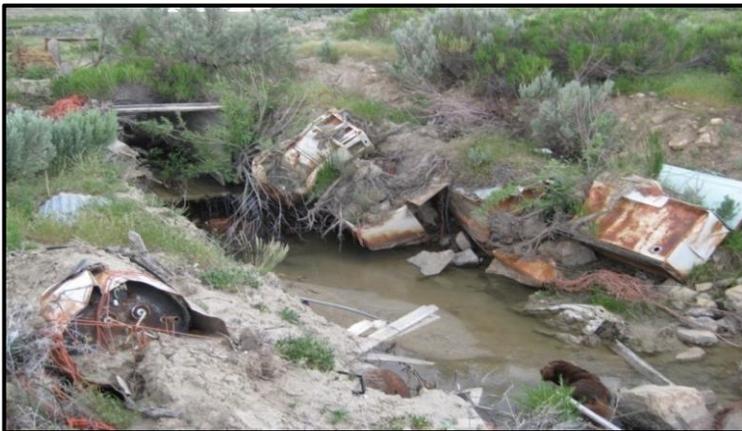
Figure 11. This irrigation return structure would be replaced and the Maytag riprap removed in a project being developed by the Casper Aquatic Habitat Project.

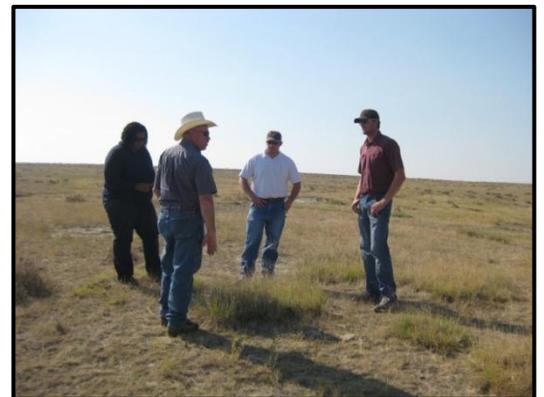
Figure 12. Grazing education by Roy Roath on SGI ranch.

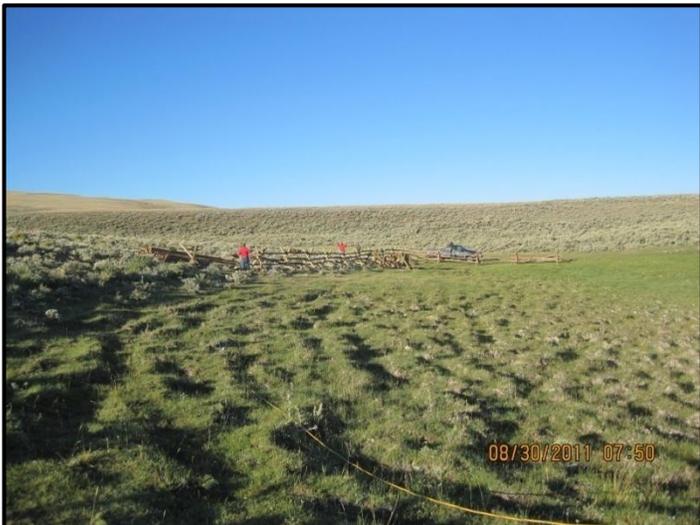
Figure 13. WGFD Habitat and Access Branch personnel constructing spring fence on Flying A Ranch.

Two riparian areas were fenced with 2,400 feet of buck and pole fencing (Figure 13) on a 15,507 acre portion of the Flying A Ranch. This project aims to protect riparian areas from over-utilization by ungulates and prevent further hummock formation. Future work includes spring developments and fencing. The property provides yearlong elk, mule deer and antelope range and a portion of the property is designated as crucial elk and mule deer winter range. There are two sage-grouse leks within two miles of the property and several within five miles. The WGFD currently holds a conservation easement partially funded by a variety of funding sources including NRCS, WWNRT, RMEF and WGFD that includes perpetual hunter access to the area.

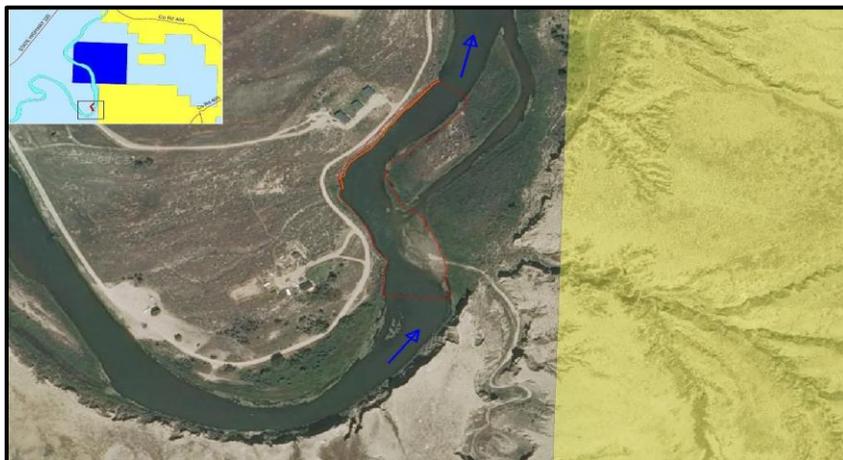
Figure 14. Lusby Public Fishing Access Area on the North Platte River. The area with significant erosion is indicated in orange, while the project area is outlined in red. Note the sediment bar up river from the damaged area that is pushing the river into the opposite bank. Flow direction is shown in blue.

A bank is being eroded along the Lusby PAA easement (Figure 14). Riprap was installed in the same location 20 years ago to protect the bank, but the erosion has progressed downstream. This eroding bank is a consequence of a sharp bend in the river channel. The channel pattern and subsequent erosion may also be influenced by the input of sediment from the far (south) side of the river, forcing or pinching the channel to the north.

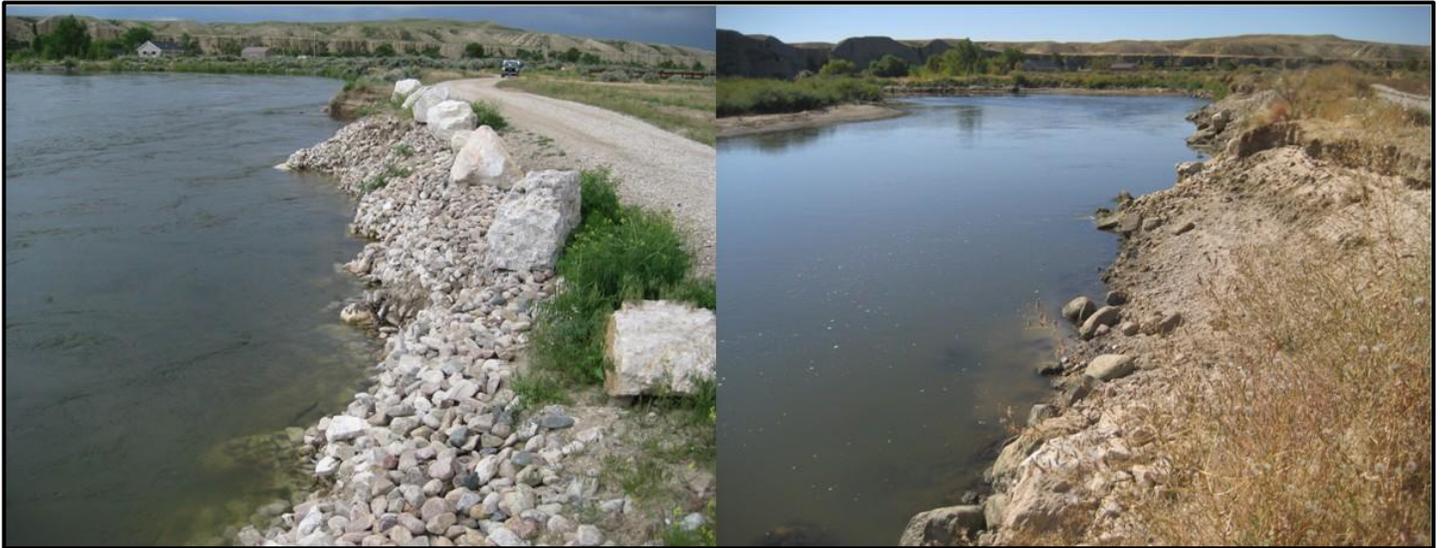
Figure 15. Eroding bank on the Lusby Public Access Area. Pre-runoff (left image, June 2011) bank armoring riprap was lost to high flows (right image, September 2011).

Approximately 150 feet of bank along the North Platte River was armored in July 2010 after washing out following high water. In 2011, another 15-20 feet of the stream bank eroded, taking much of the armoring along with it (Figure 15). This emphasizes the importance of finding a permanent solution to control the bank erosion. Left unchecked, lateral migration of the river will continue.

Currently, about 200 feet of bank is eroded and needing protection. A short-term fix would involve placing additional riprap where the bank is eroding. However, this may simply move the problem downstream and the riprap may be lost again to the next high flows. Long-term solutions will require

additional design, cost estimates and funding. Currently, one idea WGFD has considered is to install a series of barbs along the bank to redirect flow back toward the center of the channel. WGFD is working with cooperators, interest groups, land managers and landowners to protect the integrity of the bank, while concurrently promoting watershed function and ecosystem integrity by enhancing the quality of aquatic habitat along the North Platte.
