# LARAMIE REGION

## LARAMIE REGION HIGHLIGHTS

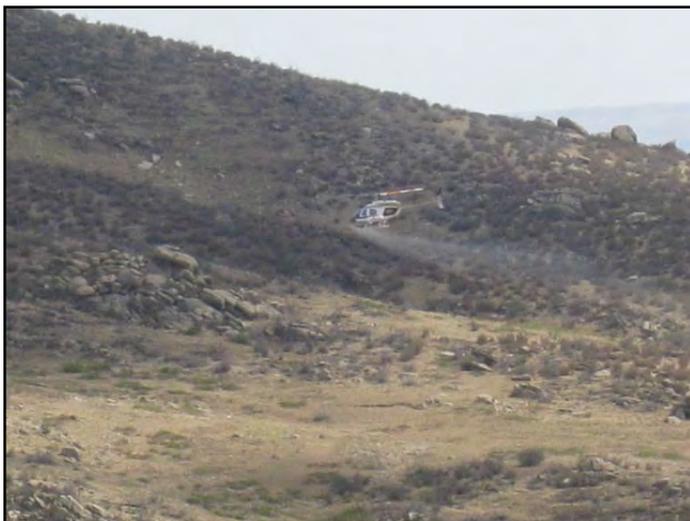
Figure 1. Steep, rugged topography made herbicide application from fixed wing or ground impossible, so a helicopter was used to apply the herbicide.

To address potential cheatgrass invasion following the August 2011 wildfire on Squaw Mountain, located southwest of Wheatland, approximately 5,100 acres of south facing aspects and areas of high fire intensity were aerially treated with imazapic herbicide in September 2012 (Figure 1). Funding from numerous partners was applied for and received to implement the treatment. Several permanent monitoring transects were established pre-treatment to measure herbicide effectiveness. Extreme drought conditions in 2012 resulted in little perennial vegetation recovery post-fire, and at the same time little cheatgrass emergence was seen (Figure 2). Two years of cheatgrass control post-treatment are expected on treated areas. The area serves as crucial winter range for mule deer and elk, and post-fire we expect to see bighorn sheep pioneer into the area as well.

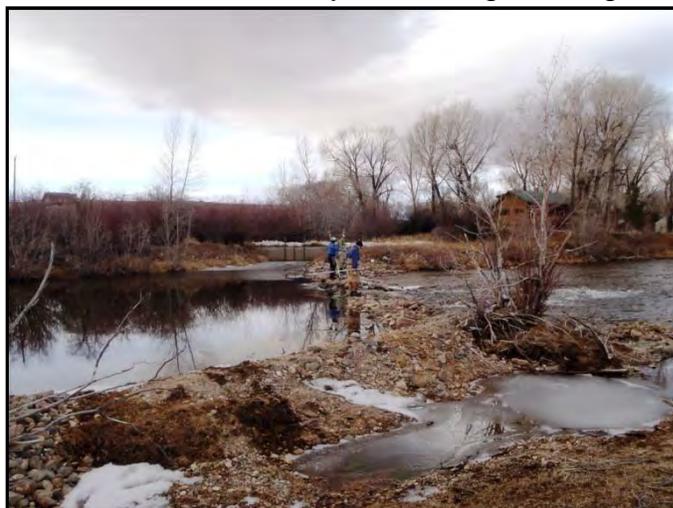
Figure 3. Surveying the Encampment River – Grand Valley Diversion for a new, stable structure and stream channel.

The Encampment River – Grand Valley Diversion improvement aims to remove an existing cobble push-up dam and replace it with a more stable cross-vane structure. In 2012, WGFD contracted with Stantec Consulting Services, Inc. for a survey and design for the diversion, which is located on the Encampment River, near the town of Riverside. Each year, during the irrigation season, heavy equipment is used to push-up the riverbed to divert flow into the Grand Valley Ditch. The push-up dam spans the width of the channel and inhibits upstream fish movement. Downstream of the dam, the channel has become over-widened and cannot efficiently transport sediment. The new diversion structure will allow water users to receive water without having to annually manipulate the riverbed, while also allowing for fish passage (primarily brown trout and rainbow trout). In order to create the stability for the new structure, the stream channel immediately upstream and downstream (~550 ft each direction) will be narrowed and deepened.

Survey work on the river was completed in December 2012, and a design is expected in spring 2013 (Figure 3). Construction is slated for fall 2013. The Saratoga-Encampment-Rawlins Conservation District (SERCD) is the lead for the project and will work closely with the landowners, water users, and funding partners. Other partners for the improvements include; WLCI, USFS Resource Advisory Council, WWNRT, and TU.

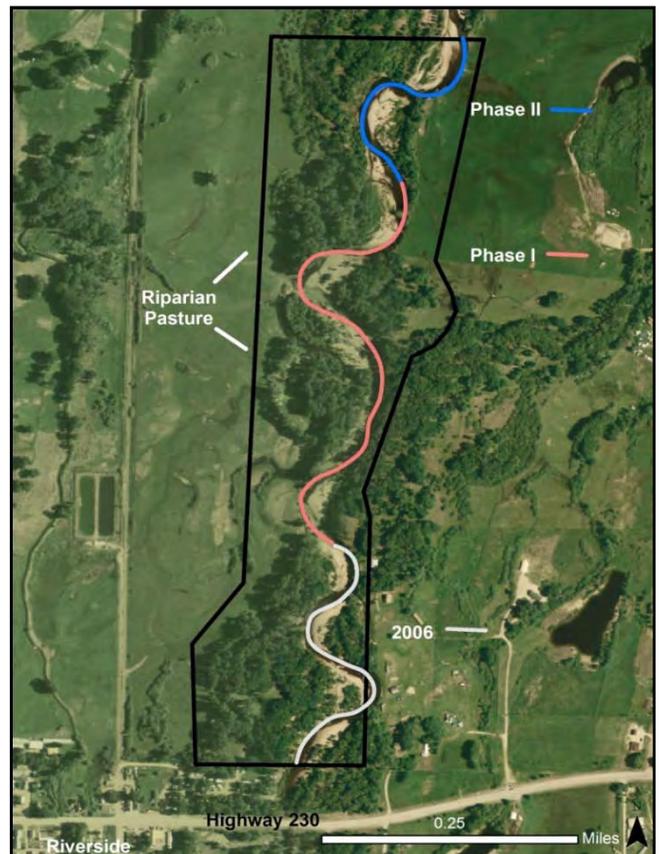
Figure 6. Aerial map of the phases of the Encampment River below Riverside Restoration and the riparian pasture. Phase I represents work completed in 2011 and 2012. Phase II represents work planned for 2013.

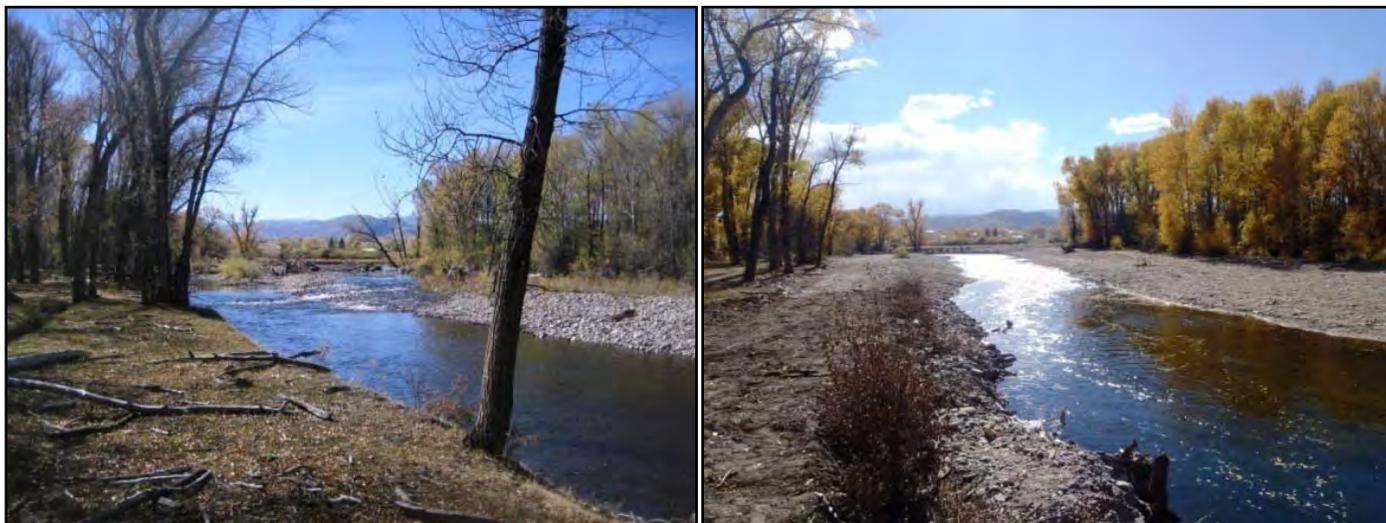
Figures 7a and 7b. The Encampment River below Riverside Restoration Phase I before (left) construction with an over-widened channel, bank erosion and excessive sediment deposition. Following construction (right), the river has a narrower, deeper channel with floodplain benches and toe wood along pool habitats.

channel was restored in 2012, and efforts focused on adjusting meander bends, grading floodplain benches, constructing in-stream rock structures, installing toe wood for bank stabilization, and planting willow stakes and clumps (Figures 7a and 7b). Daily construction oversight was provided by WGFD and TU. Additionally, 6,750 linear feet of fence was installed creating a 77 acre riparian pasture. A 10-year agreement was established between the USFWS and the private landowner for grazing within the riparian pasture.

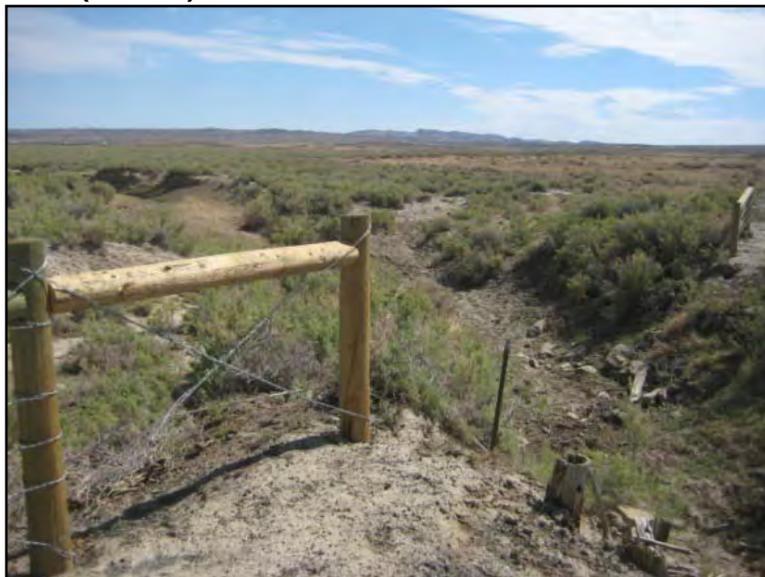
Figure 8. Red Rim - Daley WHMA fence conversion.

A contractor completed the conversion of four and one-half miles of woven wire and five wire fences to improve migration of pronghorn and other big game. The fence was converted to a four – wire wildlife friendly design (Figure 8).

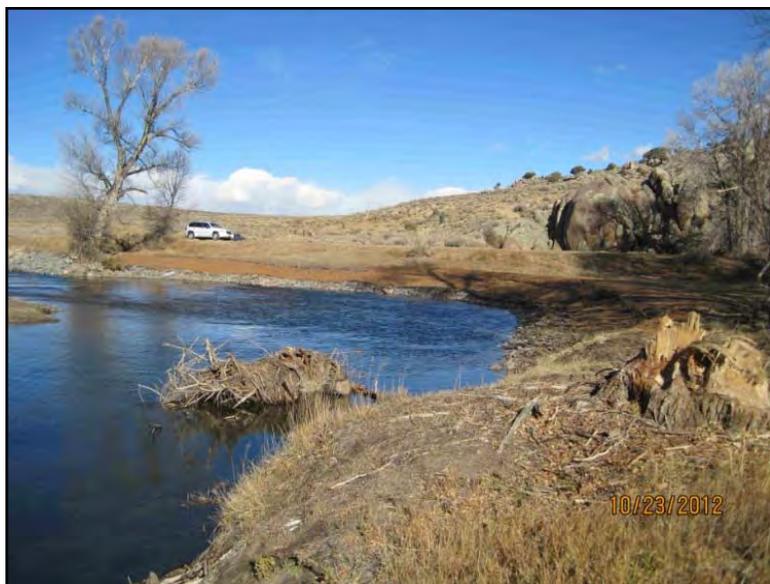
Figure 9. Bank stabilization along the Encampment River on state owned lands.

The Encampment River – School Section Bank Stabilization focused on stabilizing approximately 270 linear feet of eroding streambank on a half section of state land several miles downstream from Riverside (Figure 9). The public has access to the river through the state land via two parking lots. The Encampment River was eroding a bank adjacent to a road. Although the road is private,

the public has pedestrian access to the road. There was concern from the private landowner who uses the access road, as well as safety concerns for the public along the eroding bank. WWC Engineering was contracted to design the stabilization, which entailed re-sloping the bank to a more stable angle, installing rock barbs and rip-rap, and re-seeding the bank. The bank stabilization was constructed in fall 2012.

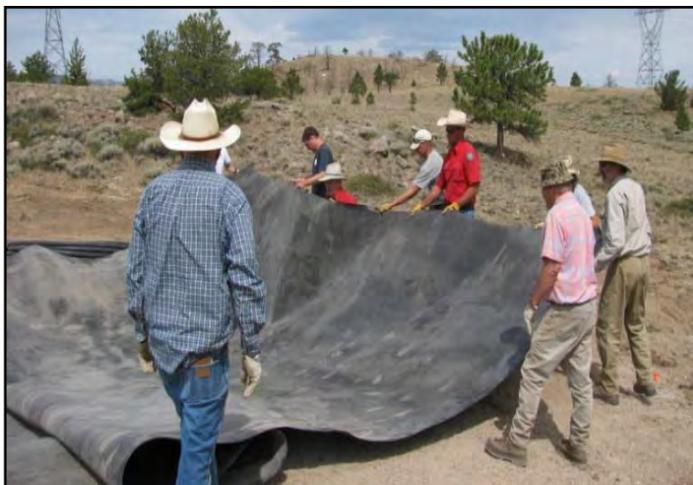
Figure 11. Rolling out the heavy mil plastic catchment apron liner.

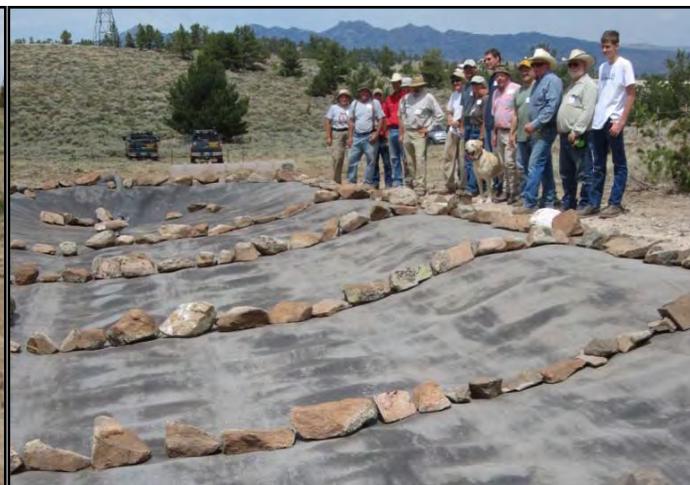
Figure 12. The 100' x 30' catchment apron will catch moisture in the form of snow and rain and transport it to the tank through a small pipeline.

In July 2012, a group of 20 dedicated volunteers and WGFD employees installed a wildlife guzzler on top of the Bennett Mountains near Seminoe Reservoir (Figure 10). The 2,000 gallon capacity guzzler was hauled to the site and initial ground site preparations were completed by the Rawlins BLM Field Office Engineering and Operations staff. The guzzler, catchment apron, and livestock exclusion fence were installed by members of the Wild Sheep Foundation, BOW, RMEF, and WGFD personnel (Figures 11 and 12).

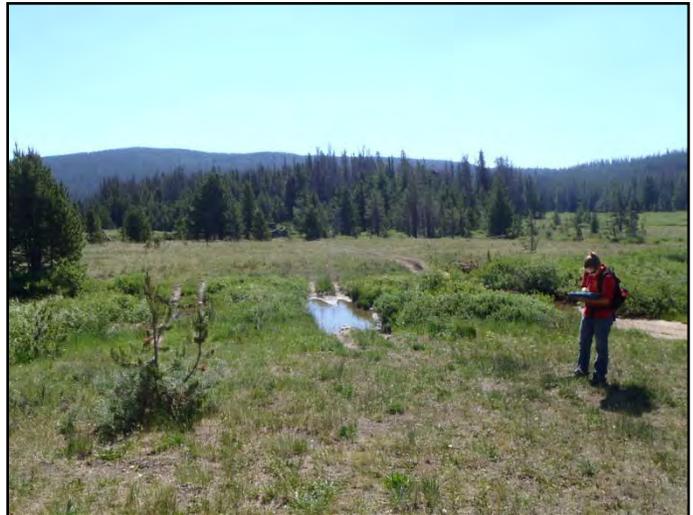
Figure 13. Three separate ATV crossings of Camp Creek in the Douglas Creek Watershed.

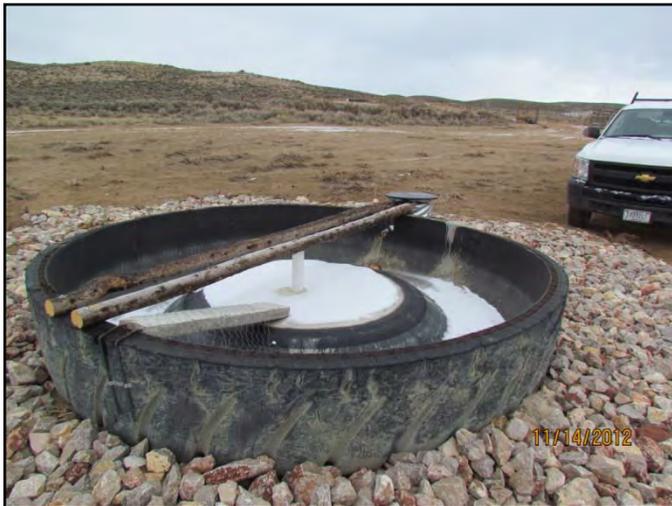
Figure 14. One of seven new tire troughs.

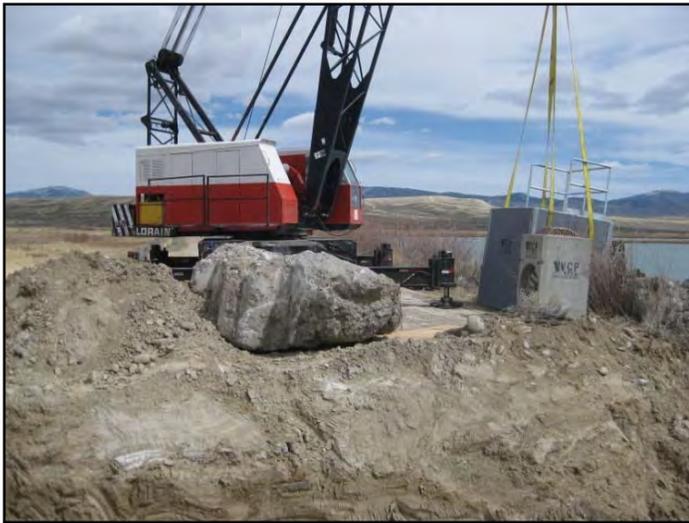
Figure 17. Saratoga Lake control headgate during construction.

A contractor completed the installation of a new control headgate and 100 feet of new culvert to repair the main outlet control structure in the Saratoga Lake dam in 2012. (Figures 17 and 18).

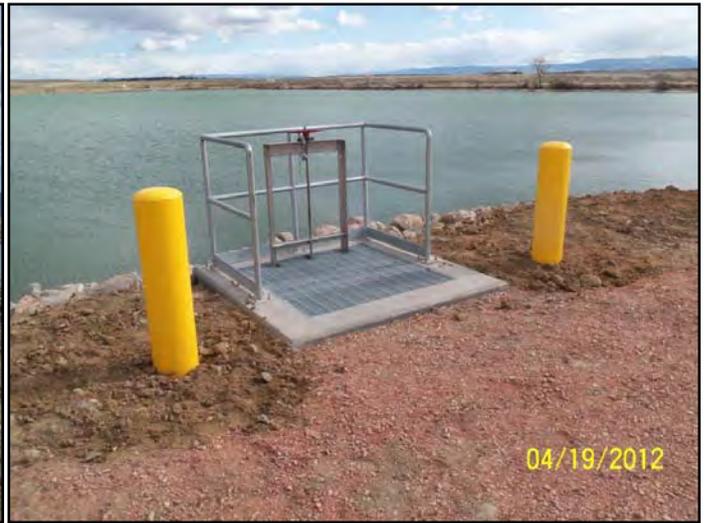
Figure 18. Saratoga Lake headgate completed.

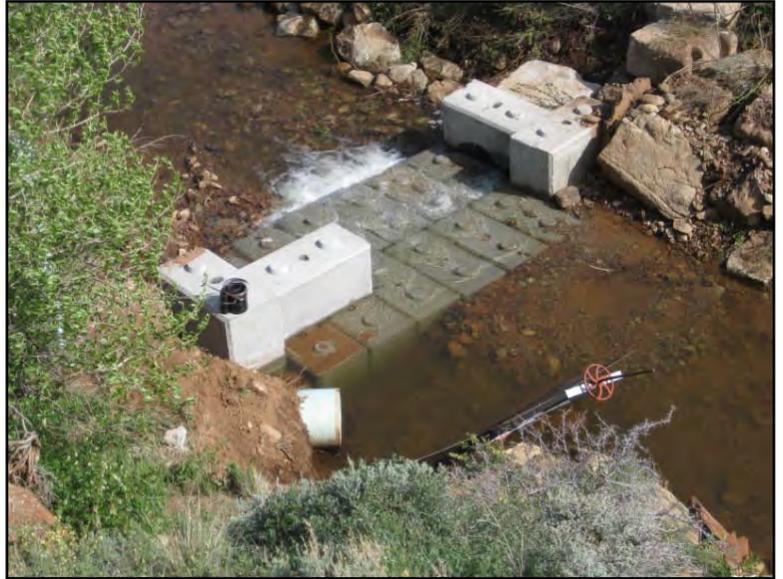
Figure 24. Wick – Olsen diversion structure.

- **Wick WHMA**, 653 acres of hay meadows were irrigated to provide forage for wintering wildlife. A total of 254 acres of noxious weed control was completed by a contractor and 20 miles of crucial winter range fence were maintained. The livestock operator used 220 AUMs on the existing grazing lease. The WGFD crew rebuilt one irrigation diversion structure on the Wick-Olsen ditch (Figure 24).

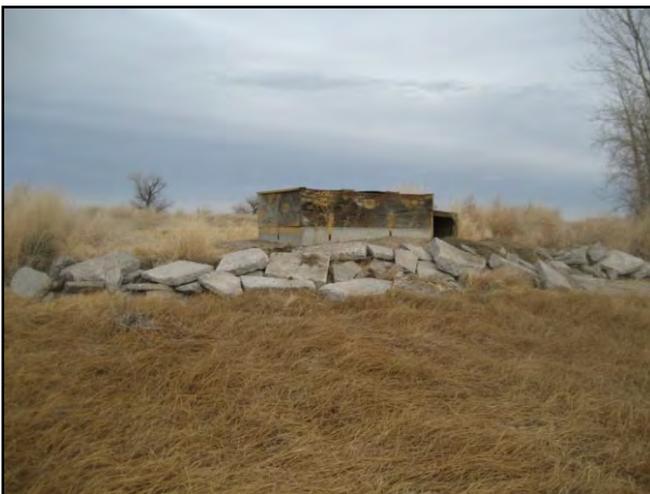
Figure 25. Goose pit with rip rap.

- **Laramie Peak WHMA**, 6 miles of crucial winter range fence were maintained and Albany County Weed and Pest sprayed one acre for noxious weeds.
- **Thorne-Williams WHMA**, 7 miles of boundary fence were maintained, fencing supplies were purchased for three miles of woven wire fence conversion, and 4 acres of noxious weed control were completed by a contractor.
- A noxious weed contractor sprayed 62 acres on the **Springer, Bump Sullivan, and Mac's 40 WHMAs**. 11 goose blinds were re-leveled and rip-rapped at Bump Sullivan Reservoir to prevent erosion and improve public access (Figure 25). Goose nesting structures were repaired and re-bedded with assistance from the Two Shot Goose Hunt volunteers. 6 miles of boundary fence was maintained and the WGFD crew repaired and rip-rapped 1,600 feet of wetland dikes at the Wellnitz ponds (Figure 26).

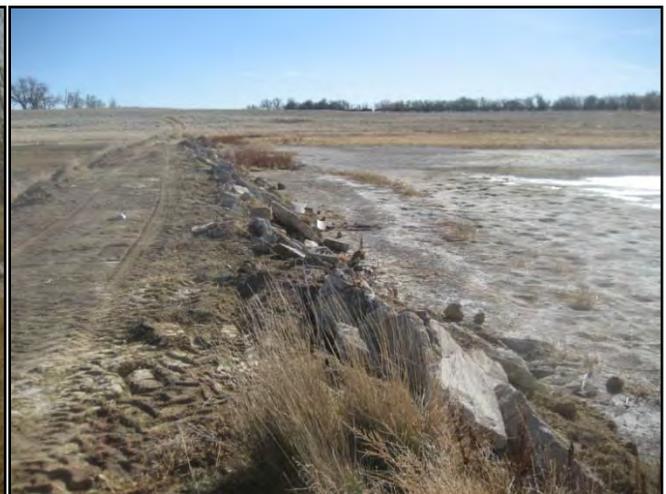
Figure 26. Wellnitz pond dike with rip rap.
