# Response of Prairie Stream Riparian Buffers to Livestock Exclusion and Short-Duration Grazing in Northeast Wyoming- A Pre- and Post- Photographic Comparison

Wyoming Game and Fish Department  
Sheridan Regional Office

# Response of Prairie Stream Riparian Buffers to Livestock Exclusion and Short-Duration Grazing in Northeast Wyoming- A Pre- and Post- Photographic Comparisons

## September 25, 2007

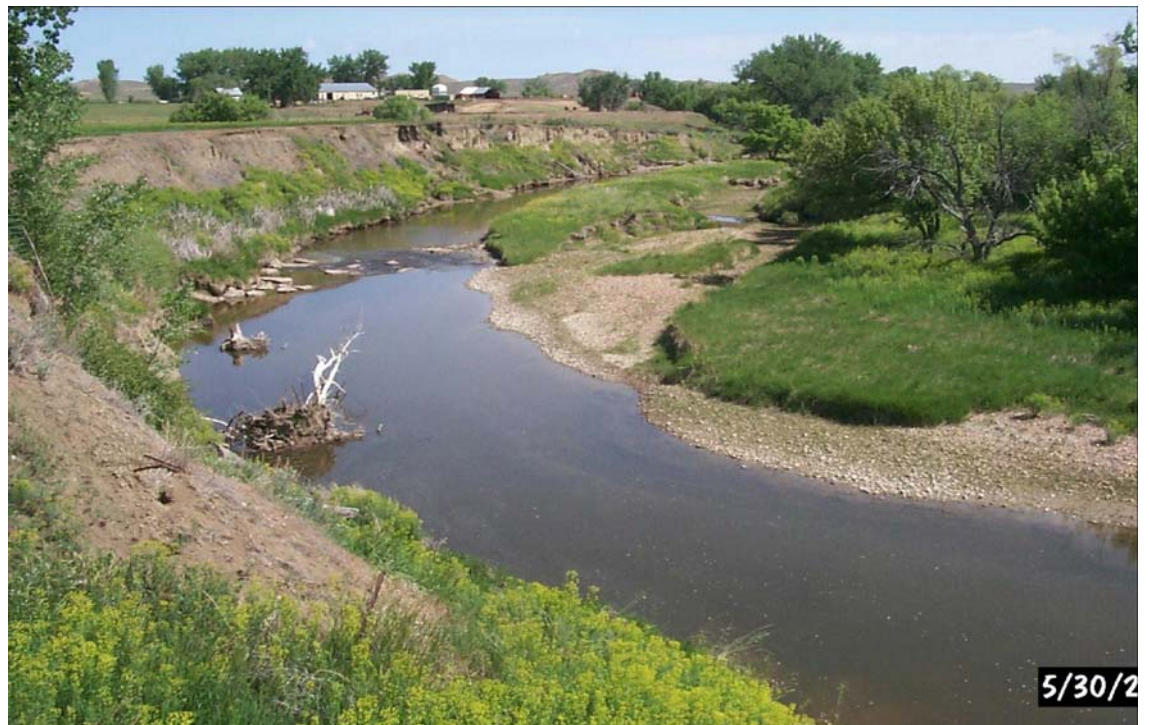
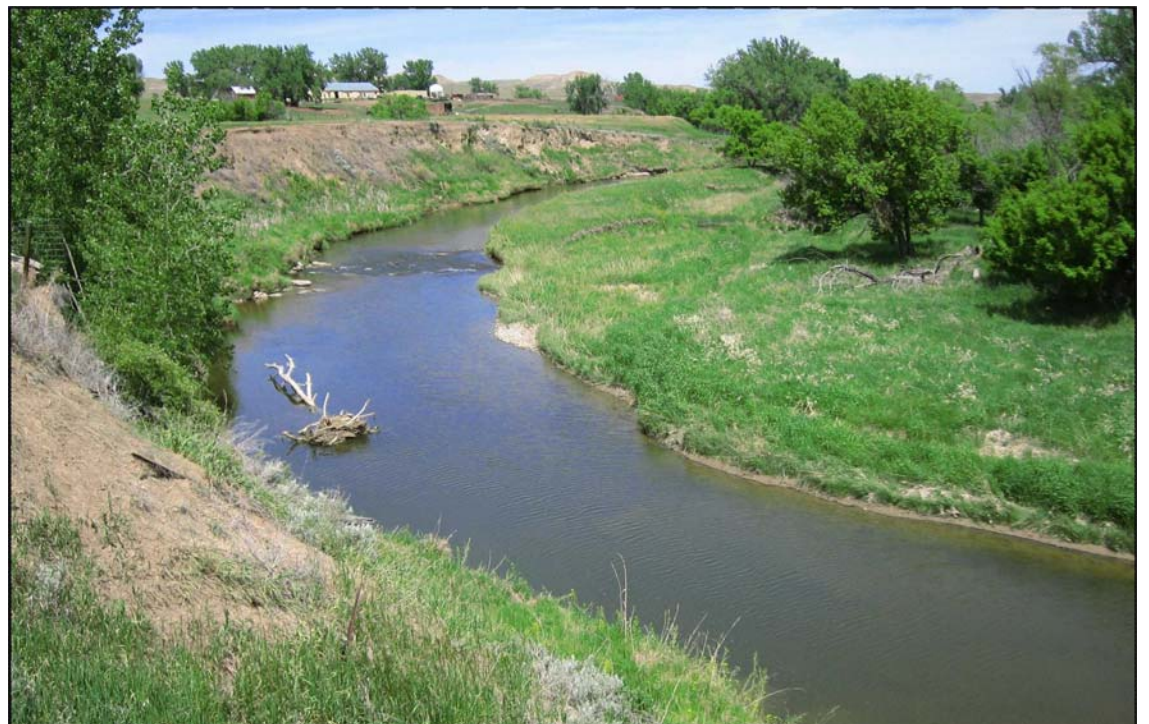
**Original Photo –**  
May 30, 2001.  
Clear Ck. Site 1

**Description -** The lower portion of Clear Creek was enrolled in the FSA’s cCRP for a 15-year period. Additional financial incentives were provided by the WGFD. The landowner fenced 42 acres of riparian-forested community to exclude livestock grazing. This cottonwood/willow community also supports boxelder, chokecherry, native plum and other species generally found in wooded draws of the Northern Great Plains. Leafy spurge (*Euphorbia esula*), which is very invasive plant, was one of the dominant understory plants occurring in the original picture. The dramatic decline in leafy spurge (yellow flowered forb) is due to the landowner’s persistence in releasing and relocating flea beetles, a bio-control agent. Also notice that the point bar is developing vegetation and collecting sediment, resulting in steeper inside banks.

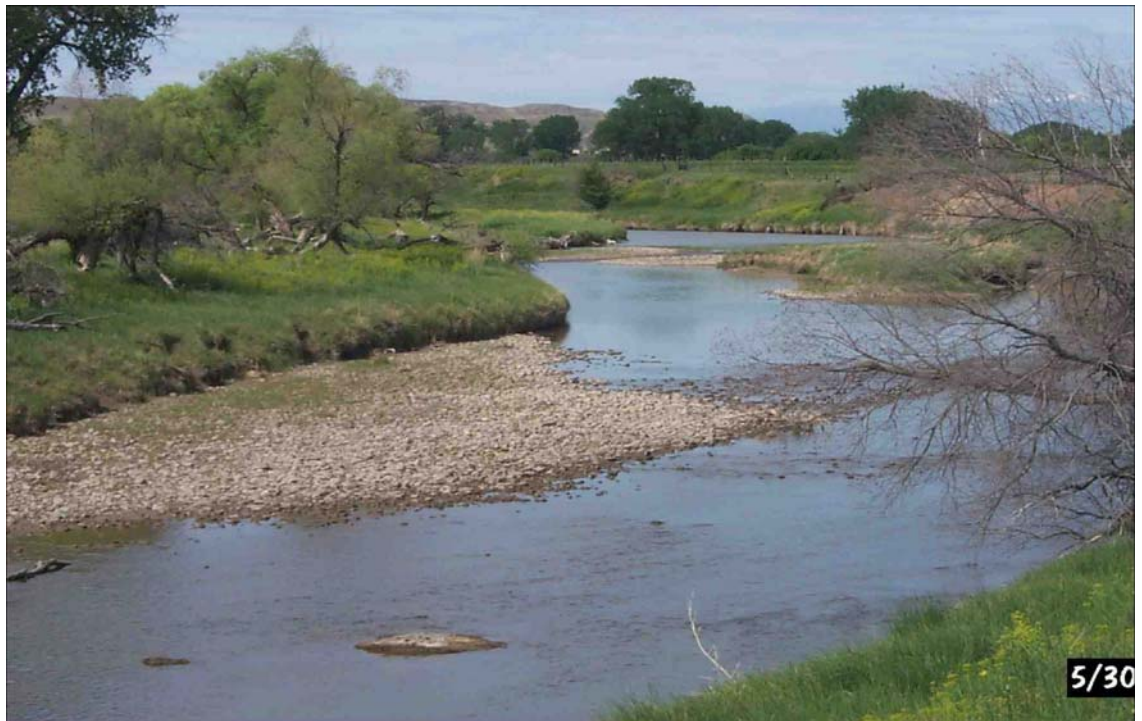
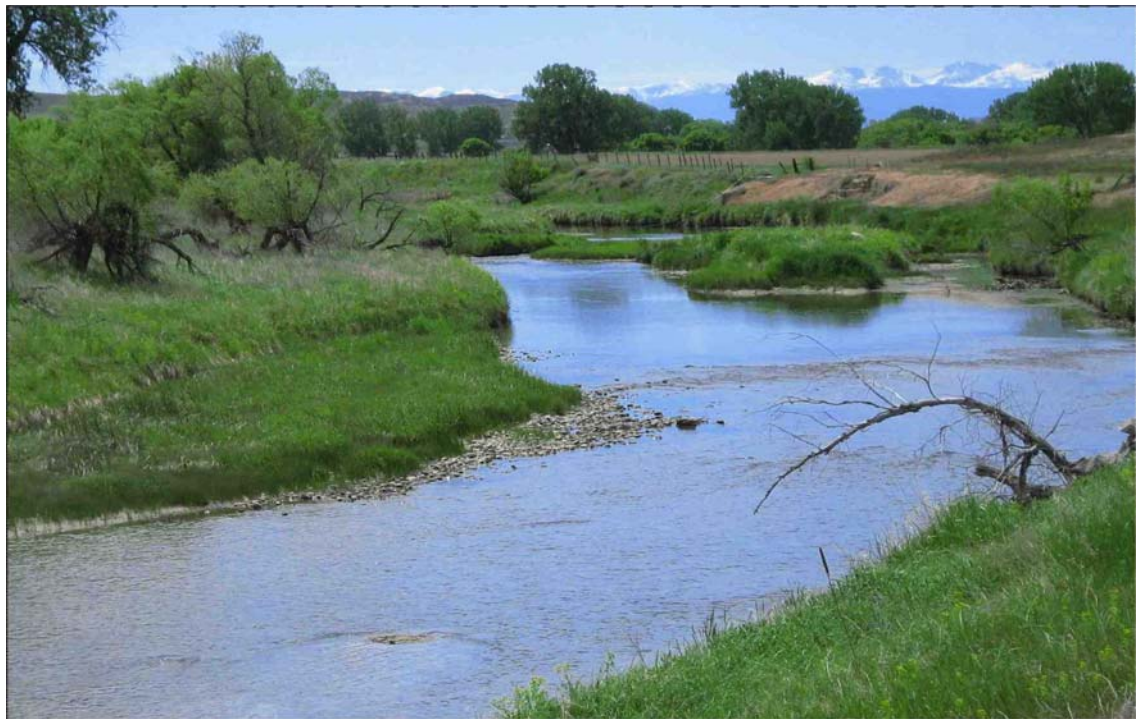
**Original Photo –**  
May 30, 2001.  
Clear Ck. Site 1

**Description** – Cobble and gravel point bars were common sights along the prairie streams being photo monitored. After five years of rest, these gravel point bars became armored with herbaceous vegetation, which has the capacity to collect small amounts of sediment during high water events. As point-bars raise, a capillary fringe that's above the zone of saturation develops. At that time, terrestrial phreatophytic vegetation, such as willow and cottonwood species, begins to respond. Once woody vegetation establish, the rate of deposition greatly accelerates. Ultimately, the bars are expected to build to the elevation of the existing floodplain and narrow the stream channel.

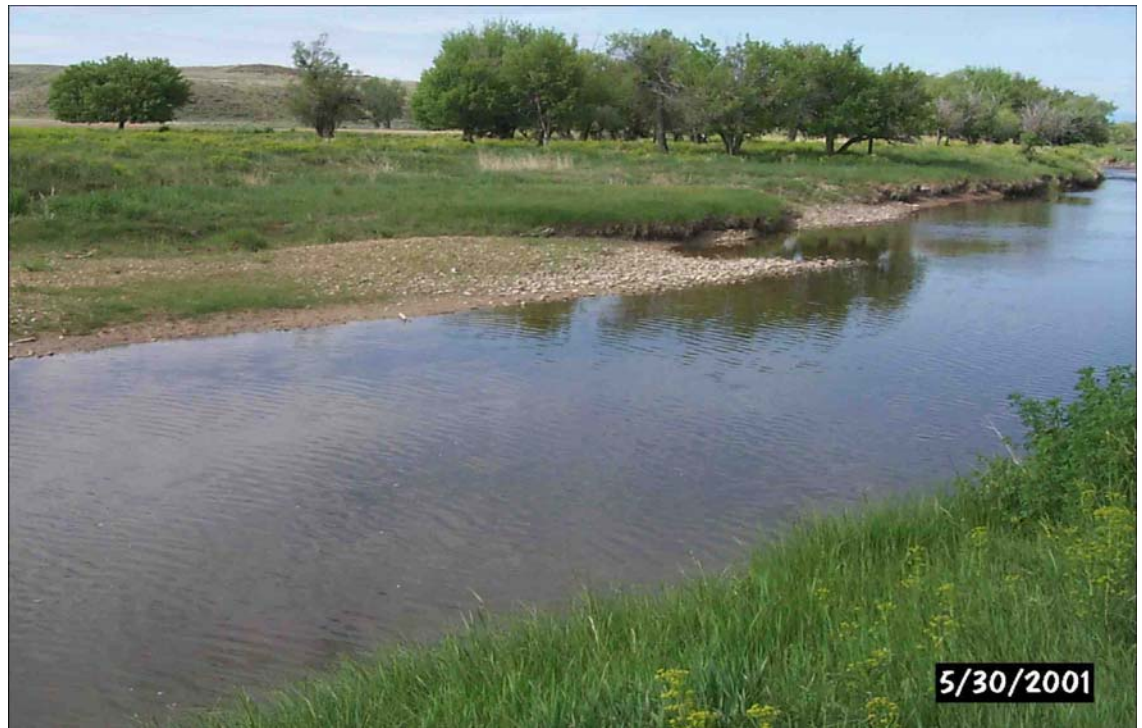
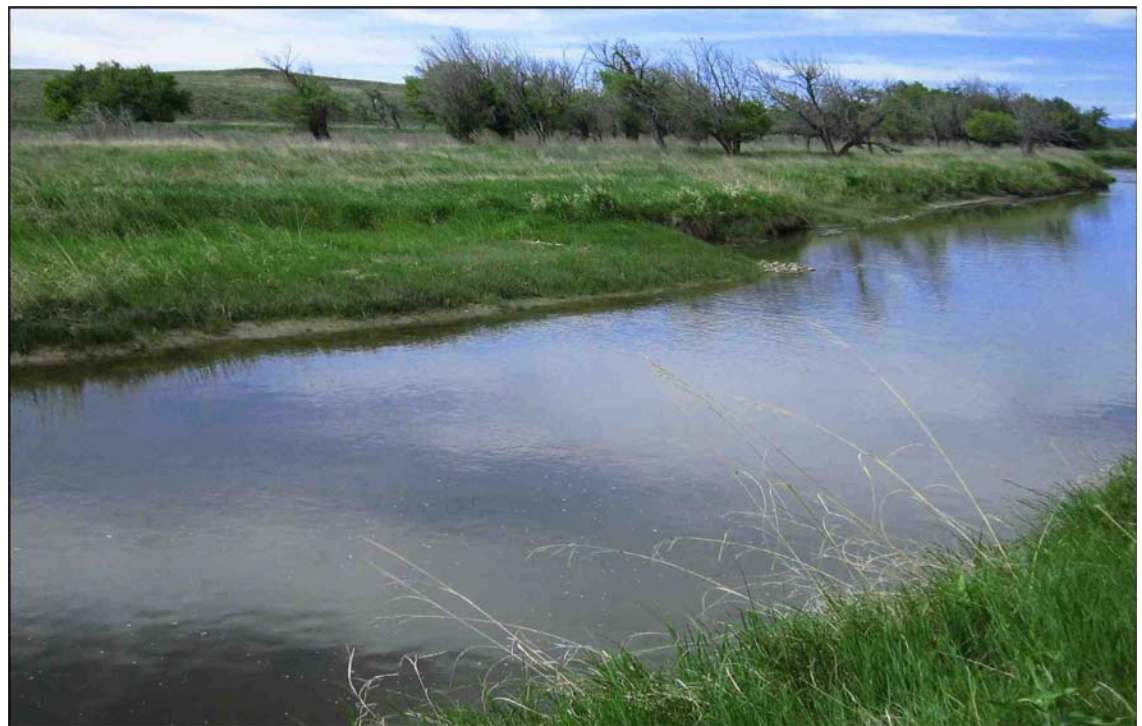
**Original Photo –**  
May 30, 2001.  
Clear Ck. Site 1

**Description** – Again, leafy spurge was a dominant understory plant along this riparian buffer strip in 2001, prior to releasing and relocating flea beetles. The boxelder trees (*Acer negundo*) in the background show considerable stress due to the prolonged drought. Mortality and reduced vigor were also observed in old-growth plains cottonwoods (*Populus deltoids*).

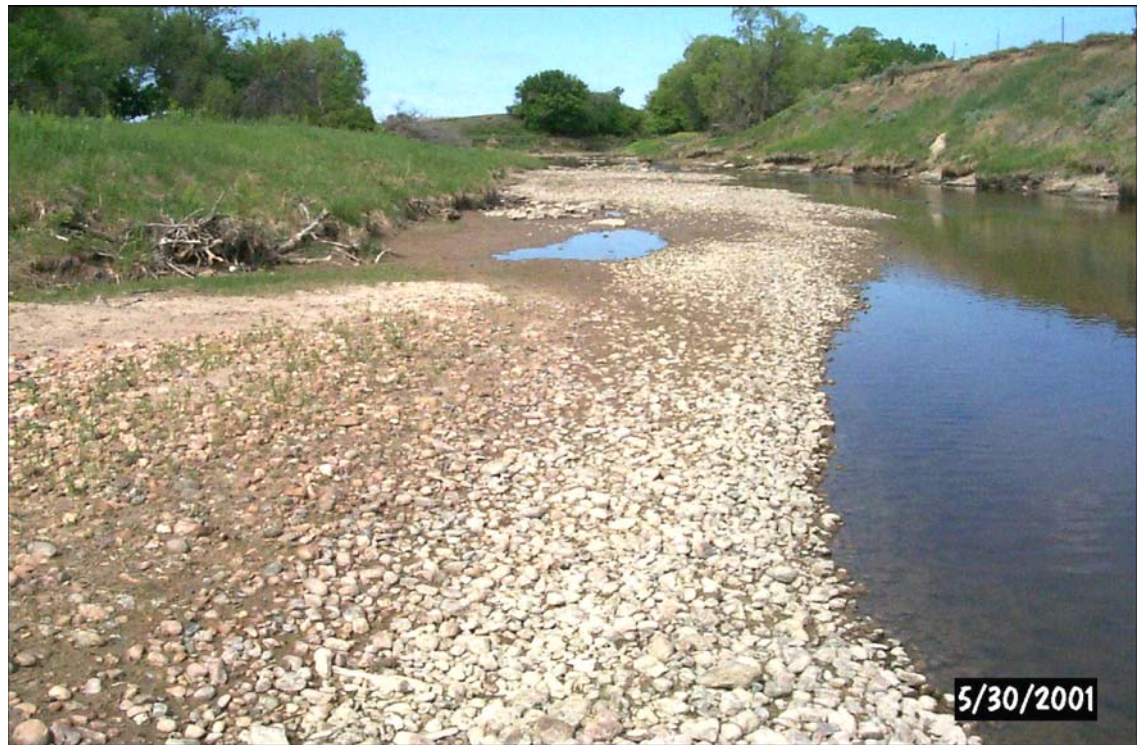
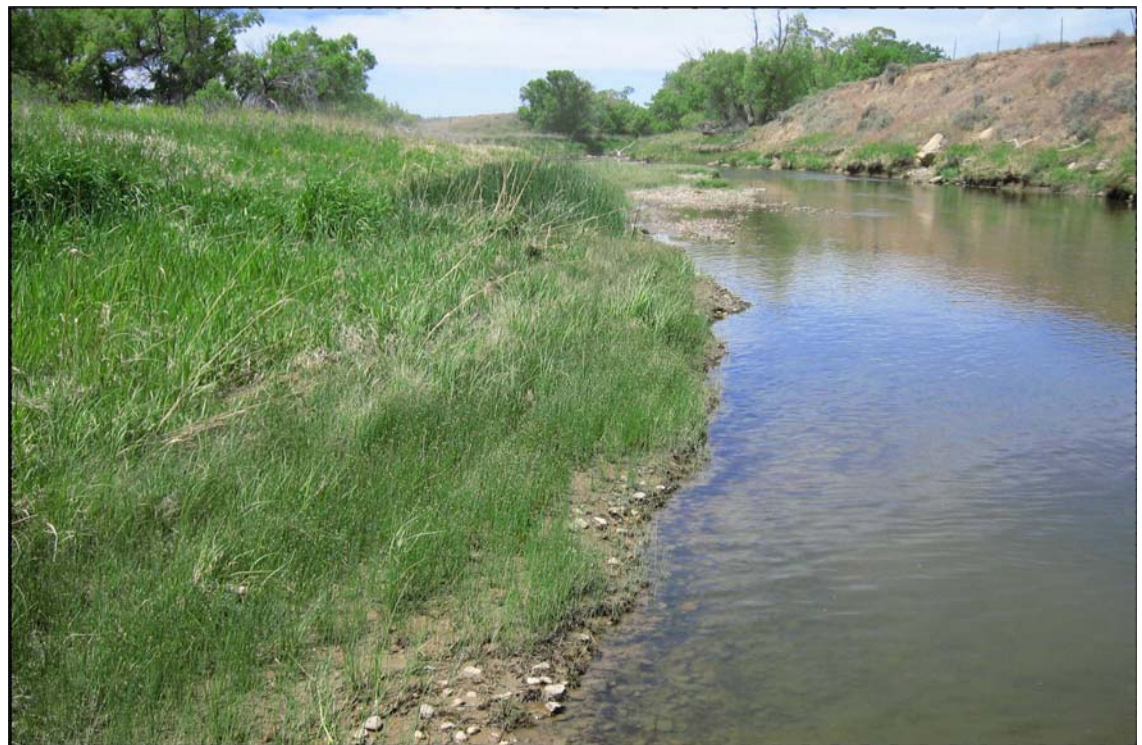
**Original Photo –**  
May 30, 2001.  
Clear Ck. Site 1

**Description** – The gravel point bar seen in the original picture shows considerable improvement after five years of livestock exclusion. With vegetation established, the stream is protected during high water events and can filter sediments, which will further reduce the width-to-depth ratio. Once deposition occurs, there seems to be a full complement of plant species that are well adapted to occupy and secure these new soils under most hydrologic conditions. Consequently exposed soils are rarely apparent. At this site, emergent aquatic vegetation is established in the saturated soils (low spot on the point bar) and sedge and rush species are occupying soils that are periodically saturated.

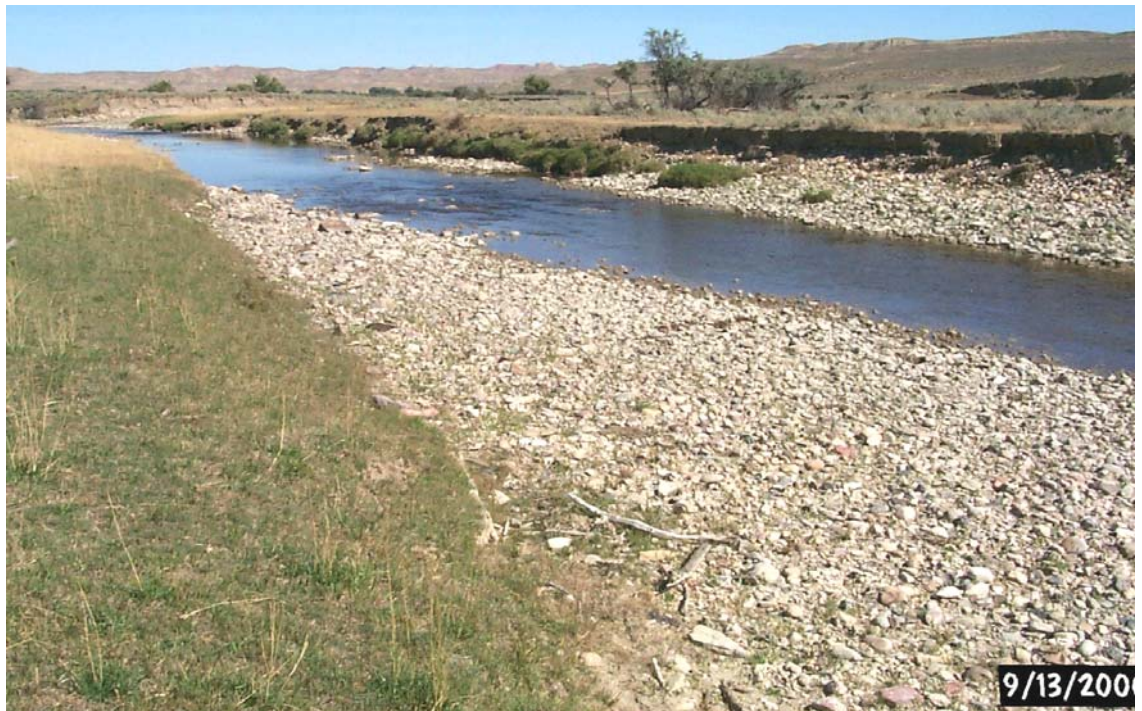
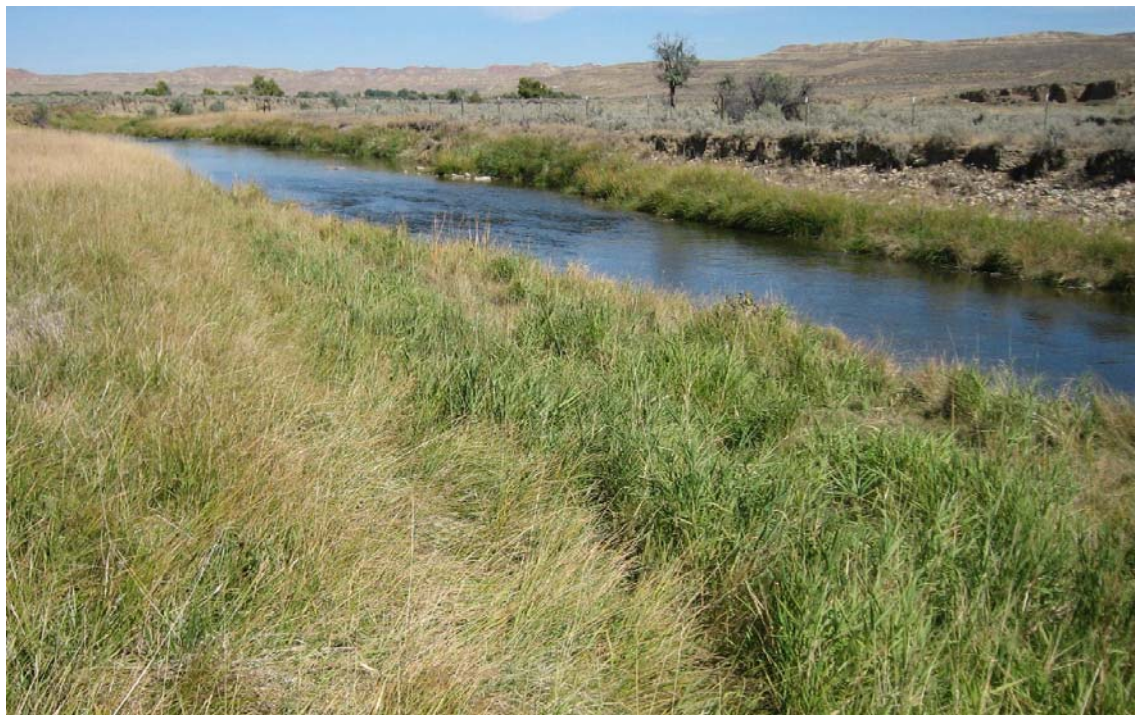
**Original Photo –**  
Sept. 13, 2000.  
Clear Ck. Site 2

**Description** – Another 15-year cCRP riparian buffer strip exists upstream on Clear Creek. As with the previous cCRP, additional financial incentives were provided by the WGFD. This landowner fenced 73 acres of riparian habitat. Most of which has the potential of supporting a cottonwood/willow community. In many cases, invading noxious weeds quickly occupy exposed soils. The landowners spent considerable time and money controlling them until native vegetation could establish.

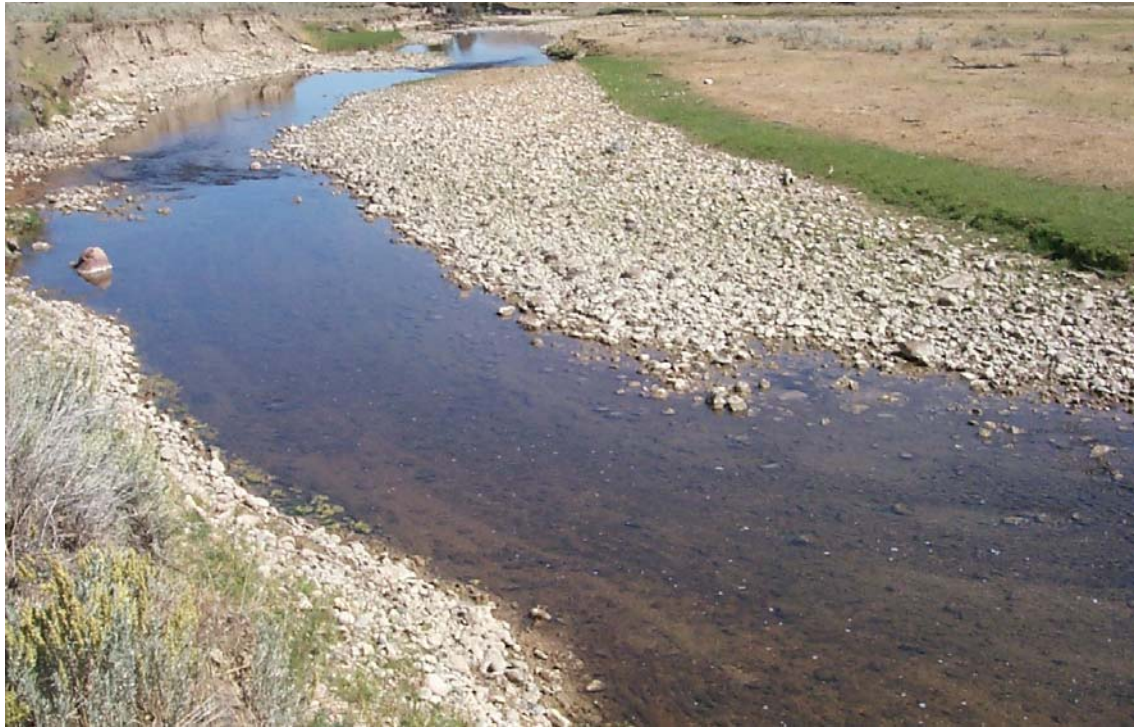
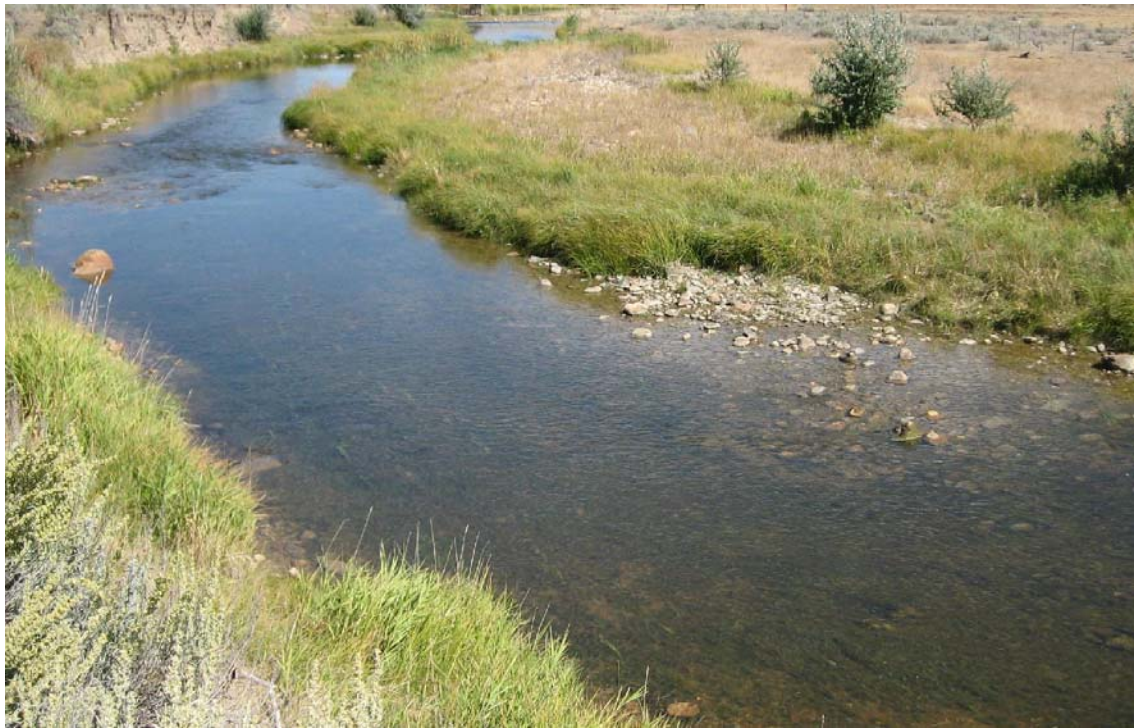
**Original Photo –**  
Sept. 13, 2000.  
Clear Ck. Site 2

**Description** – Large cobble point bars and outside meander cut banks were a common occurrence on this section of Clear Creek. Six years of livestock exclusion have allowed perennial wetland vegetation to colonize the point-bars, which continue to collect and trap sediment. Although not observable in this photo retake, woody plants are also establishing on most point-bars. In addition, a healthy riparian green-line is developing near steep cut banks (note vegetation along the outside meander). Lateral movement will eventually undercut this stabilized bench and create habitat for brown trout (*Salmo trutta*). Russian olive (*Elaeagnus angustifolia*) is also establishing.

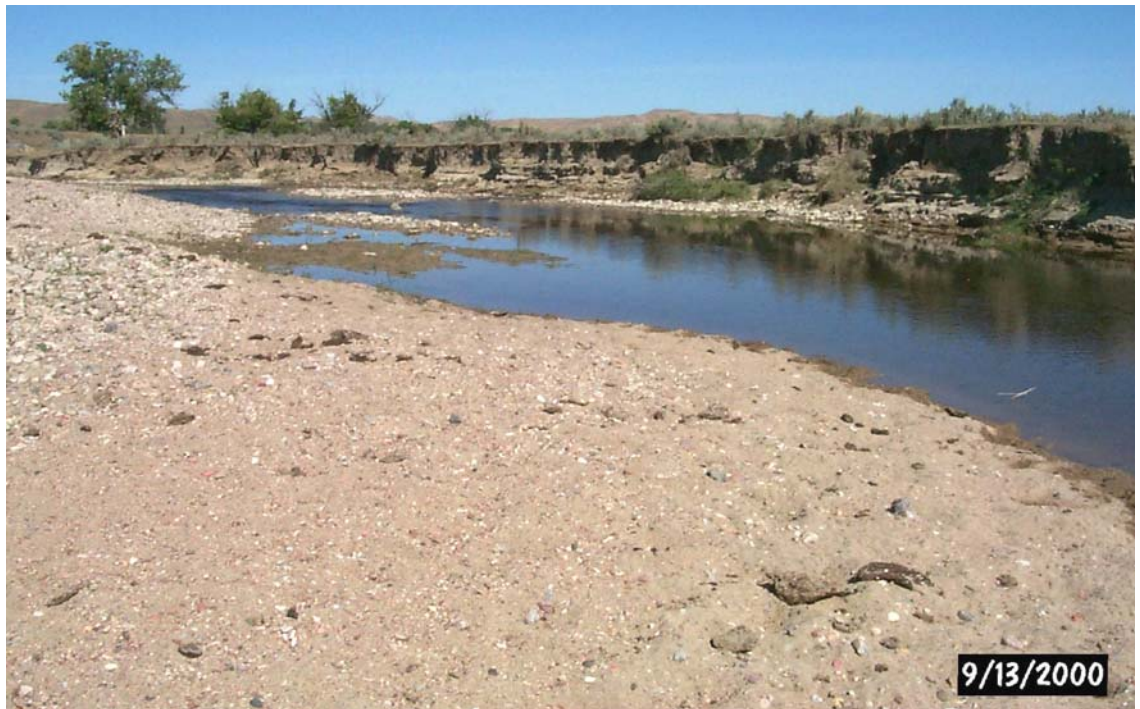
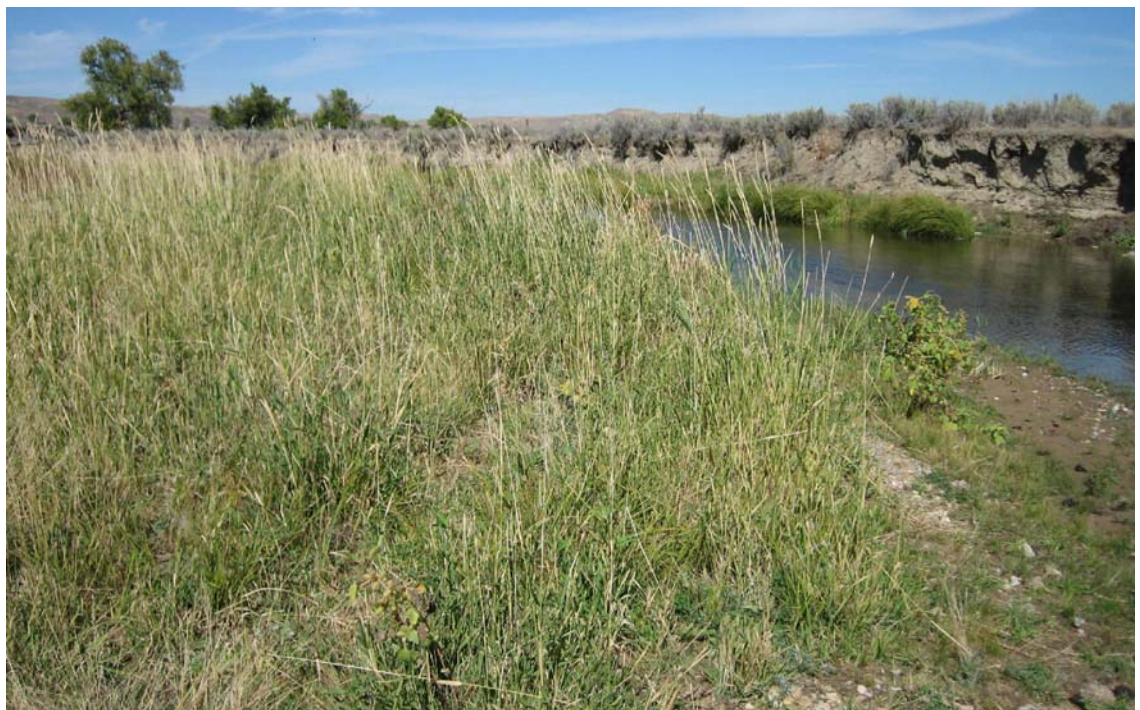
**Original Photo** –  
Sept. 13, 2000.  
Clear Ck. Site 2

**Description** – Note the perennial vegetation that has established along the cut bank on the outside bend of the oxbow. The long-term stability of this vegetation is unknown, but it's conceivable that over time, a stable floodplain bench may develop and the angle of repose may improve along the face of the cut bank. The bench would reduce the erosive power of future high water events. Woody vegetation has also begun to establish on the point bar.

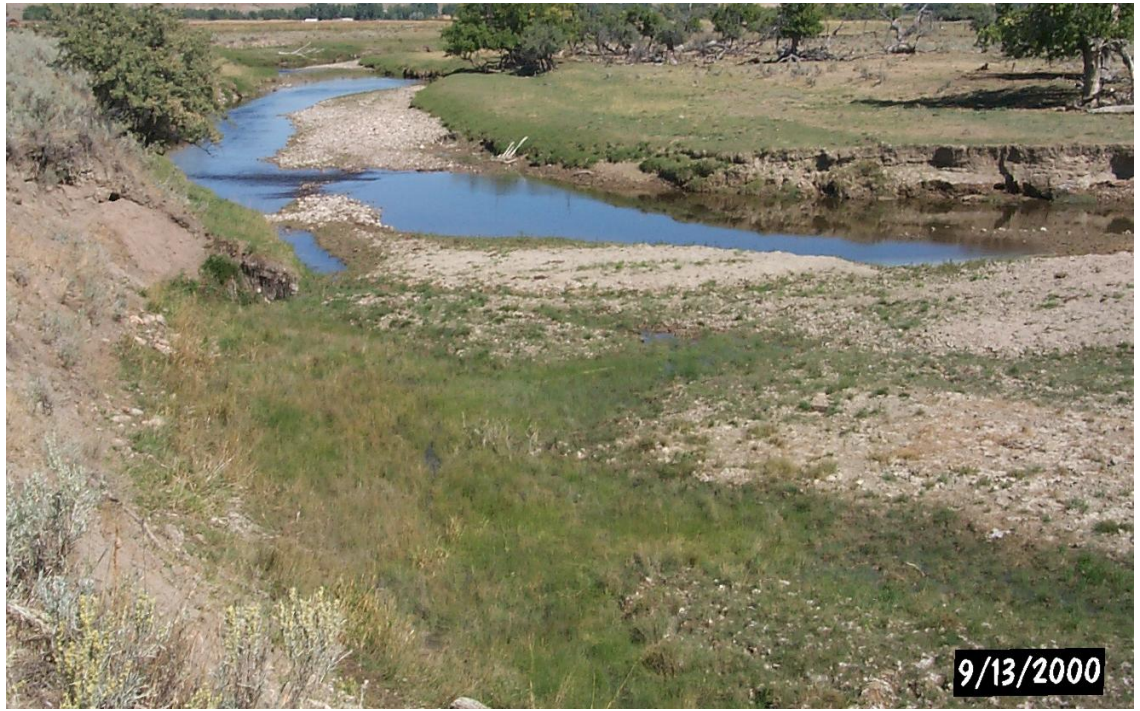
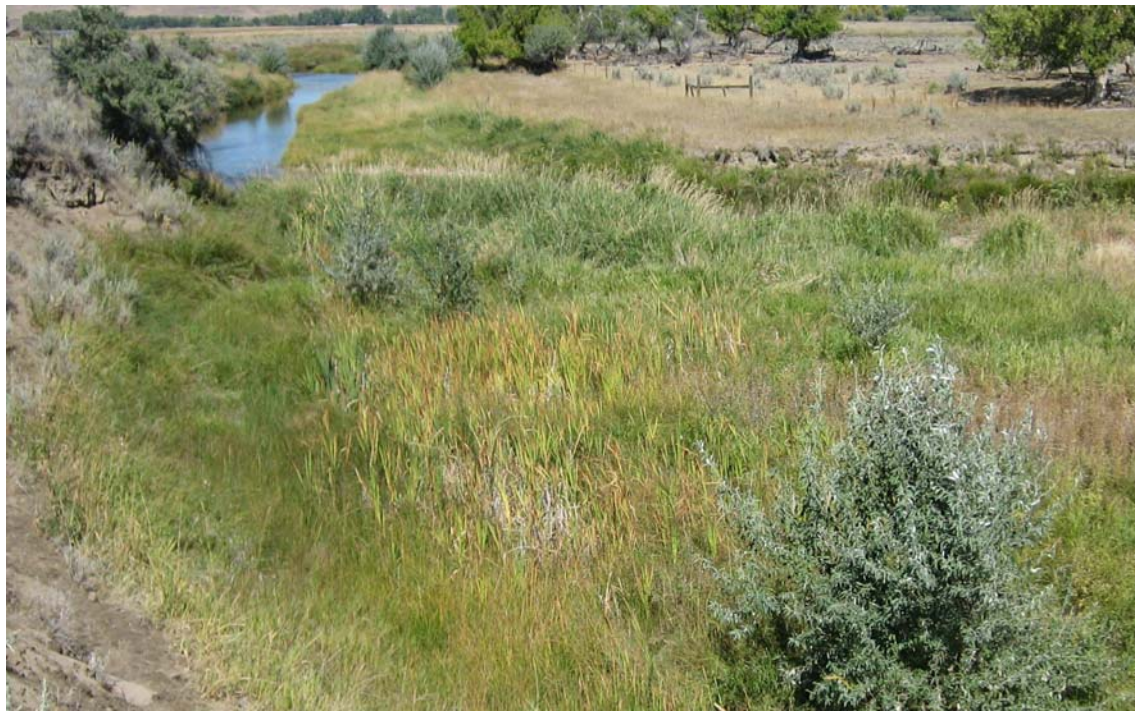
**Original Photo –**  
Sept. 13, 2000.  
Clear Ck. Site 2

**Description** –Tall, deep-rooted herbaceous vegetation is establishing within the riparian greenline on both point bars and steep cut banks. This vegetation could plausibly develop an angle of repose that further protects the streambank from erosion. As floodplain soils deepen and remain moist, tall plant species quickly dominate the community, such as basin wildrye (*Leymus cinereus*), Reed canarygrass (*Phalaris arundinacea*), prairie cord grass (*Spartina pectinata*) and common cattail (*Typha latifolia*). Unfortunately, Russian olive (*Elaeagnus angustifolia*) is also establishing where seed sources exist.

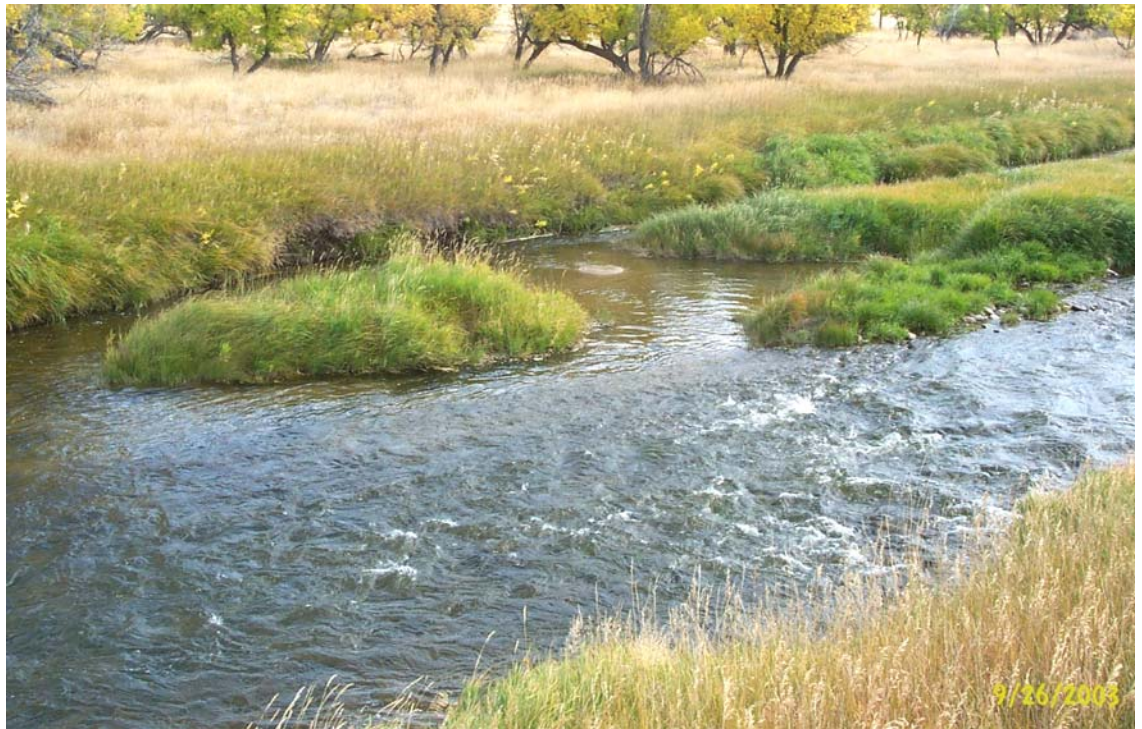
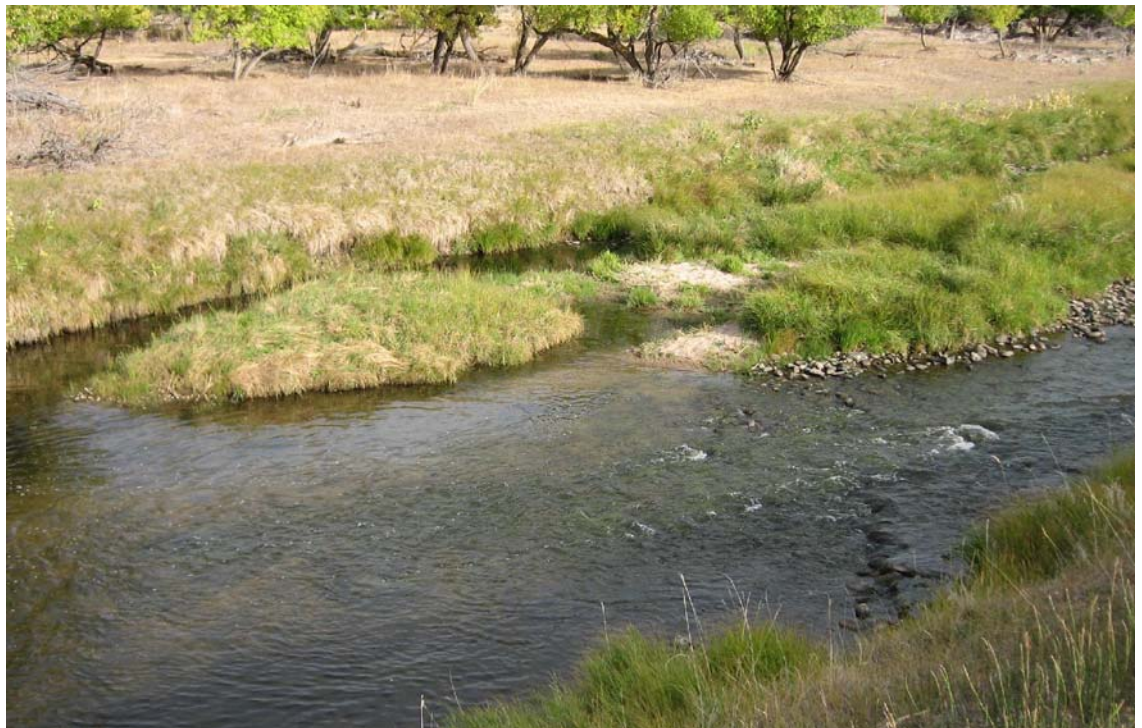
**Original Photo –**  
Sept. 26, 2003.  
Clear Ck. Site 3

**Description** – The third site on Clear Creek is a 104 acres riparian buffer strip with 54 acres qualifying for the FSA’s cCRP. Notice the two islands that are filling and connecting. As sediment accumulates in the vegetation buffer, we expect the island will connect with the floodplain and the channel width-to-depth ratio will narrow substantially. Most islands within the riparian buffer strips being monitored seem to be undergoing a similar process.

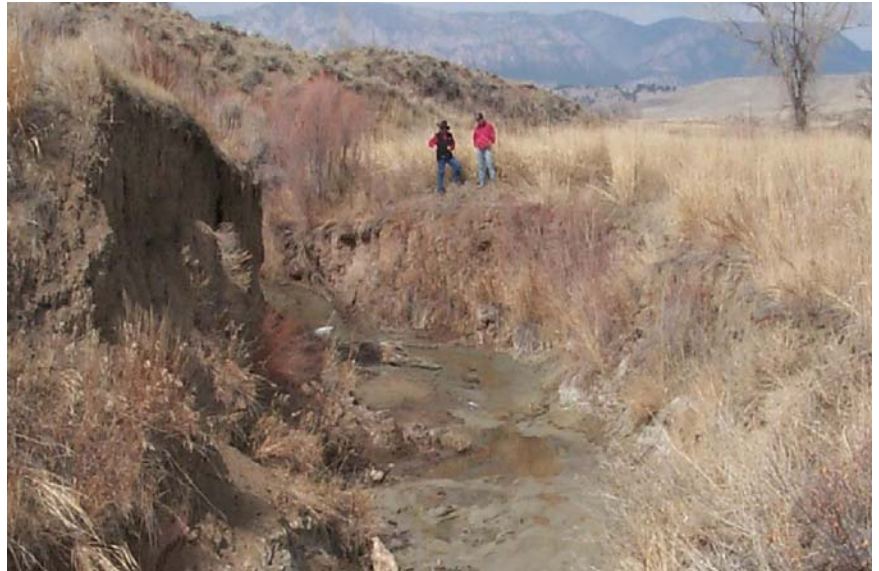
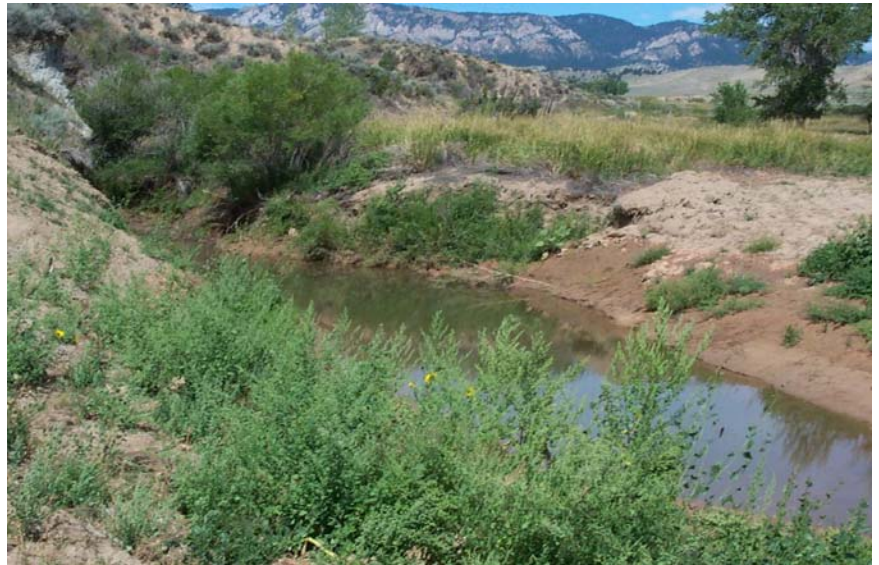
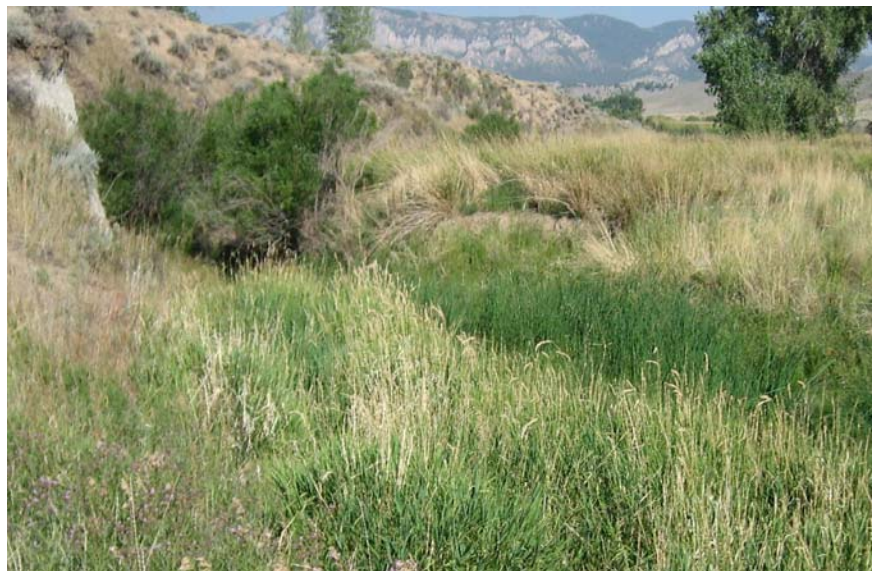
**Original Photo –  
March 2001.  
Muddy Creek**

The incised channel (shown in the original photo) was the consequence of the stream being straightened in the 1970's. Channel length decreased from 3,400 to 747 linear feet during this process. The straightened channel allowed the water to accelerate through the area with high erosive power. Over time, the channel was able to cut a thirteen-foot deep gully. After enrolling in the cCRP program the NRCS and WGFD worked together to return the stream to its original meandering course, thus stabilizing the degradation process. Five years after enrollment, little evidence remains to detect previous effects.

This cCRP excludes livestock grazing from approximately 30.5 acres with 19 acres qualifying for the FSA's cCRP.

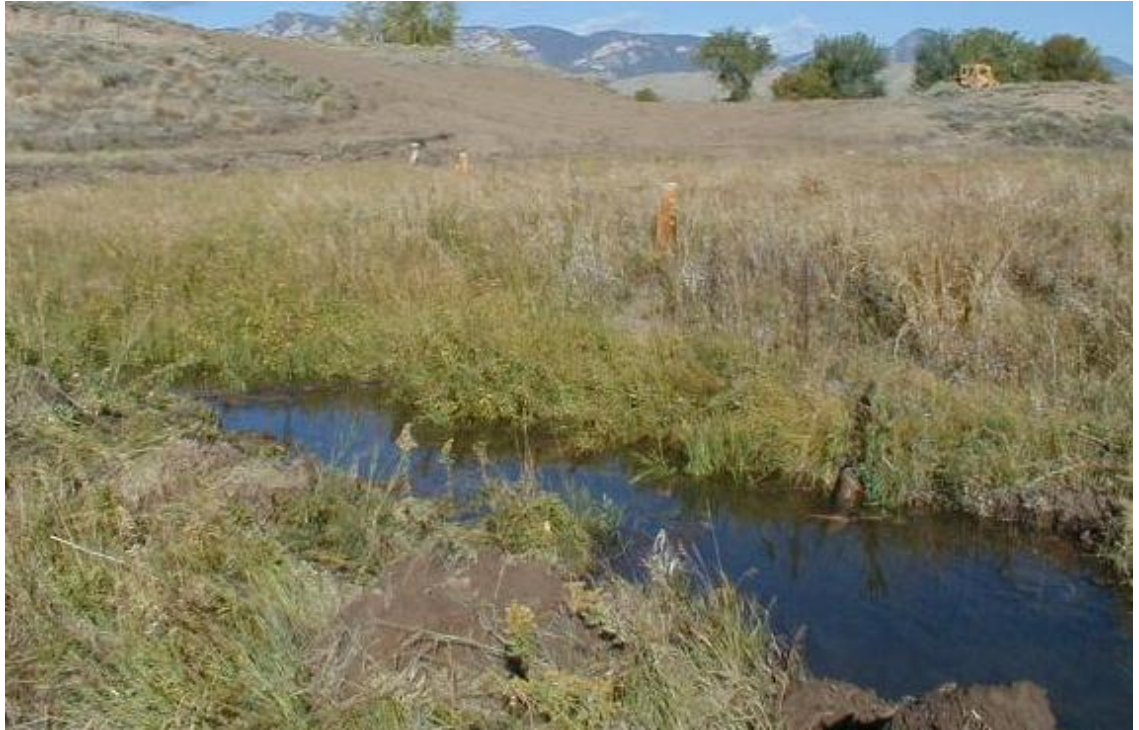
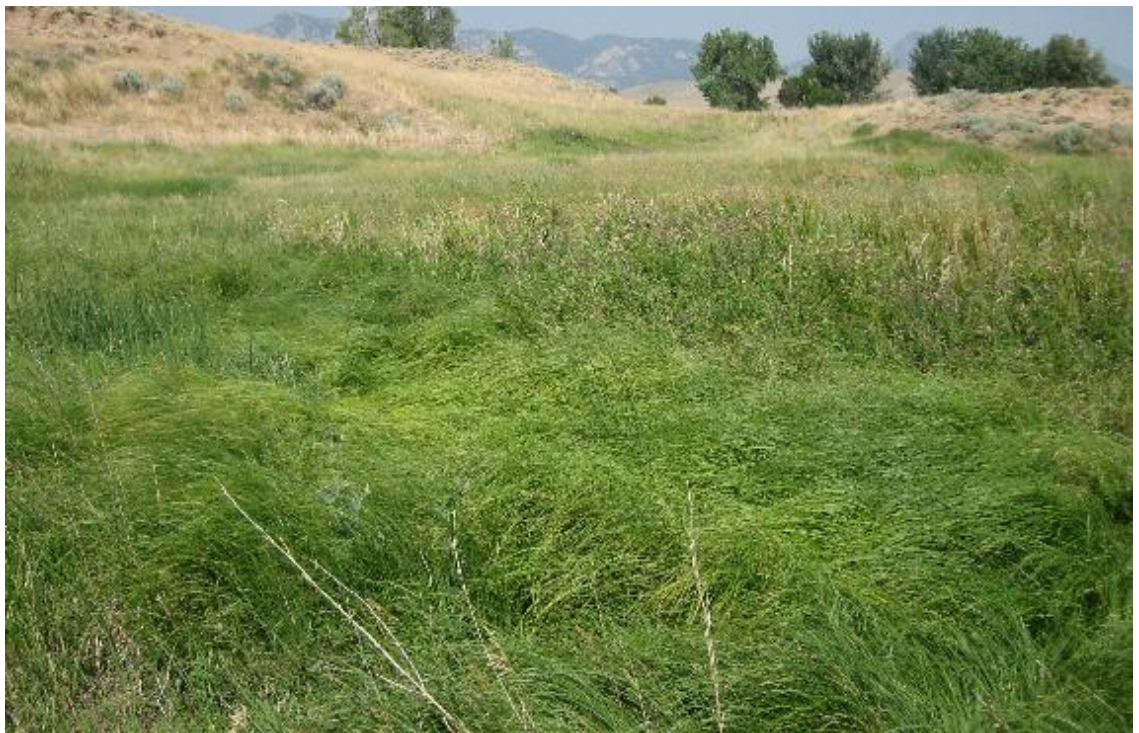
**First Retake –**  
August 2002.  
Muddy Creek

This picture was taken shortly after the stream was returned to its original meandering channel.

**Description** – The channel seen in the first retake occurred shortly after diversion-dikes returned the stream to its original meandering channel. The new water course raised the water table throughout the flood plain and restored hydrologic conditions for growing preferred riparian plant species. The channel is covered with overhanging vegetation that maintains cooler water during the summer months, thus enhancing conditions for trout. Basin wildrye is now dominating upper-terrace soils found in the floodplain.

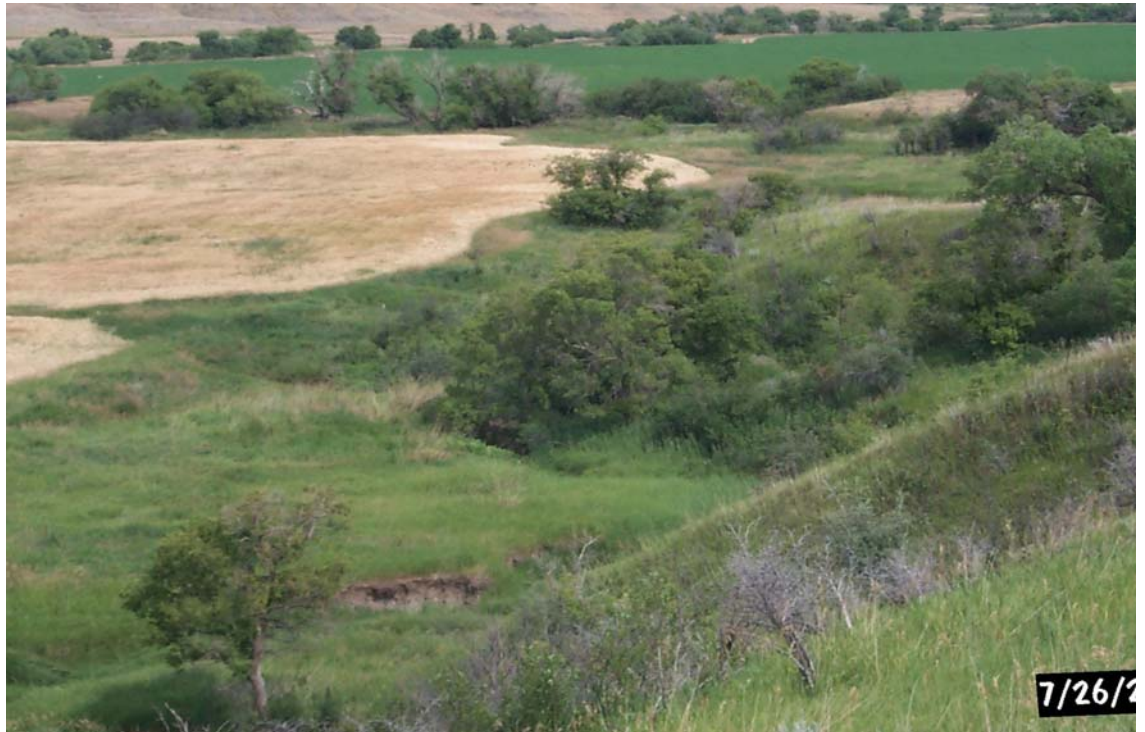
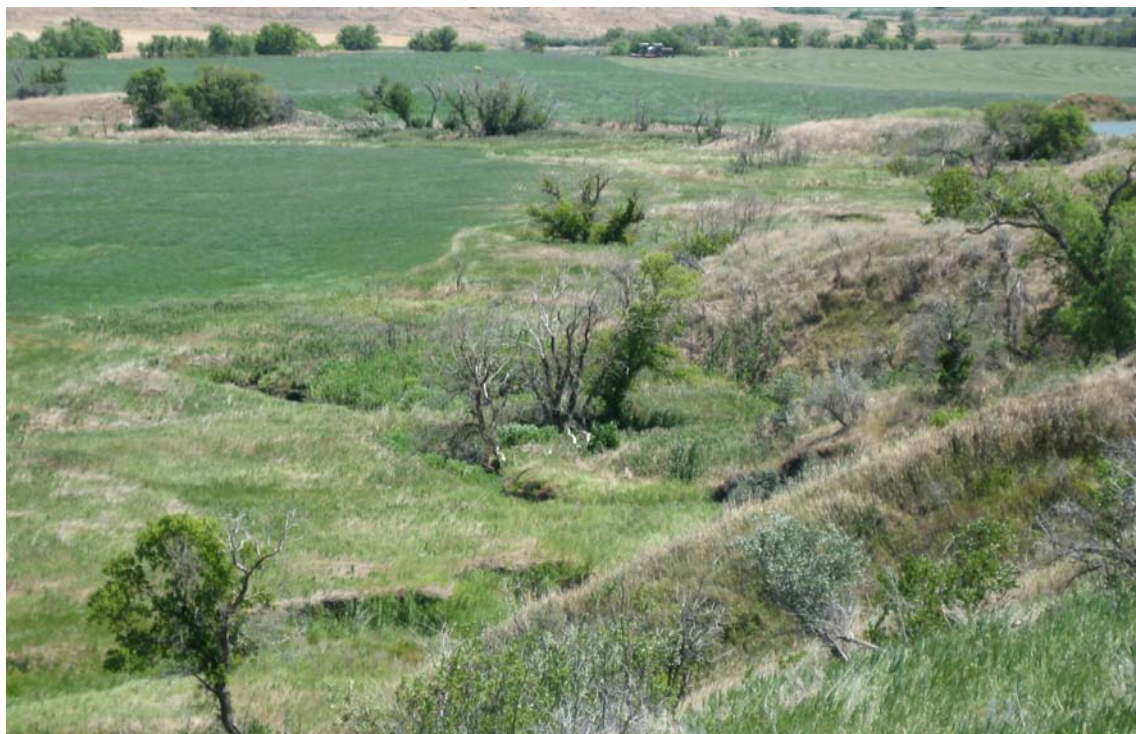
**Original Photo –**  
July 26, 2000.  
Columbus Creek

**Description** – Before enrolling in the FSA’s cCRP, the riparian buffer strip was in fair condition. Nevertheless, the channel remains incised. This incision has caused the water table to decline. The former floodplain has become disconnected from the channel and acts as a higher terrace, which left woody vegetation more susceptible to drought stress. This is apparent by the decadent/dead condition of boxelder, chokecherry and other trees/shrubs.
