# Response of Prairie Stream Riparian Buffers to Livestock Exclusion and Short-Duration Grazing in Northeast Wyoming- A Pre- and Post- Photographic Comparison

Wyoming Game and Fish Department  
Sheridan Regional Office

# Response of Prairie Stream Riparian Buffers to Livestock Exclusion and Short-Duration Grazing in Northeast Wyoming- A Pre- and Post- Photographic Comparisons

## September 25, 2007

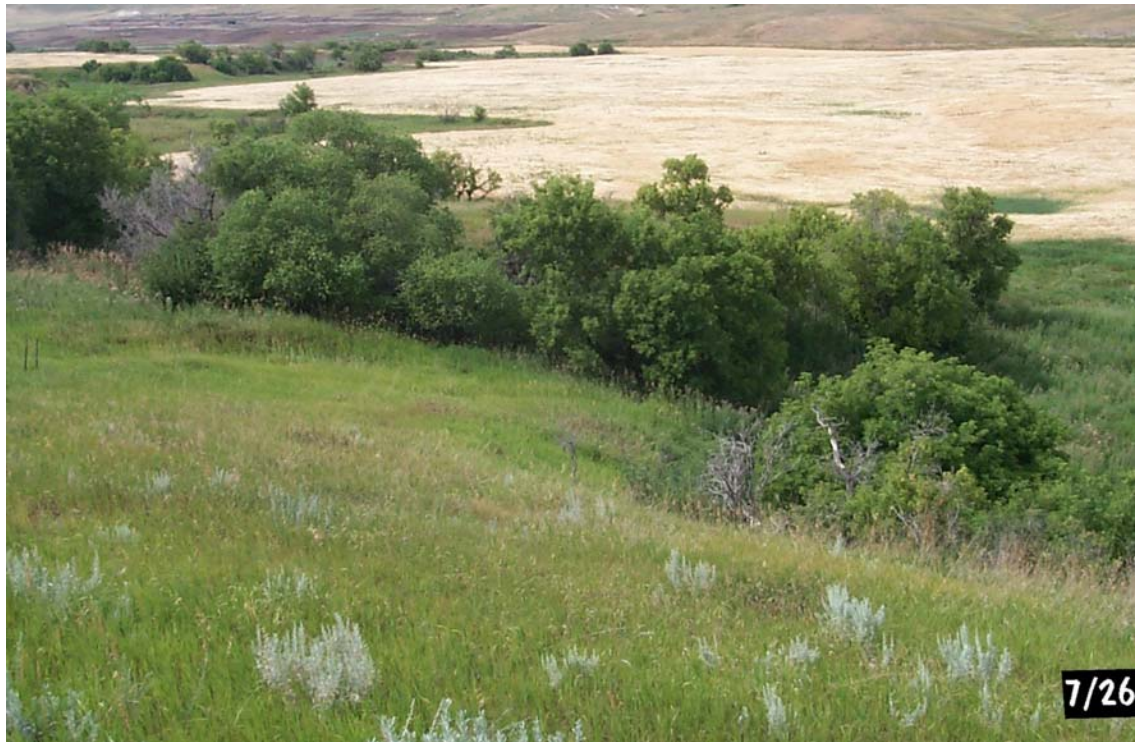
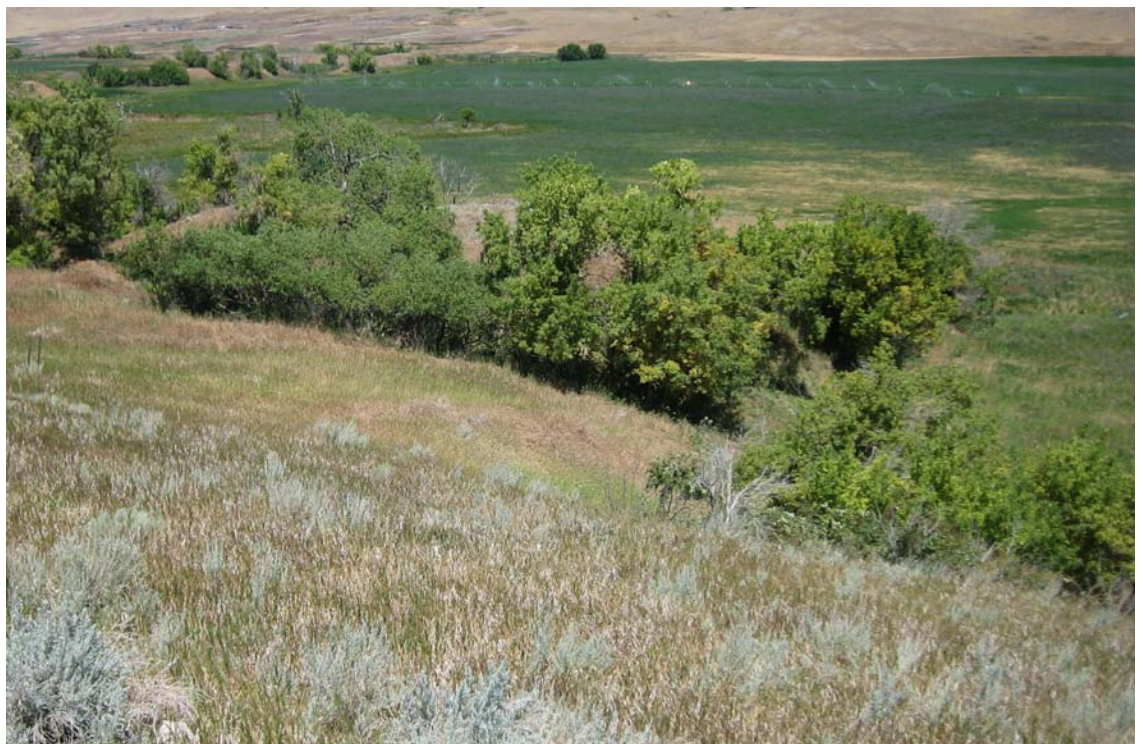
**Original Photo –**  
July 26, 2000.  
Columbus Creek

**Description** – The foreground of the original photo shows silver sagebrush (*Artemisia cana*) mixed with grasses. The photo retake shows a higher frequency of this species. Without livestock grazing, almost all woody plants have increased in frequency and canopy cover, including both upland and riparian associated species. The one exception is attributed to the loss of trees/shrubs from drought stress.

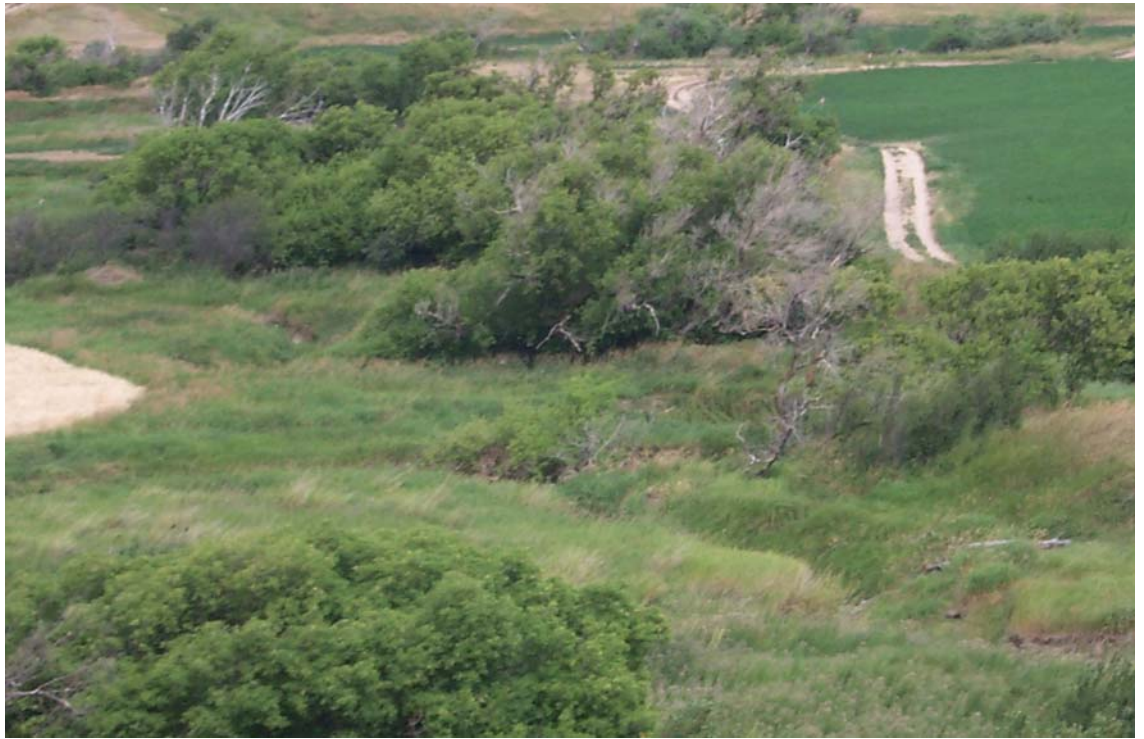
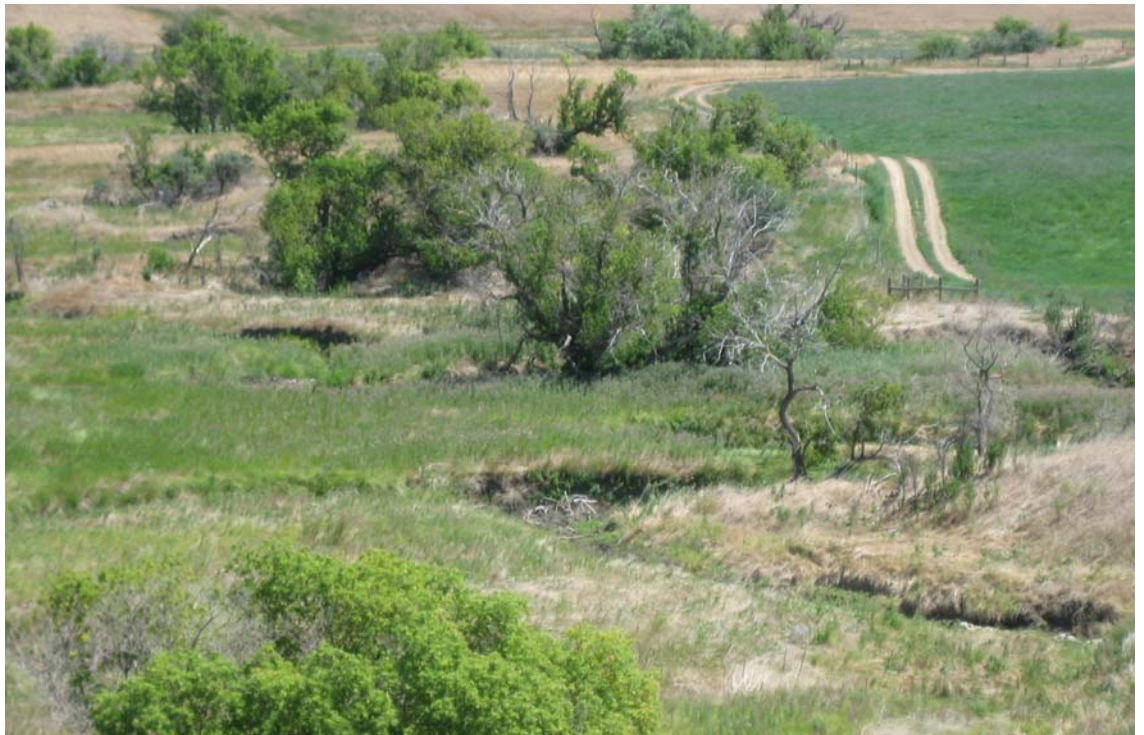
**Original Photo –**  
July 26, 2000.  
Columbus Creek

**Description** – Again, drought effects are clearly evident in this photo. Drought conditions from 2000 to 2006 were considered extremely dry, but conditions in 2006 appear much worse. Boxelder, chokecherry and other woody vegetation show many signs of decay. The incised channel has disconnected the stream from the floodplain and lowered the water, thus leaving woody vegetation high-and-dry. Active rehabilitation steps may be necessary to aggrade the stream channel.

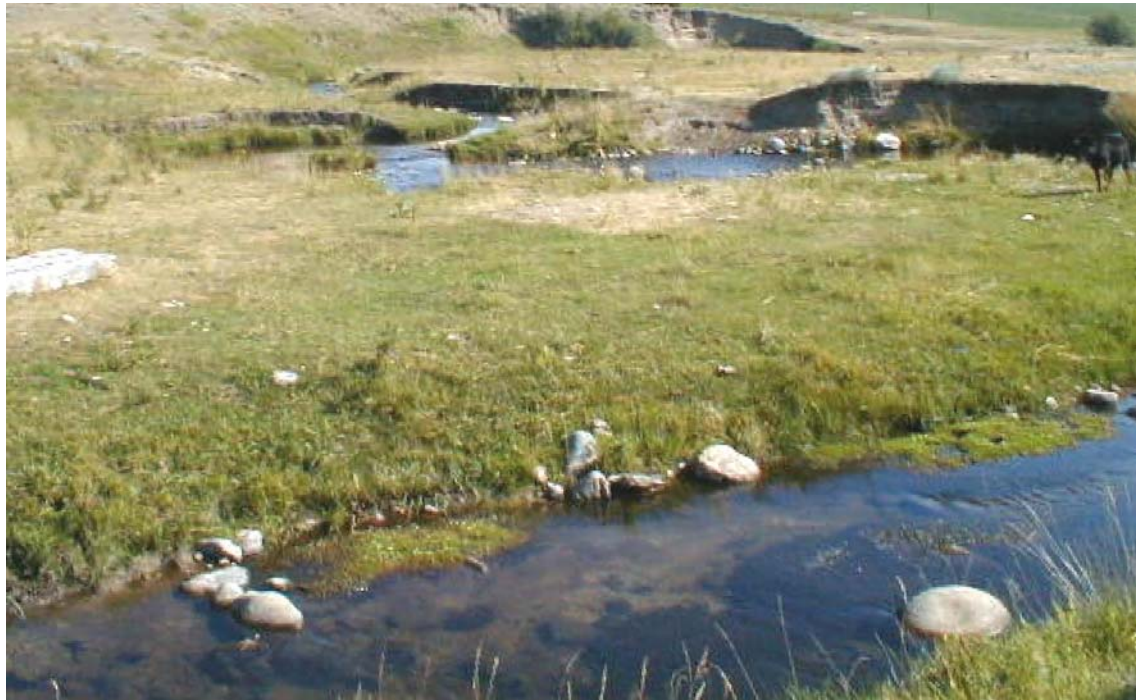
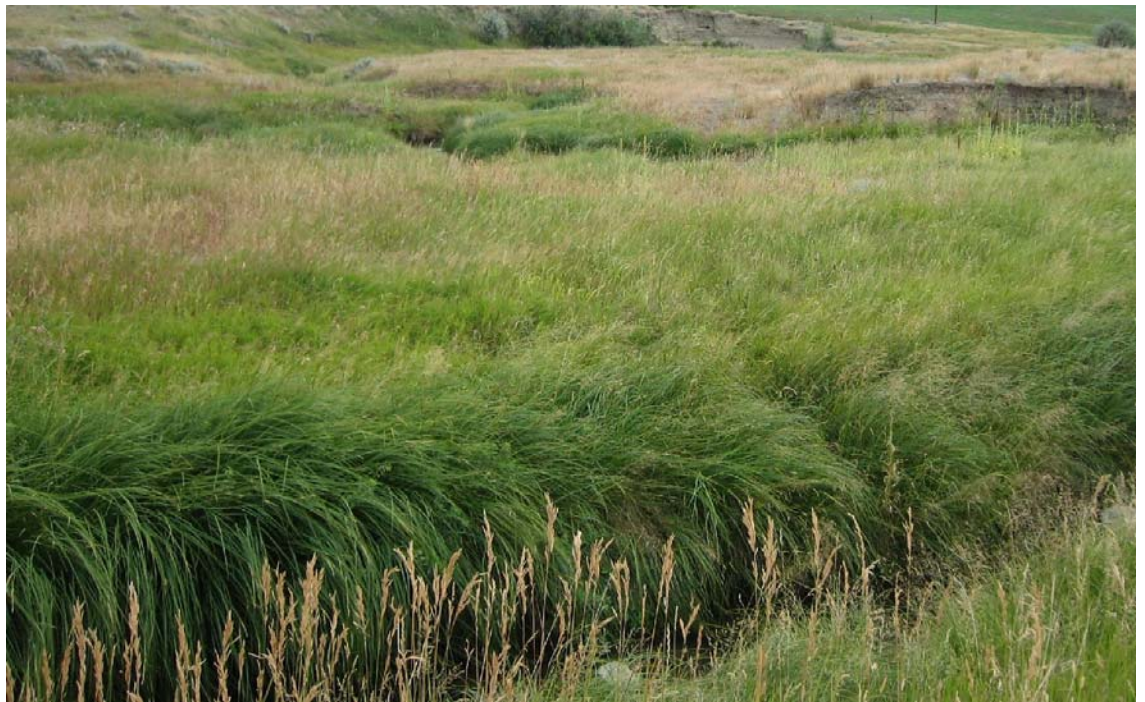
**Original Photo –**  
August 11, 2000.  
French Creek

**Description** – This riparian buffer strip on French Creek excludes livestock for a 10-year period. The 119 acre buffer strip provides excellent habitat for both terrestrial and aquatic species. Thick, healthy vegetation after six years of rest provides terrestrial wildlife with forage and cover. This same vegetation improves the fishery by shading the stream and stabilizing undercut bank habitat. Warm season grasses such as prairie cord grass are re-establishing along the stream. This plant does an excellent job securing stream banks.

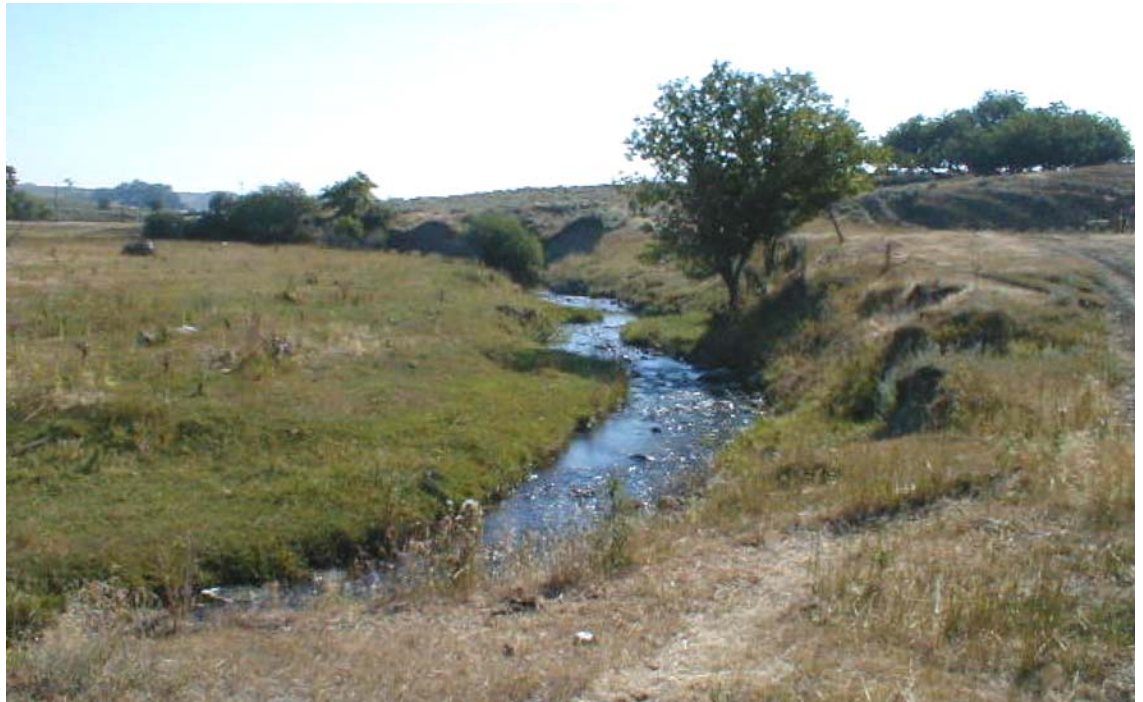
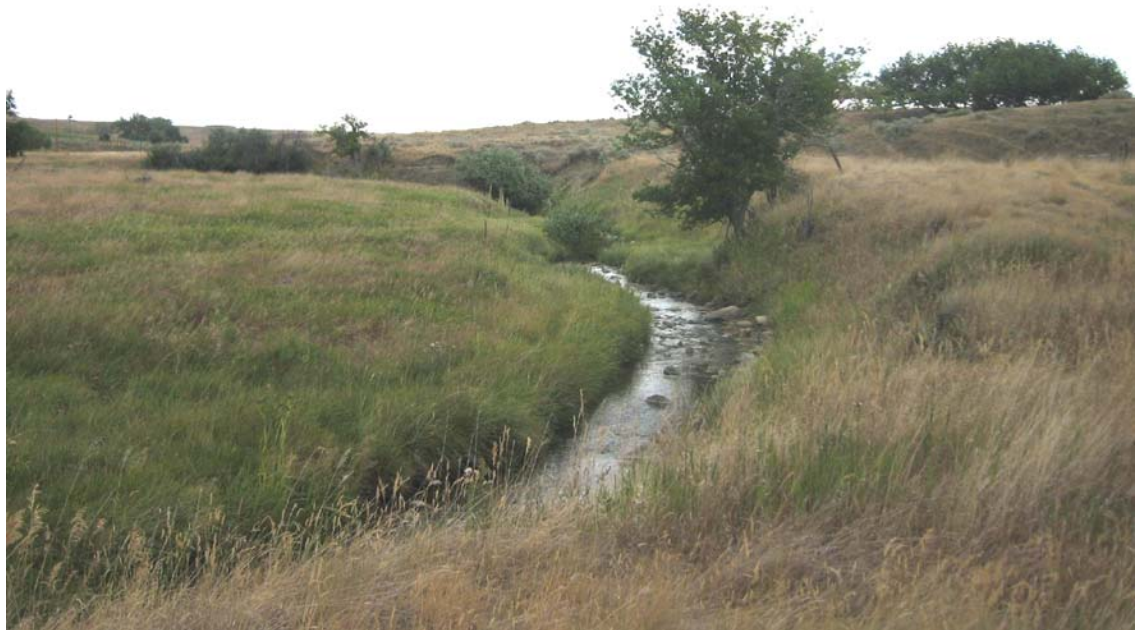
**Original Photo –**  
August 11, 2000.  
French Creek

**Description** - Once point bars recover, sediment deposition allows vegetation to encroach the channel, resulting in a narrower stream. A narrower watercourse must deepen to accommodate flows, thus increasing its capability to support fish throughout the winter months.

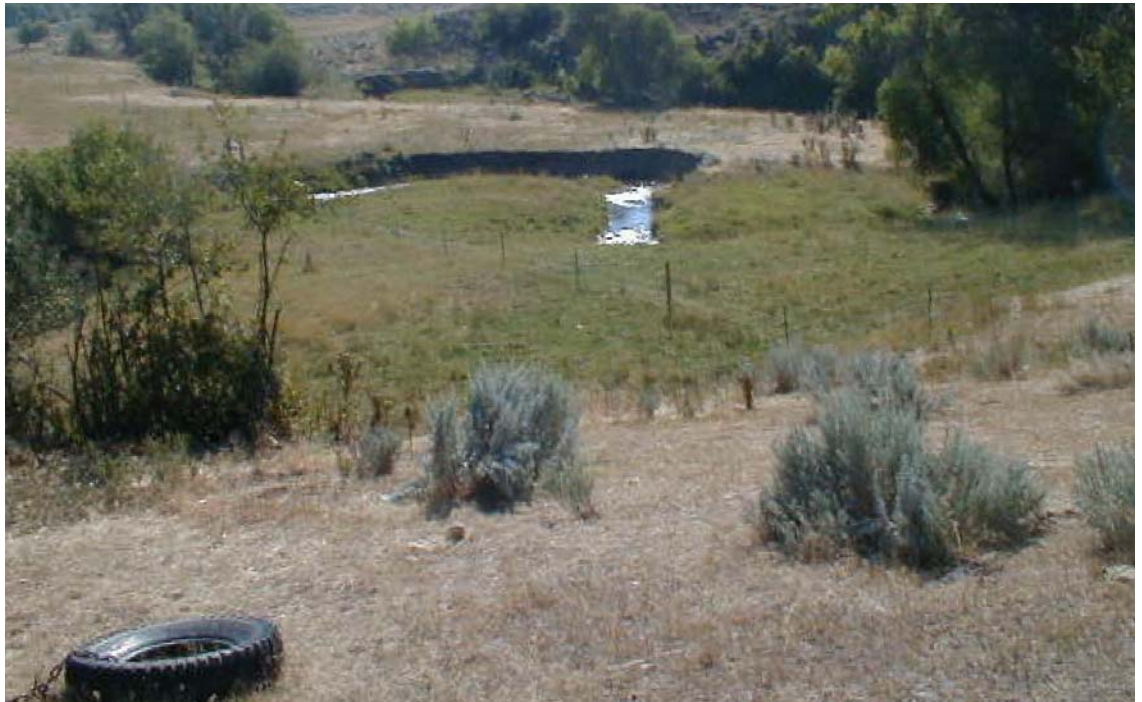
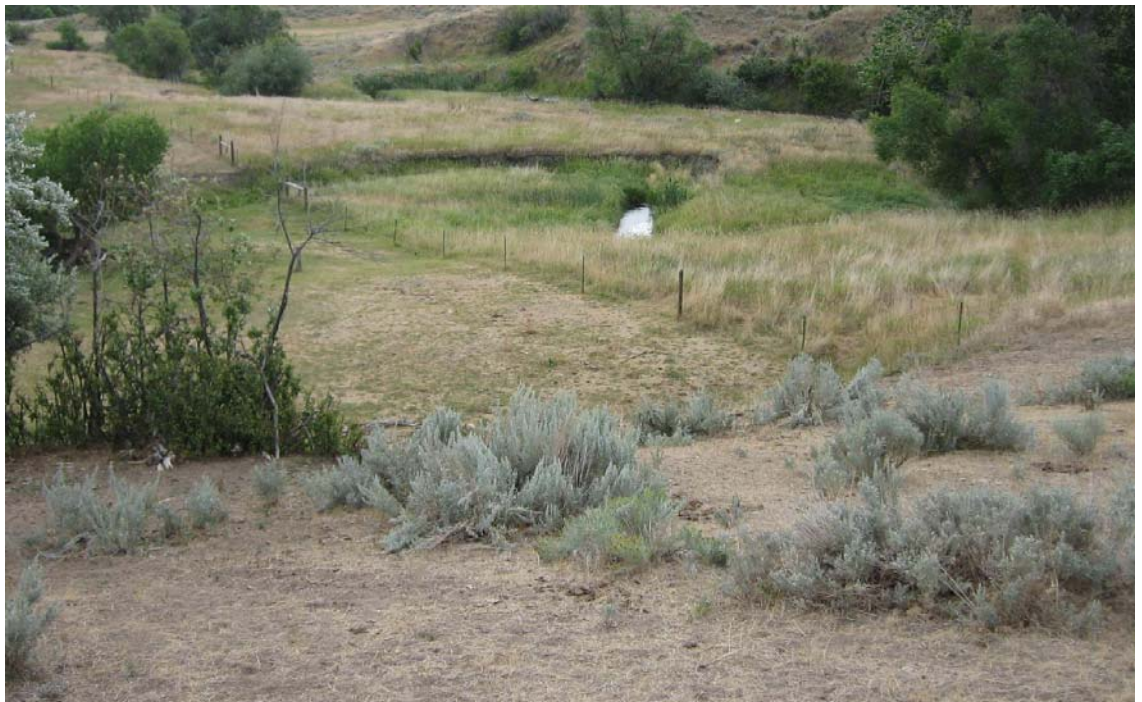
**Original Photo –**  
August 11, 2000.  
French Creek

**Description** – The photo retake shows a water gap in the foreground with a fence-line contrast between it and the cCRP. The original photo shows an unstable oxbow. After livestock exclusion the inside and outside bends of the oxbow are vegetated, thus protecting the banks during spring runoff events.

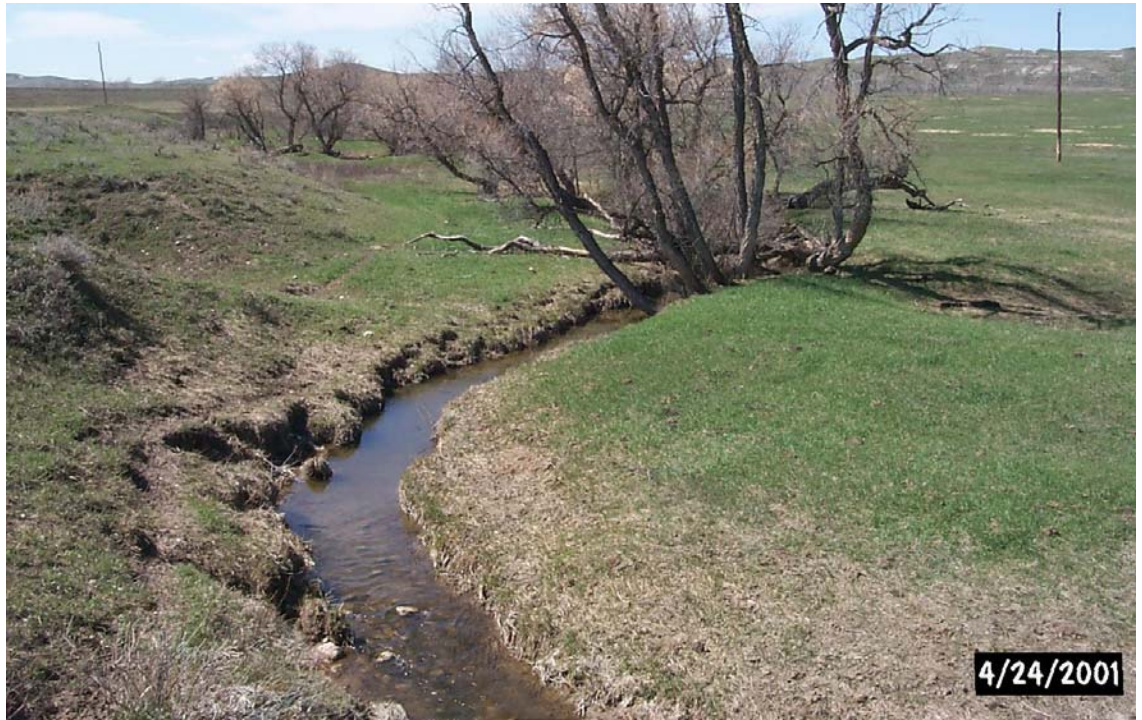
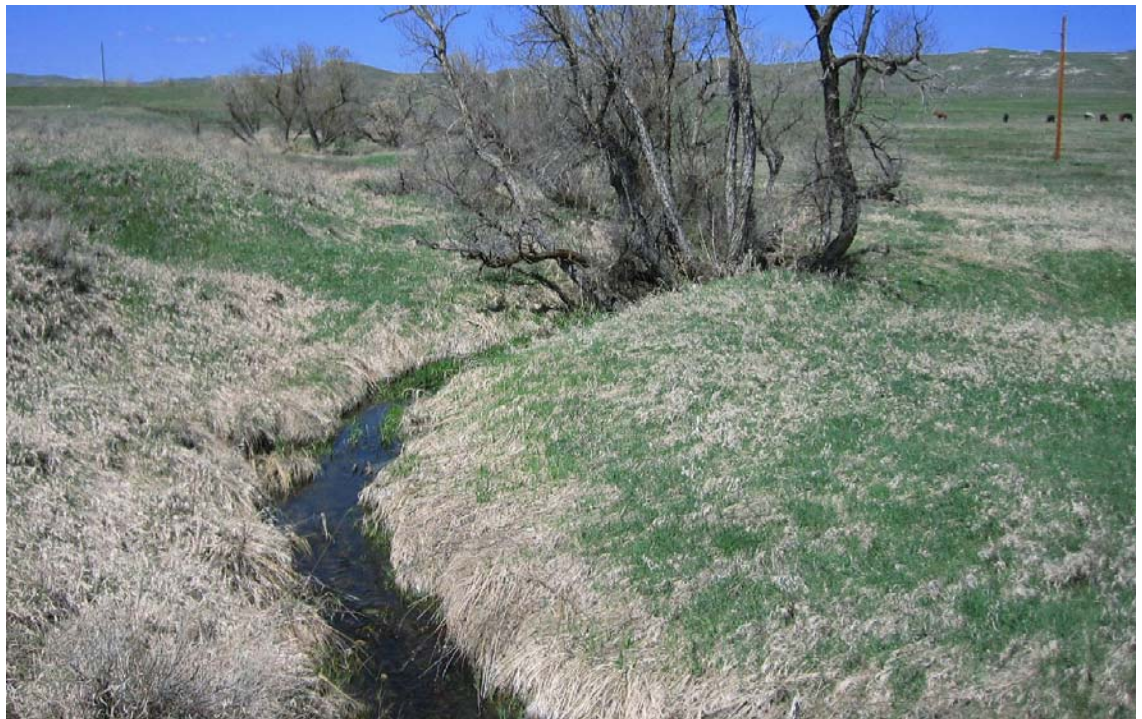
**Original Photo –**  
April 24, 2000.  
5-mile Creek

**Description** – This riparian buffer strip excludes livestock grazing on approximately 150 acres. The livestock exclusion contains approximately 50 acres of green ash community that qualifies for the FSA’s cCRP. In-stream vegetation is helping to narrow and deepen the channel. Also notice that slough banks and nicks are healed.

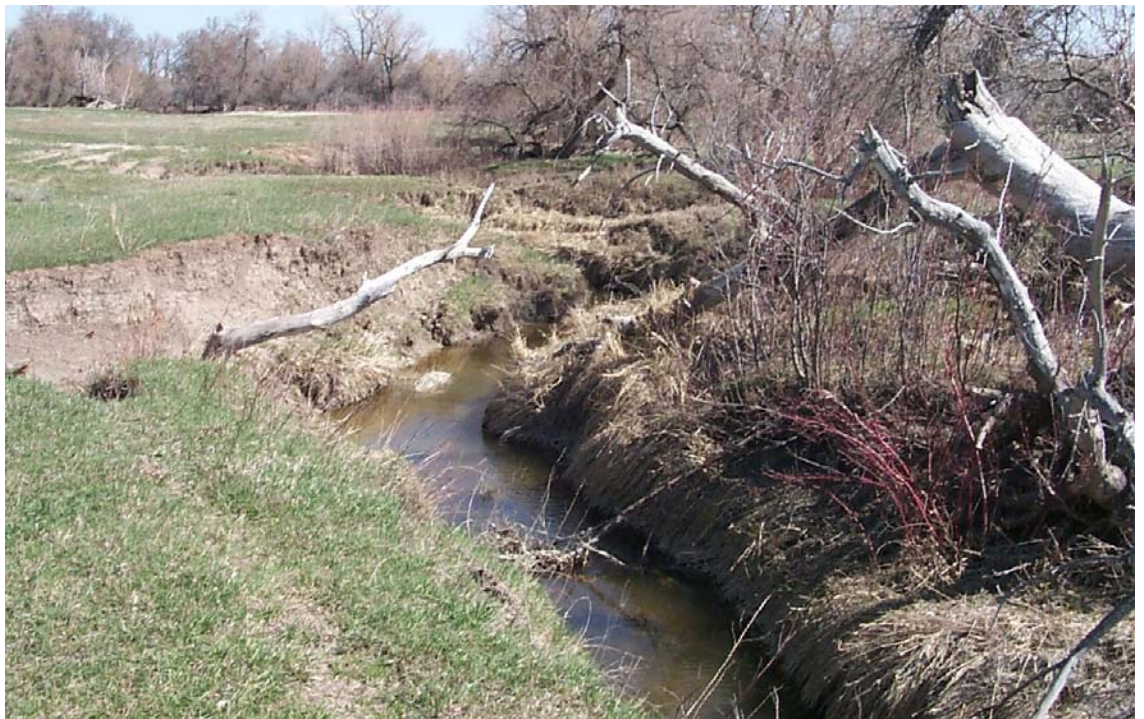
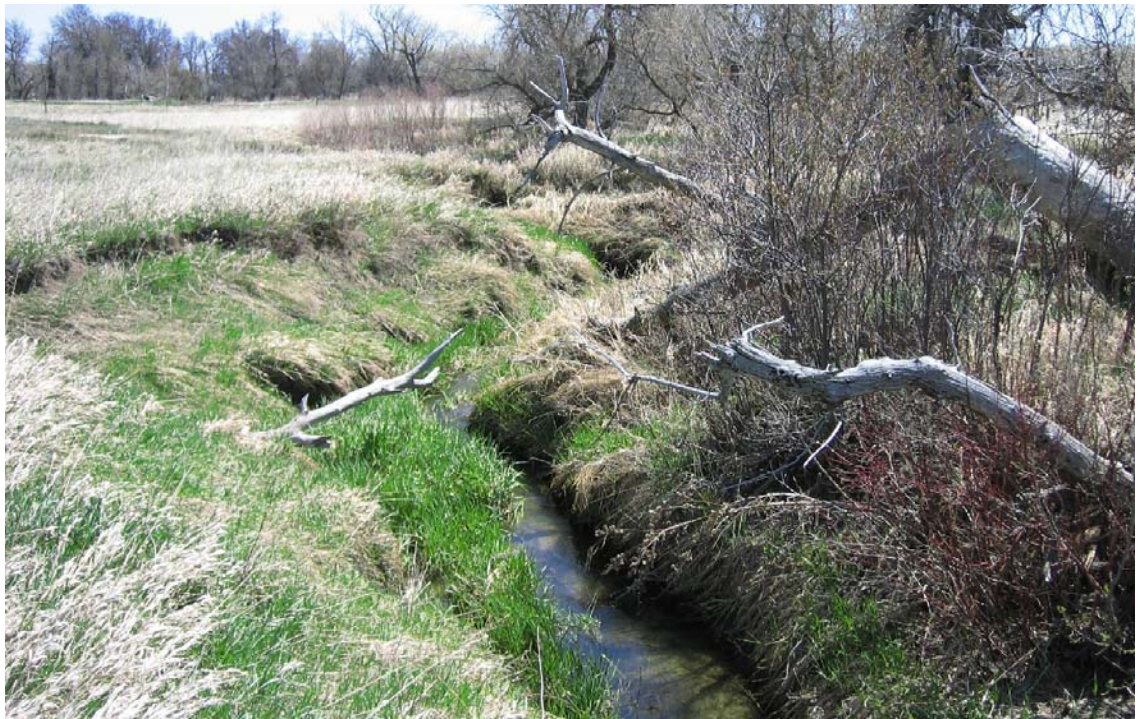
**Original Photo –**  
April 24, 2000.  
5-mile Creek

**Description** – The channel in the original photo is incised. Unfortunately, it can take years for aggradation to restore the hydrologic condition necessary to benefit riparian vegetation, such as willows. Once willows begin to colonize, however, beaver can accelerate the rise in elevation in the bottom of the channel. Again cut banks and unvegetated scars have been filled with herbaceous vegetation. The stream is also significantly narrower.

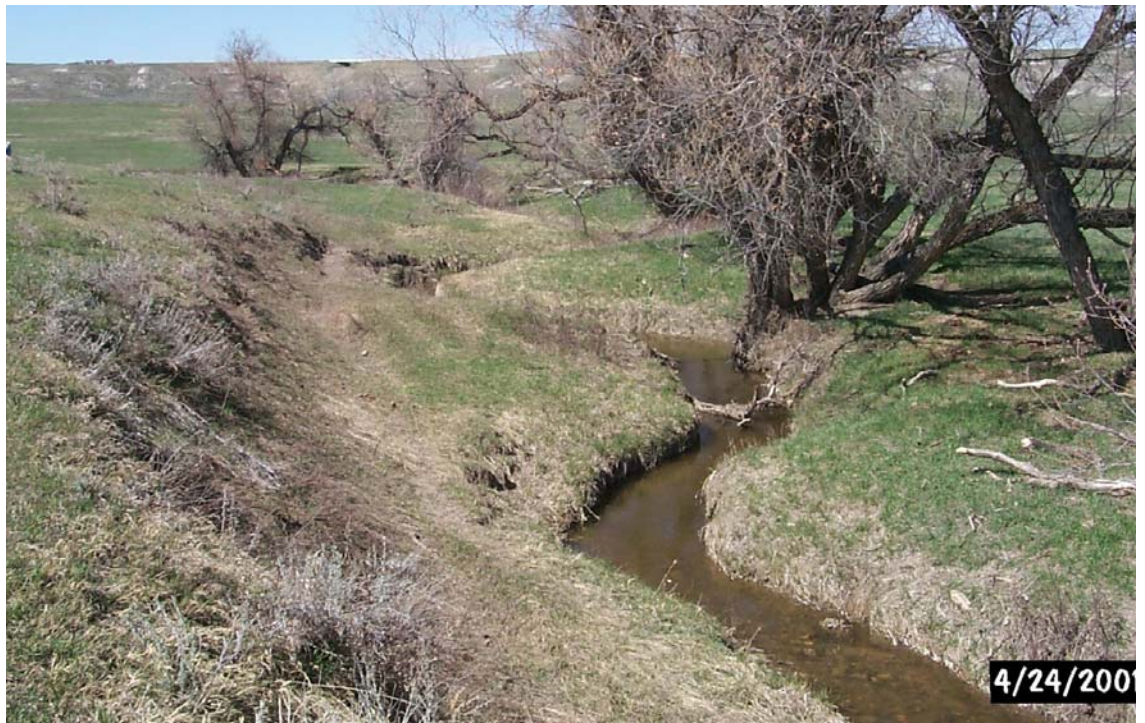
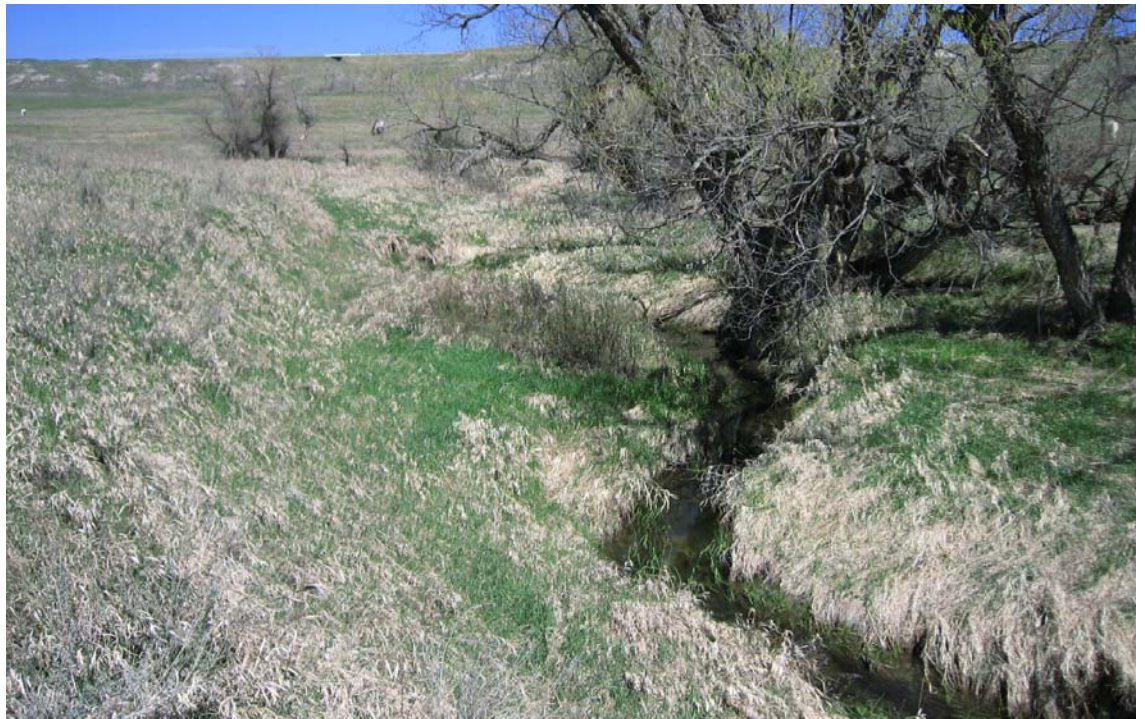
**Original Photo –**  
April 24, 2000.  
5-mile Creek

**Description** – The steep bank in the original photo was susceptible to erosion during high water events. Submergent vegetation that has established in the channel should continue to filter fine sediment, allowing the stream to narrow and deepen.

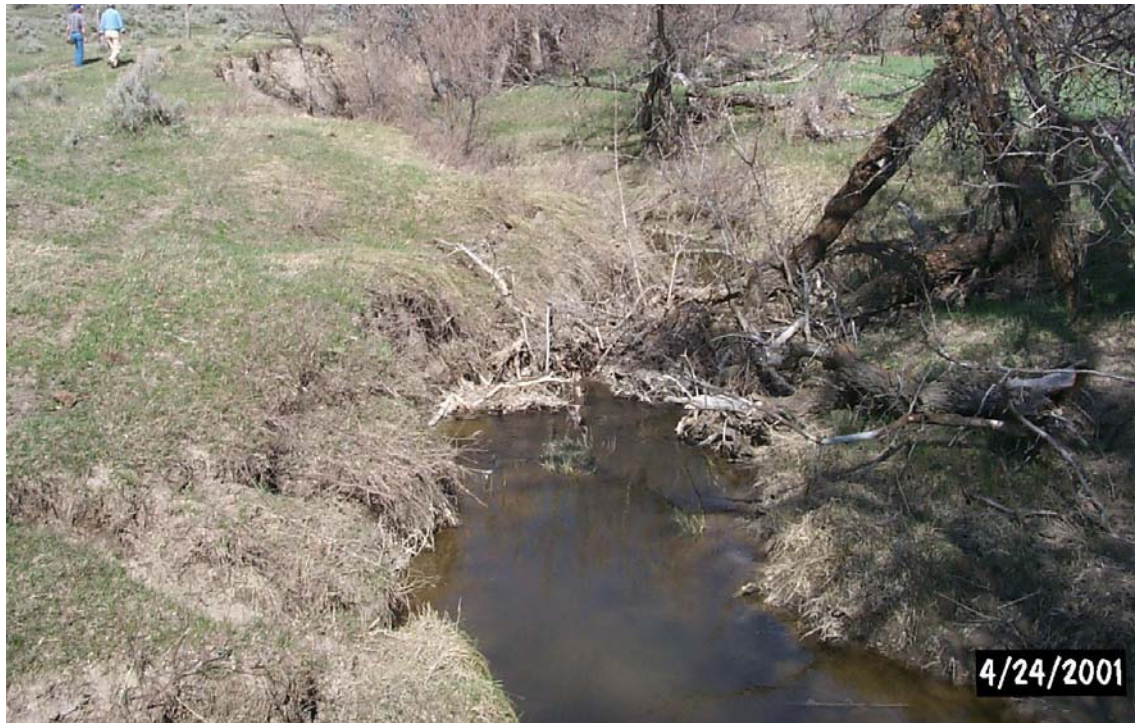
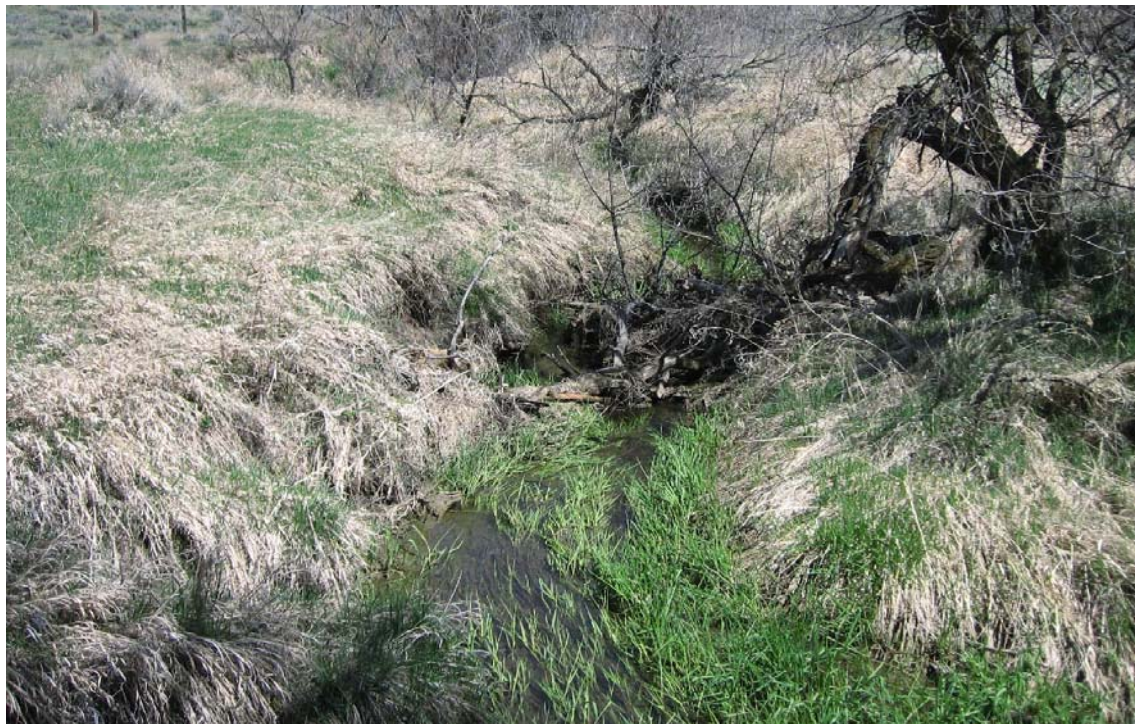
**Original Photo –**  
April 24, 2000.  
5-mile Creek

**Description –** With six years of livestock exclusion, this channel is narrower and more stable. Riparian and aquatic vegetation are now collecting bed load.

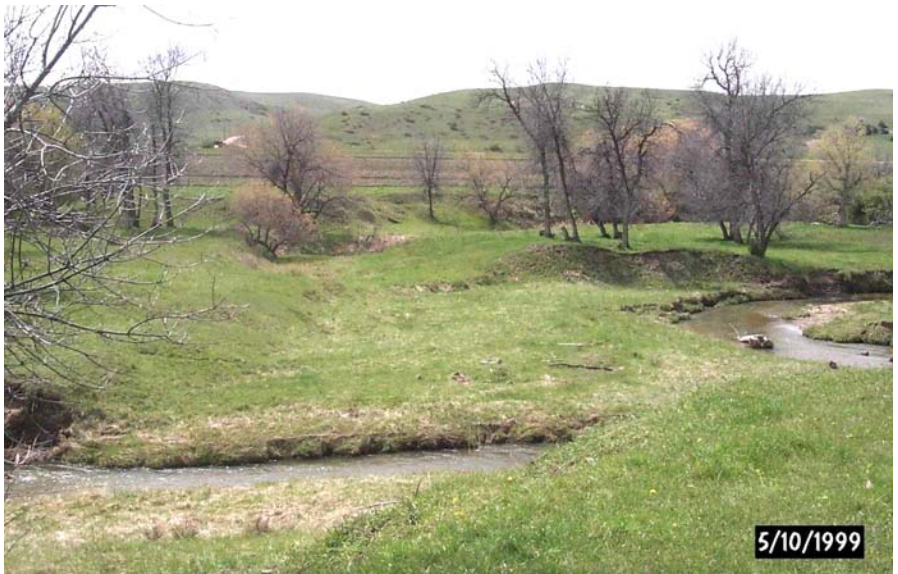
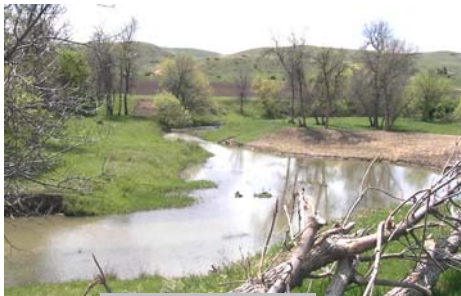
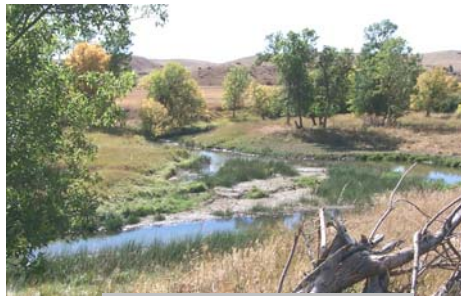
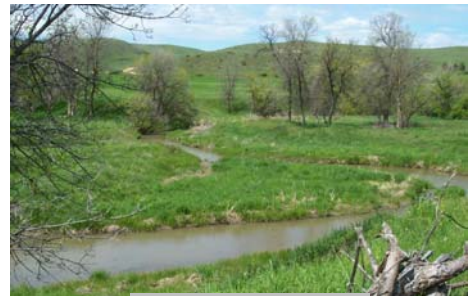
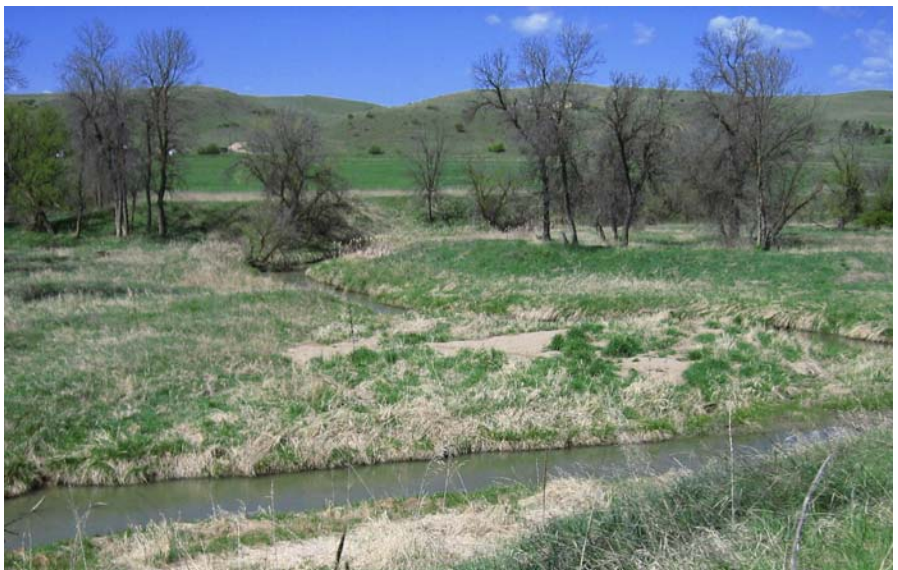
**Original Photo –**  
May 10, 1999.  
Prairie Dog Creek

**Description** – The original photo shows a channelized stream before it was returned to its original watercourse, which is 300 percent longer. The May 15, 2000 picture shows the ponding affect caused by the cross-dike that was installed to return the stream to its original channel. The September 14, 2000 and May 23, 2002 pictures provide a time-lapse view of point bar development. The May 12, 2006 picture shows a dramatically higher point bar. This project was designed by the NRCS Sheridan Field Office and funded by the U.S. Fish and Wildlife, WGFD and NRCS. The project site was fenced and is managed to promote riparian vegetation via the NRCS’s Wetland Reserve Program.

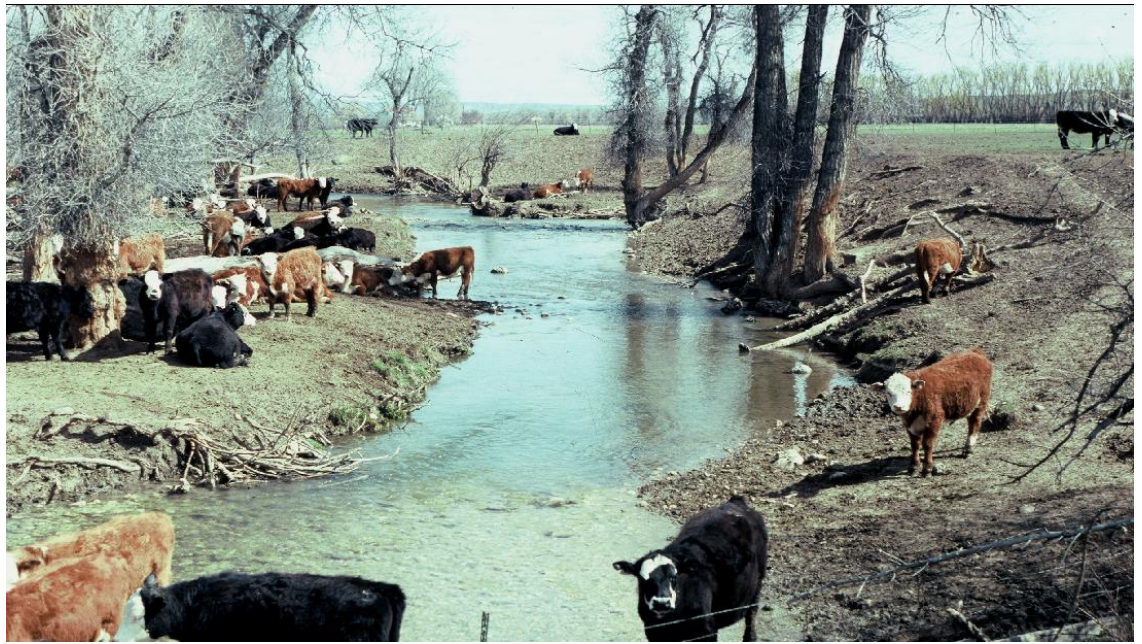
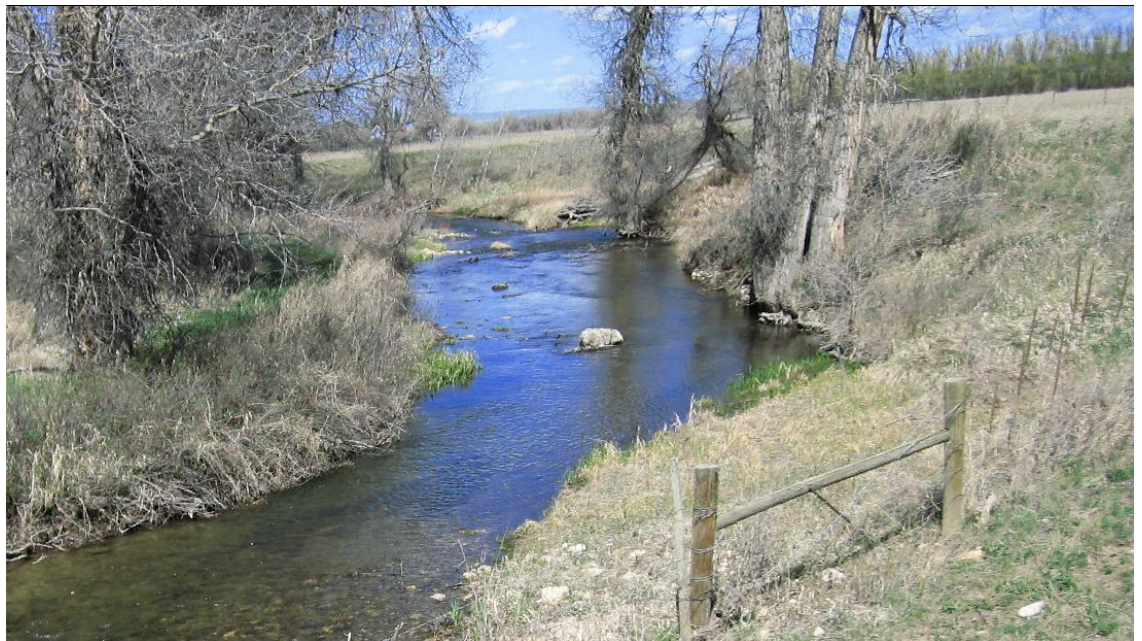
**Original Photo –**  
April 1993.  
Wolf Creek

**Description** – The owner of this property stopped using the stream as a water gap and implemented a short-duration low-intensity grazing system. This change has restored riparian habitats and allowed Wolf Creek to narrow and deepen. Flushing flows have remove silt deposits, thus improving spawning habitats for trout. Today, an excellent brown trout population exists.

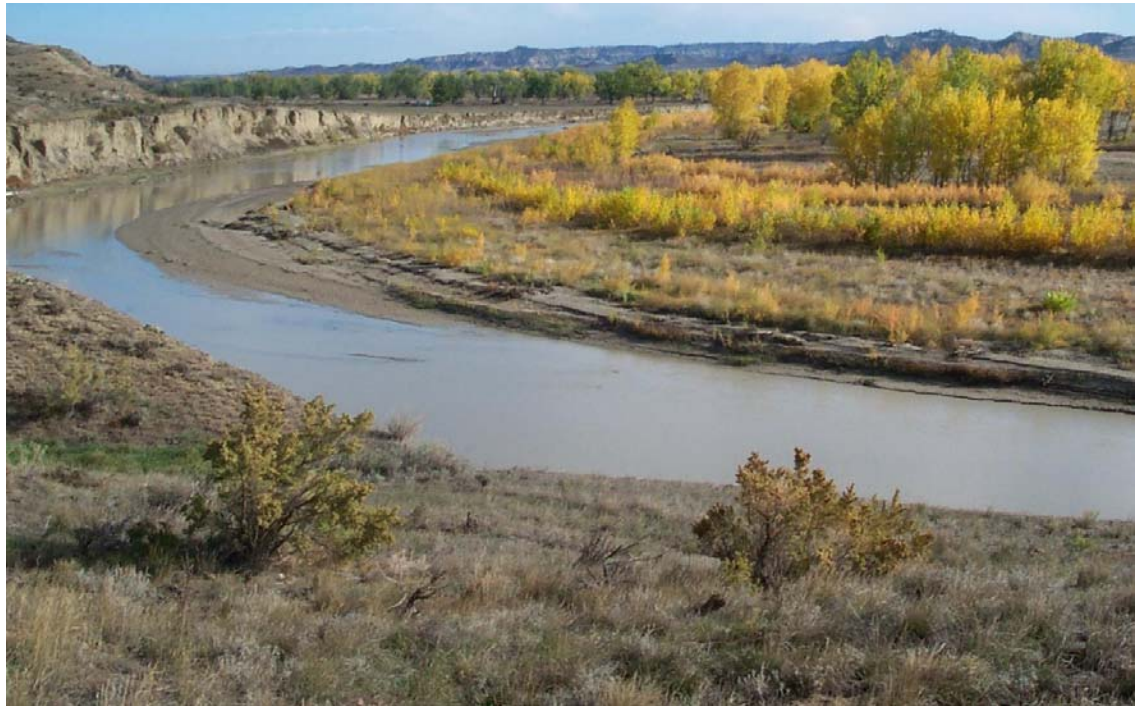
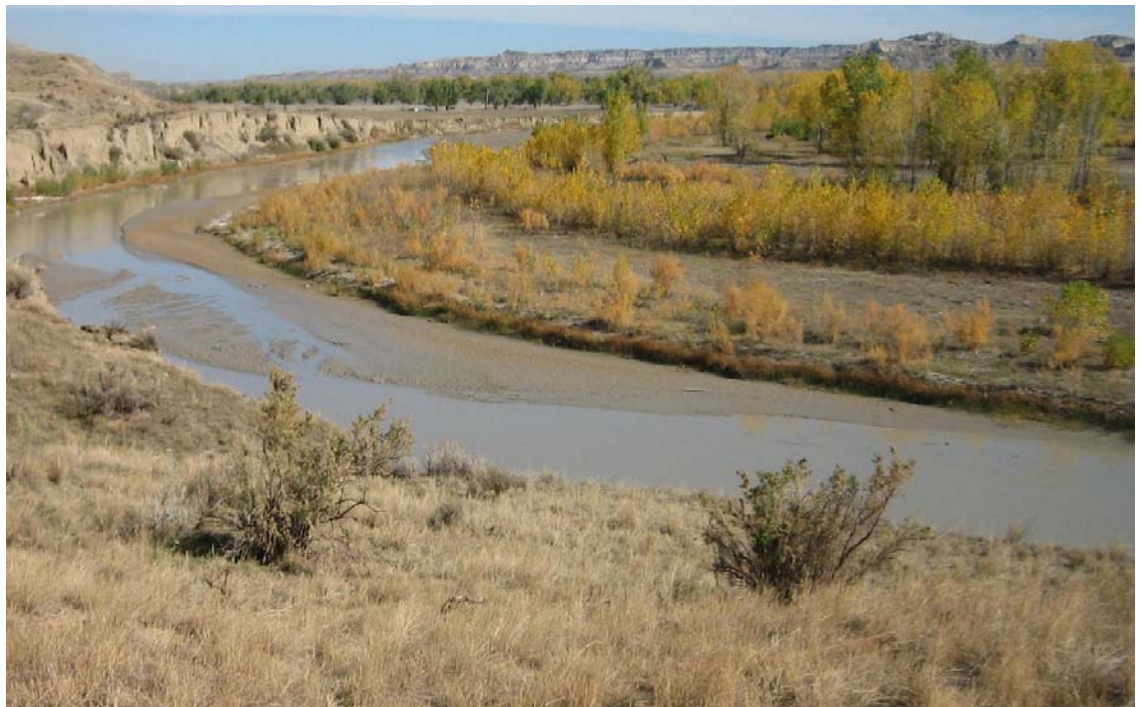
**Original Photo –**  
October 2002.  
Powder River

**Description** - The Powder River riparian buffer strip is approximately 644 acres of land consisting of 442 acres qualifying for the FSA's cCRP. The riparian buffer strip is only 4 years into a fifteen-year contract period. This river has a tremendous bed load and the channel undergoes substantial change from year to year. Consequently it's difficult to identify cause-and-effect mechanisms.

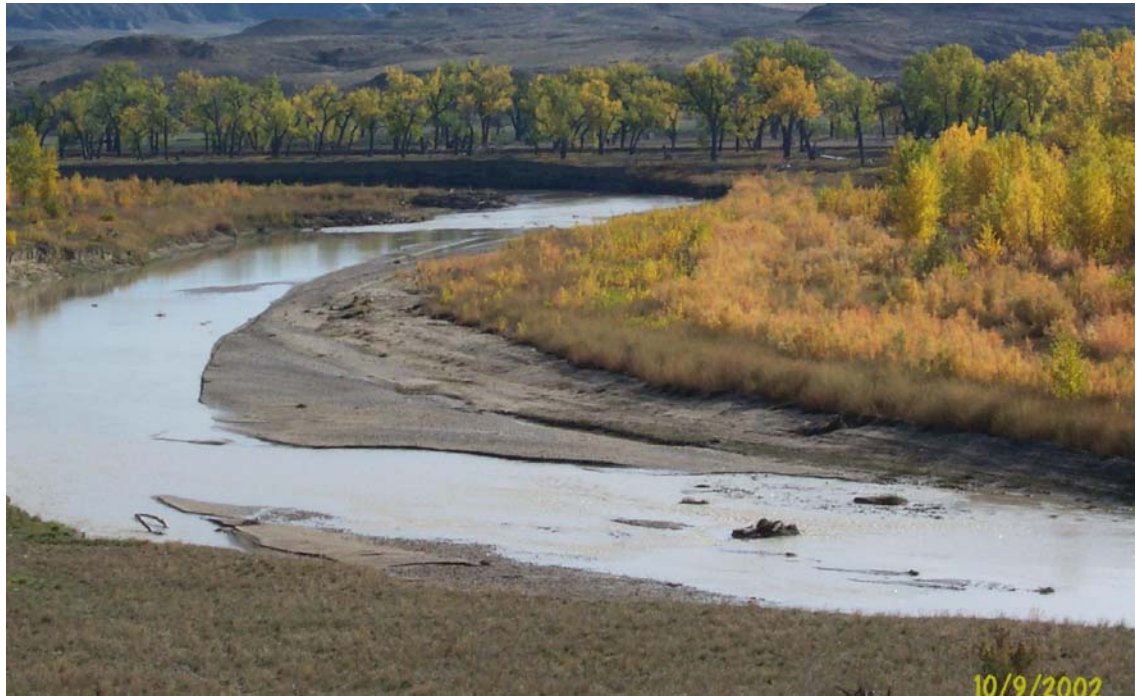
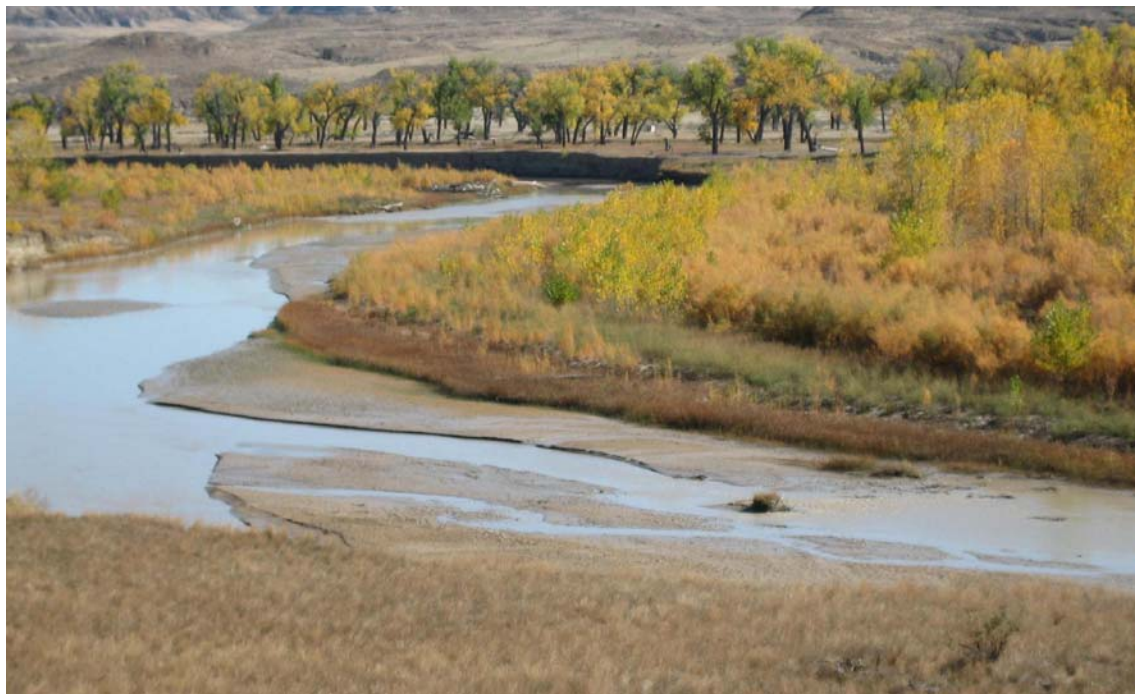
**Original Photo –**  
October 2002.  
Powder River

**Description** – The Powder River is a very dynamic stream system. The active channel can change dramatically in a matter of hours. Salt cedar (*Tamarix ramosissima*) expansion appears to be fairly static on this cCRP. Vegetation may be establishing on the point bars and outside toe of the oxbow. Vegetation on the outside bank is not expected to remain stable, as the river is known for significant lateral movement within its floodplain.
