# Response of Prairie Stream Riparian Buffers to Livestock Exclusion and Short-Duration Grazing in Northeast Wyoming- A Pre- and Post- Photographic Comparison

Wyoming Game and Fish Department  
Sheridan Regional Office

# Response of Prairie Stream Riparian Buffers to Livestock Exclusion and Short-Duration Grazing in Northeast Wyoming- A Pre- and Post- Photographic Comparisons

## September 25, 2007

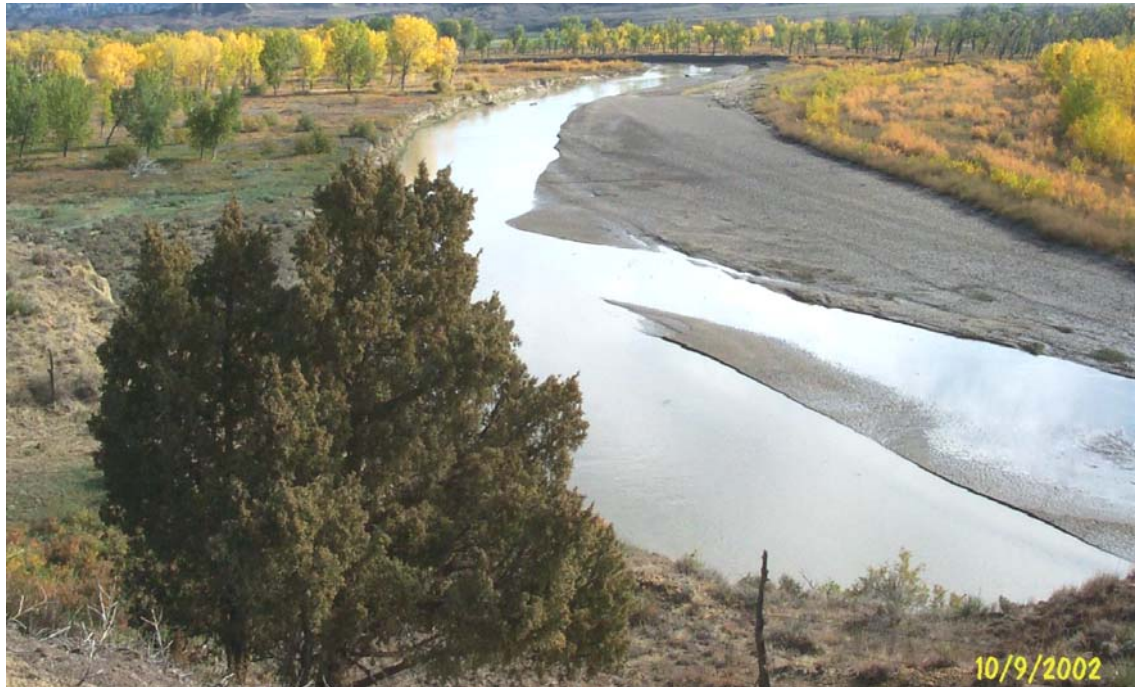
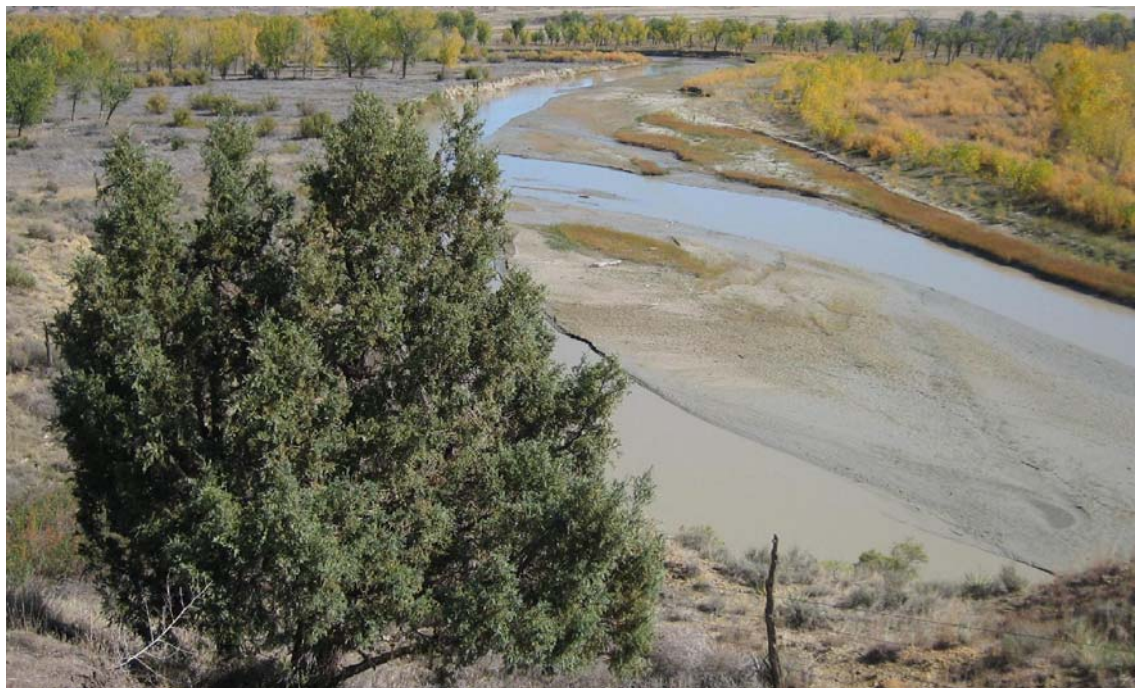
**Original Photo –**  
October 2002.  
Powder River

**Description** – The photos show laterally active channel with some point bar vegetation. Again vegetation stability is unknown due the dynamics of the Powder River.

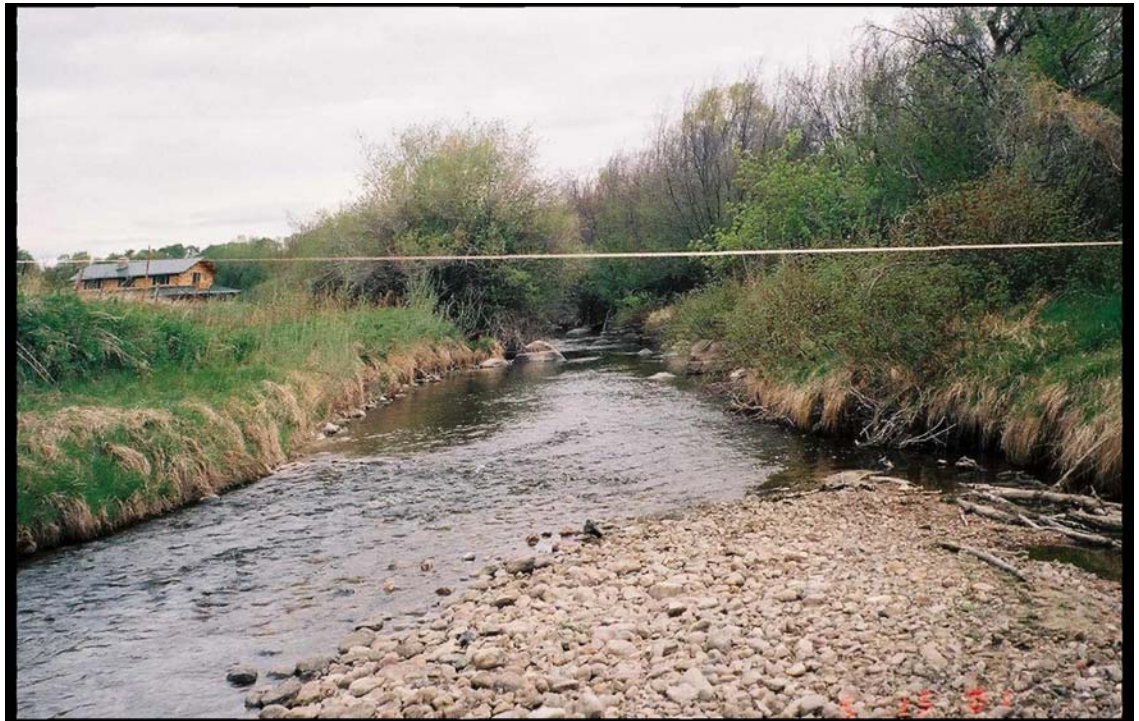
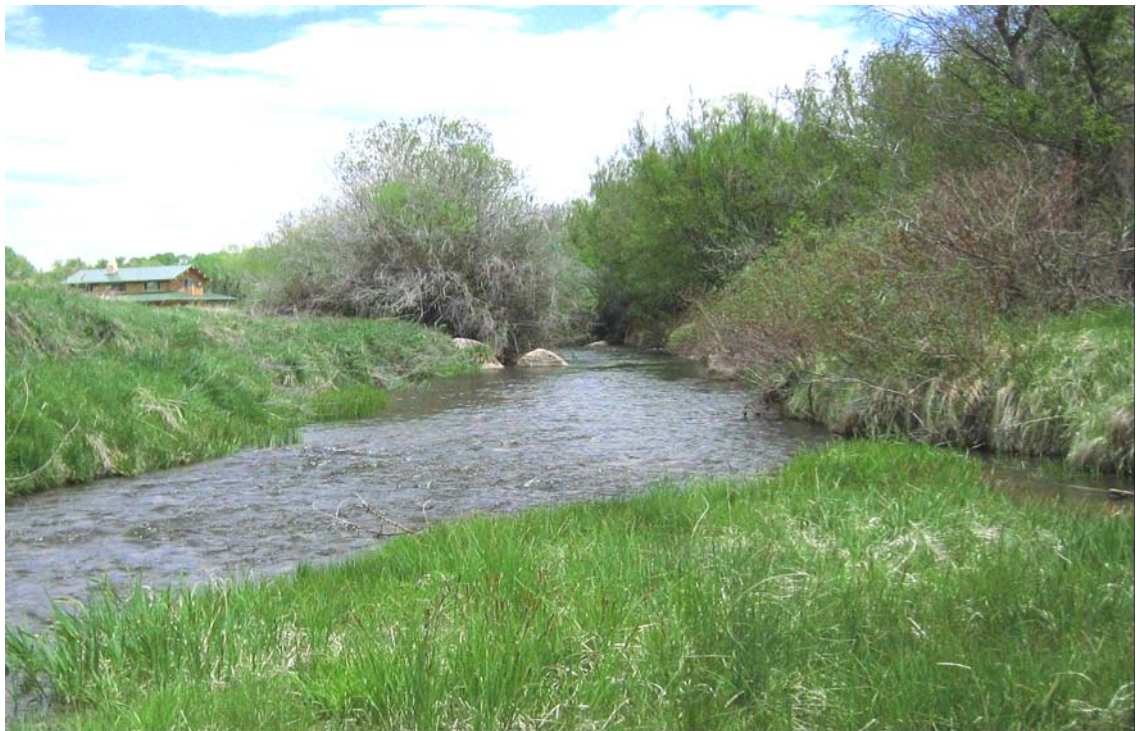
**Original Photo –**  
May 22, 2001.  
Piney Creek

**Description** – The Piney Creek cCRP riparian buffer strip is approximately 30 acres. This stream has an excellent trout population. All cobble point bars, which were once commonplace, are now vegetated. The stream has also narrowed and deepened.

After livestock were excluded, Canada thistle (*Cirsium arvense*) quickly invaded most moist soils. Once this noxious weed was controlled, a host of native warm season plants replaced it. Most notable is prairie cord grass. Needless to say, noxious weeds rarely reestablish in the presence of this competitor.

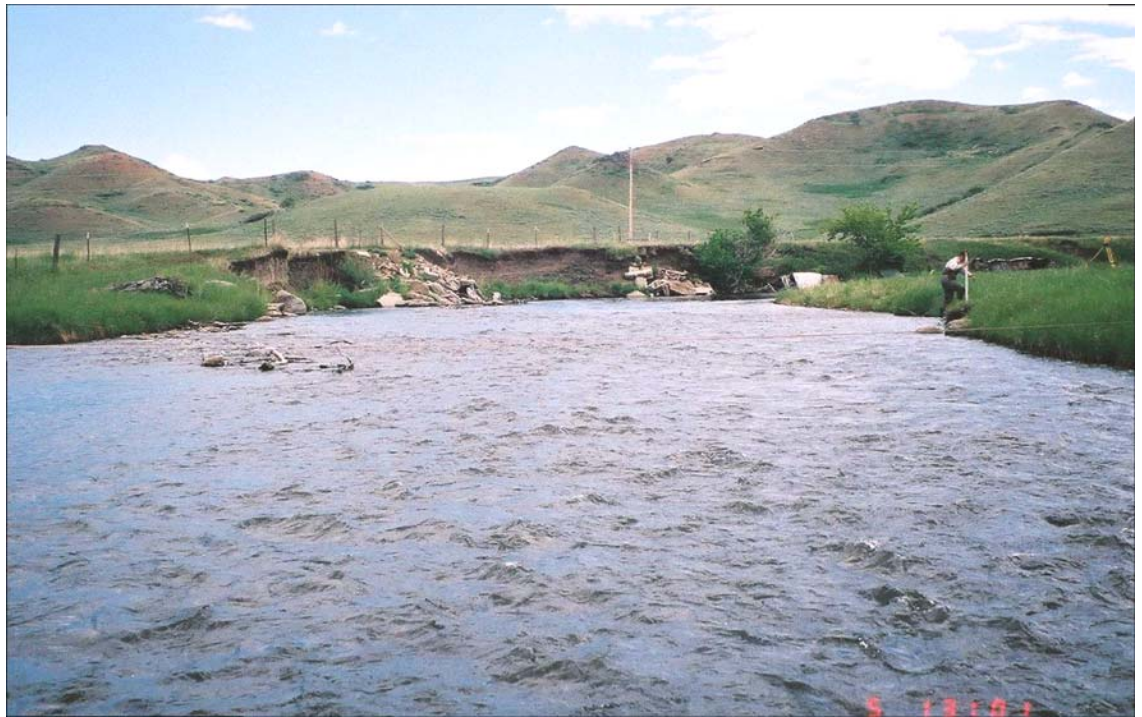
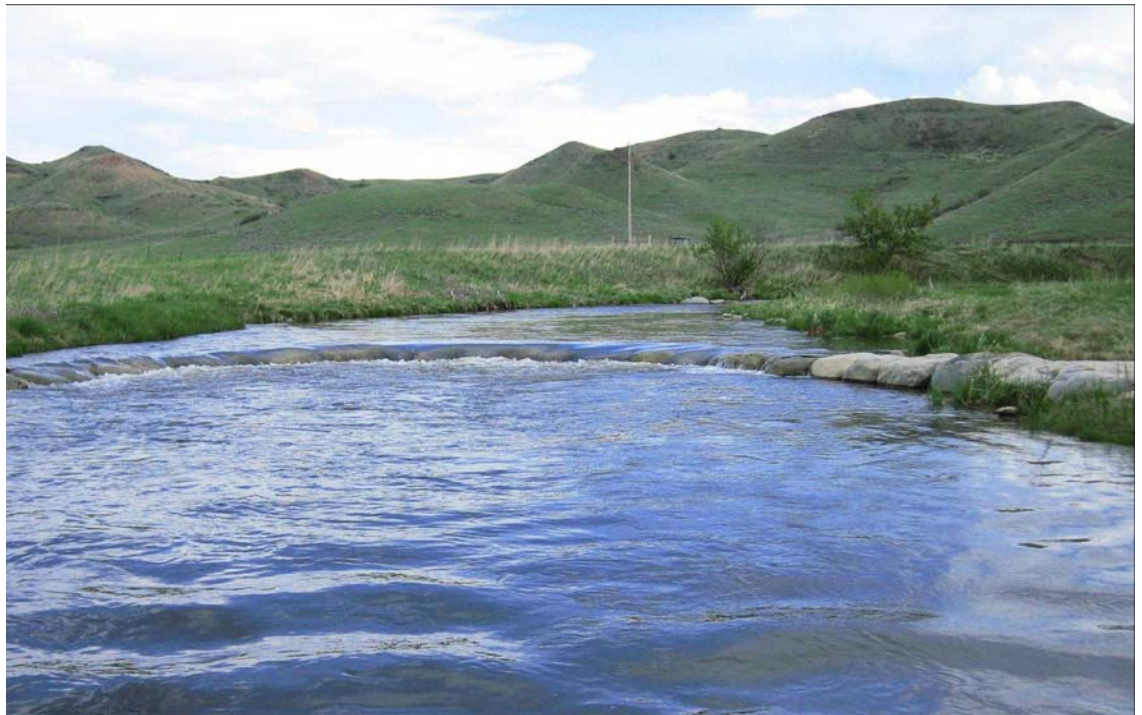
**Original Photo –**  
May 22, 2001.  
Piney Creek

**Description –** This riparian buffer strip contains man-made structures to adjust the thalweg to minimize erosional forces on banks. In this case, the new technology replaced the previous owner's attempt to armor the cut bank using various materials. Even so, this section of stream is still called "Corvair" Corner.
