**A Compendium of Trout Stream Habitat Improvement
Projects Done by the Wyoming Game and Fish
Department, 1953-1998.**

**N. Allen Binns,
Aquatic Habitat Supervisor**

**Fish Division
Wyoming Game & Fish Department
Cheyenne, Wyoming 82006
April, 1999**

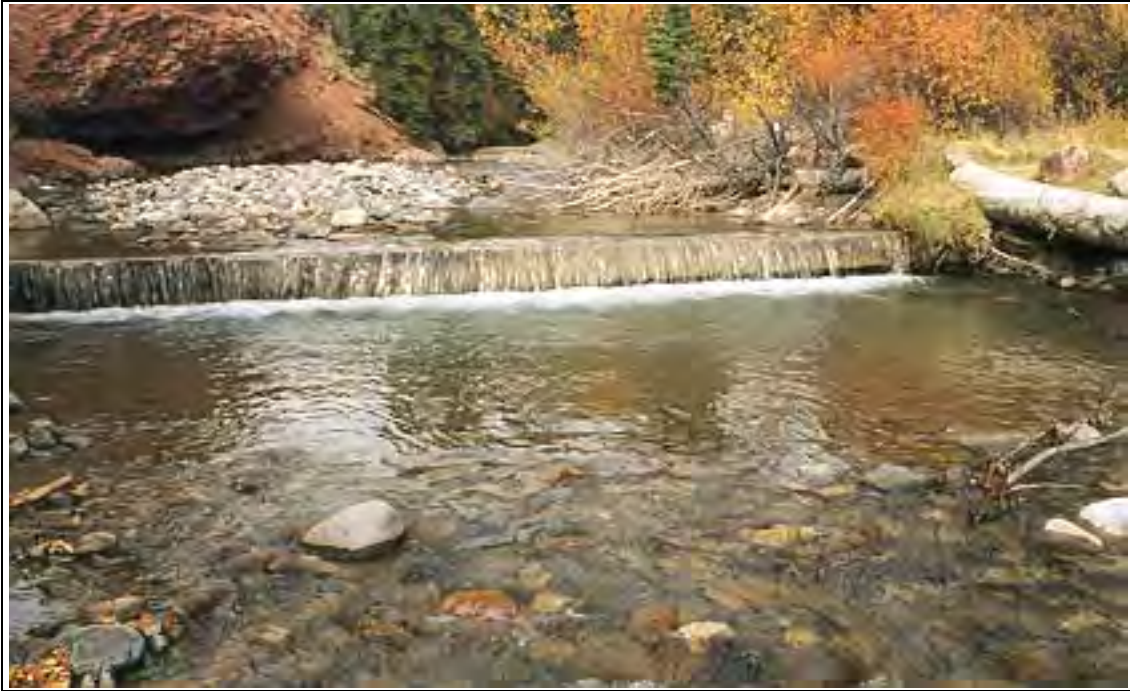
Figure 1-2. A log plunge located near the mouth of Bear Creek Canyon provides deep pool shelter for trout and helps dissipate energy during high flow events.

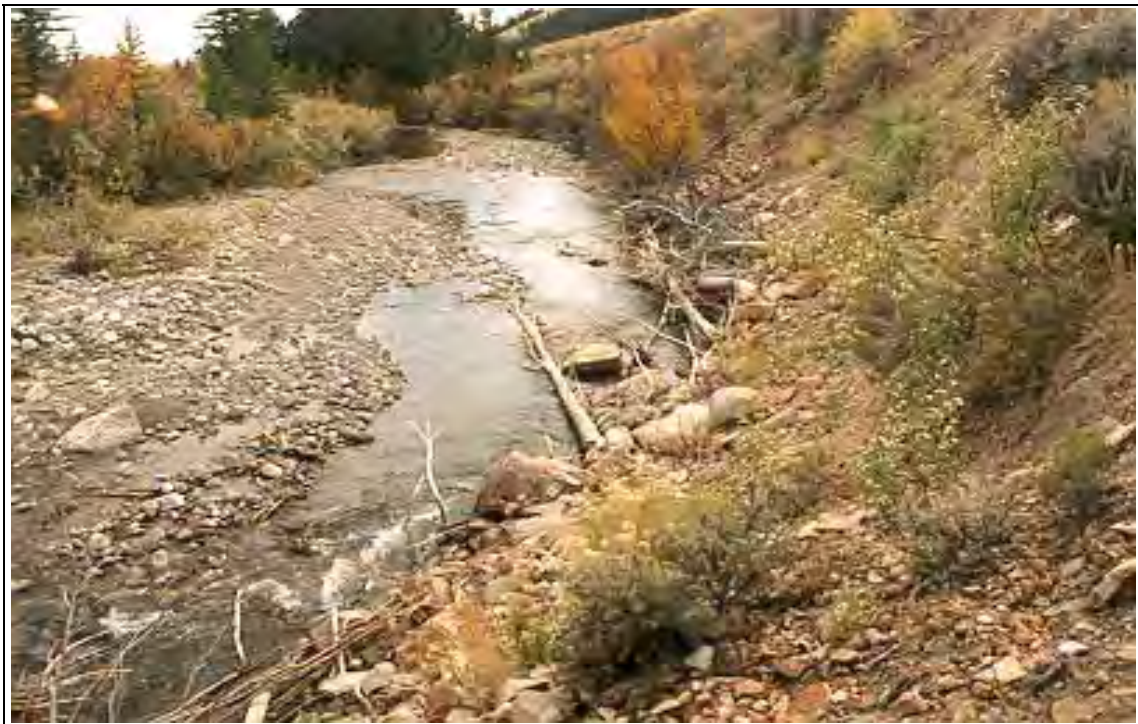
Trout Habitat Response - Habitat changes were not evaluated, but steep, formerly eroding bluffs were visibly more stable when examined in 1998 (Figure 1-3). In contrast, an unprotected bluff downstream from the project continued washing away. The treated bluffs have begun to slope themselves and a good growth of willows, shrubs, and grasses has developed. Stabilization has also eliminated the large sediment plumes (bars) that formerly occurred just downstream from each bluff. The channel appeared to be more stable than pretreatment and its pool and riffle sequence was well developed. Although scour and pocket pools had developed near the rocks, development of large pools at the “S” dams was generally poor. Only one “S” dam pool had an RPD over 1.5 ft. Vortex weir RPD was 1.85 ft.

Figure 1-3. Six years after tree and rock revetment installation, severe bank erosion is controlled and the bank is stable. There is good growth and development of plants.

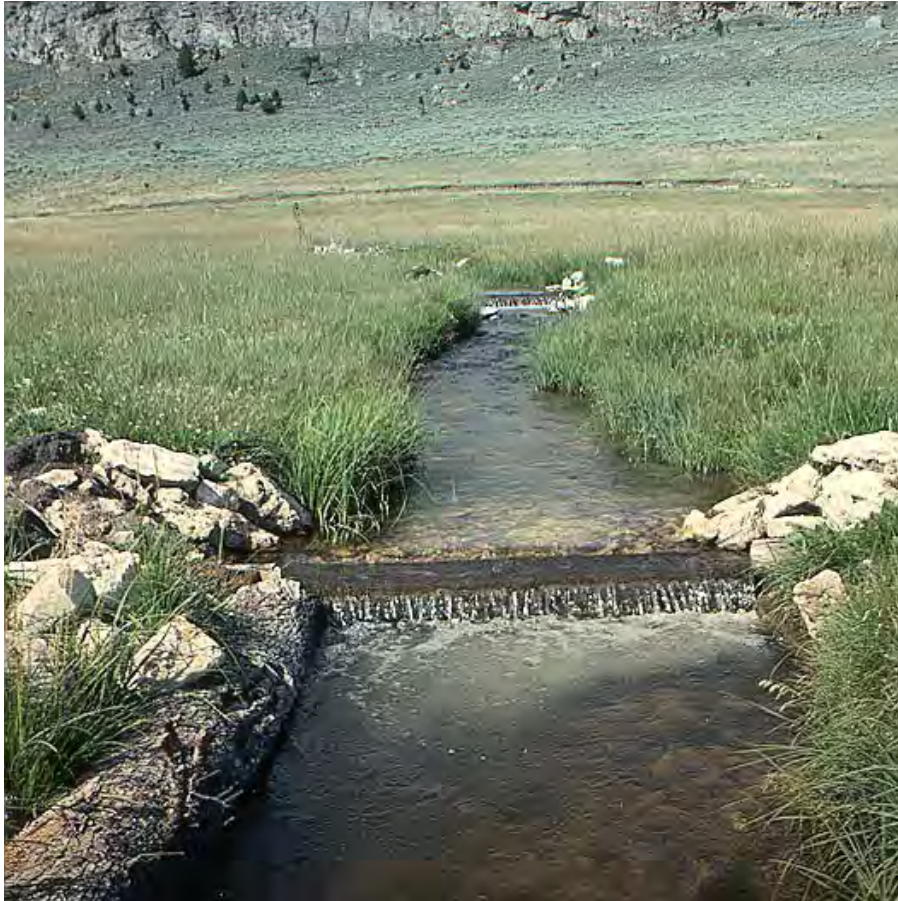
Figure 3-2. To provide deep pool cover for trout, as well as to help subirrigate the riparian vegetation, 58 pool digger structures were installed at Beartrap Meadows.

In 1989, increased angling pressure and deterioration of the hand-built rock dams prompted a second habitat improvement project. Goal of the project was to increase trout shelter on public land by creating more deep pools (Figure 3-2). A WGF construction crew used machinery to install 43 timber plunges, 15 rock plunges, 47 cover trees, and rock riprap to 100 ft of eroding bank. Project cost was \$13,423 (\$23,264/mile).

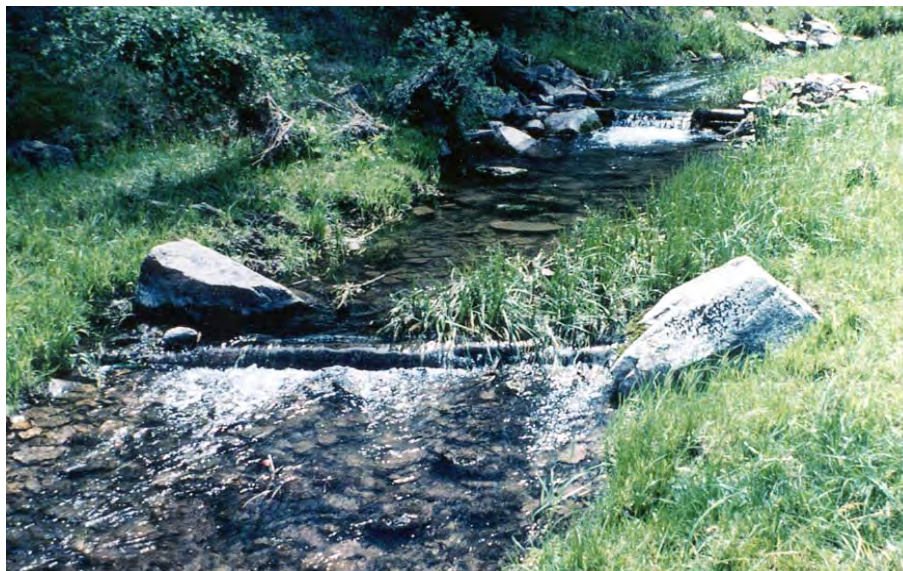
Figure 4-2. This timber plunge at Beaver Creek had a log grade control to maintain pool depth.

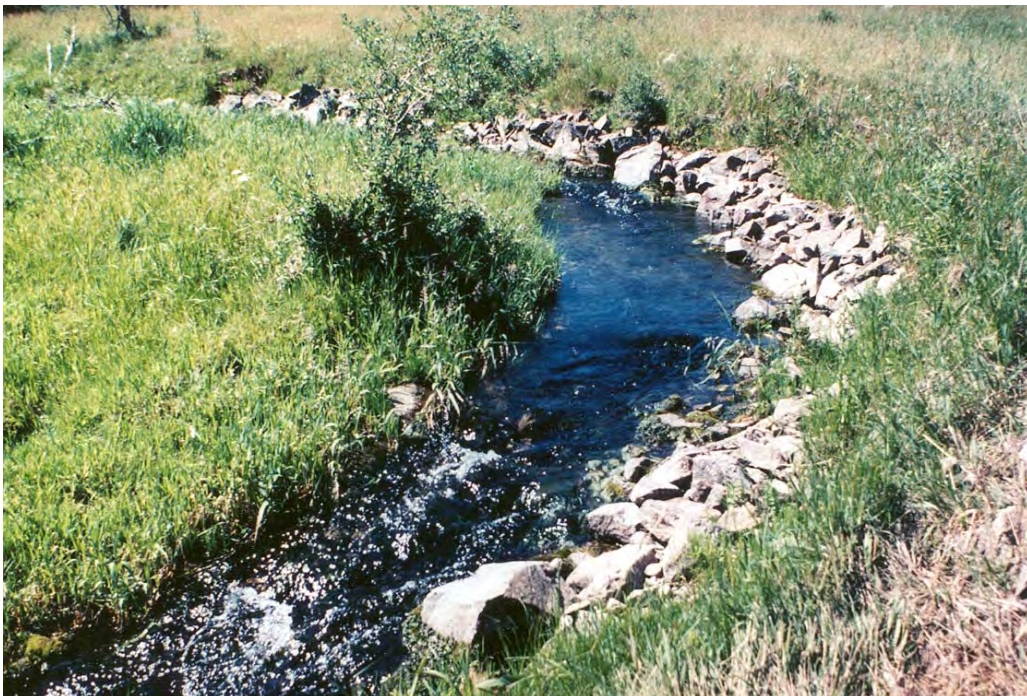
Figure 4-4. Eroding stream banks at Beaver Creek stabilized with rock riprap, which also sheltered trout by furnishing many hiding places among the rocks along the water's edge. Juvenile trout were especially fond of such habitat. Good vegetation growth and bank stability displayed at this site only two years after treatment.

HABITAT MANAGEMENT: In the early 1970s, Beaver Creek had few deep pools or overhanging banks (Figure 4-1). Much of the stream was riffle. Bank erosion was more widespread than would be expected from natural causes. Much of the bank instability was related to use of the stream bottoms by cattle. The HMA was fenced by USFS in 1973 and grazed only lightly thereafter. To correct these habitat shortcomings, a WGF construction crew installed 111 stream habitat improvement devices in the HMA: 47 triangular wooden deflectors, 16 wooden plunges (Figures 4-2 and 4-3), 8 wooden double deflectors, 7 wooden bank overhangs, 6 channel blocks, 3 wooden overpour ramps, 2 rock deflectors, 1 rock double deflector, 21 large pine trees, and rock riprap on 2,150 ft of eroding bank (Figure 4-4). Project cost was \$27,400 (\$12,455/mile).

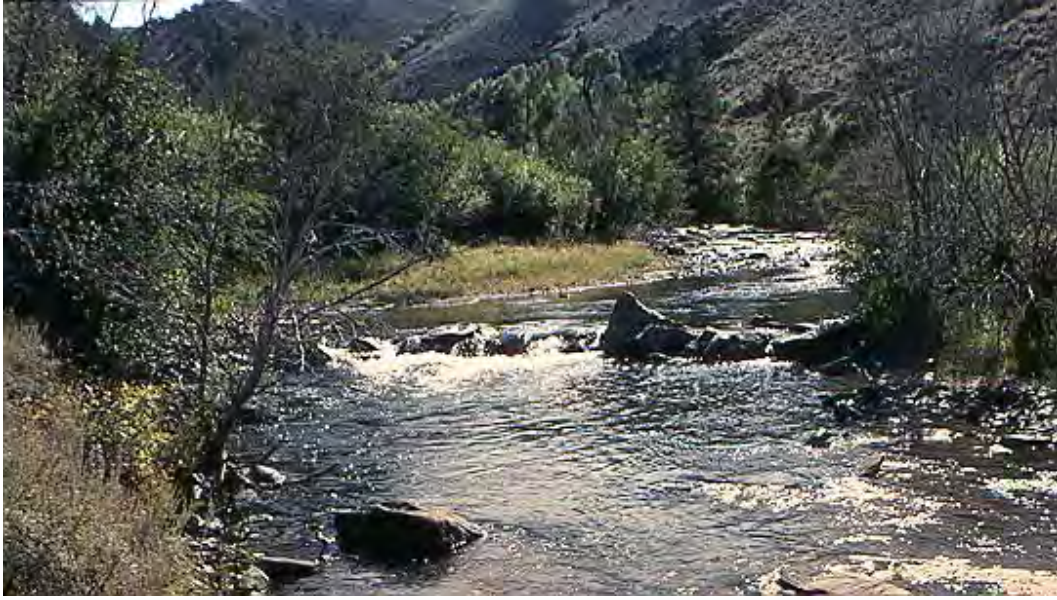
Figure 5-1. Addition of boulder weirs to Big Creek increased deep pool habitat for trout.

HABITAT MANAGEMENT: An evaluation of fish habitat on Big Creek through the canyon found that habitat was generally good, but some sections of “flat” water lacked suitable pool shelter for trout. Structures (four rock weirs and four rock deflectors) were constructed by Stream Team, Ltd., Longmont, Colorado (Figures 5-1 and 5-2).

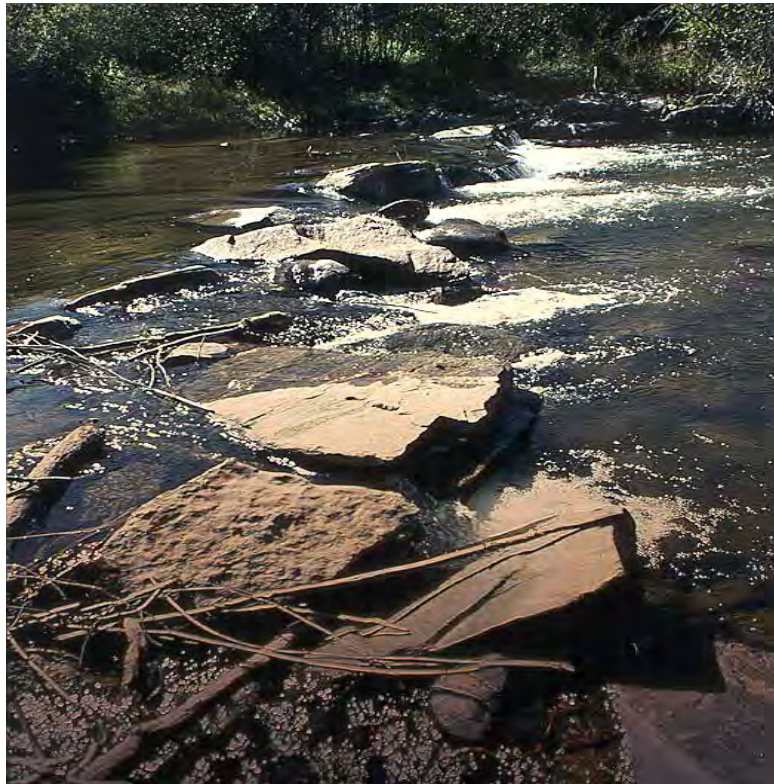
Figure 5-2. Close-up view of a boulder weir at Big Creek, which created pocket pools, a dam pool, and a plunge pool. These weirs also acted as grade controls and helped increase subirrigation of the riparian zone.

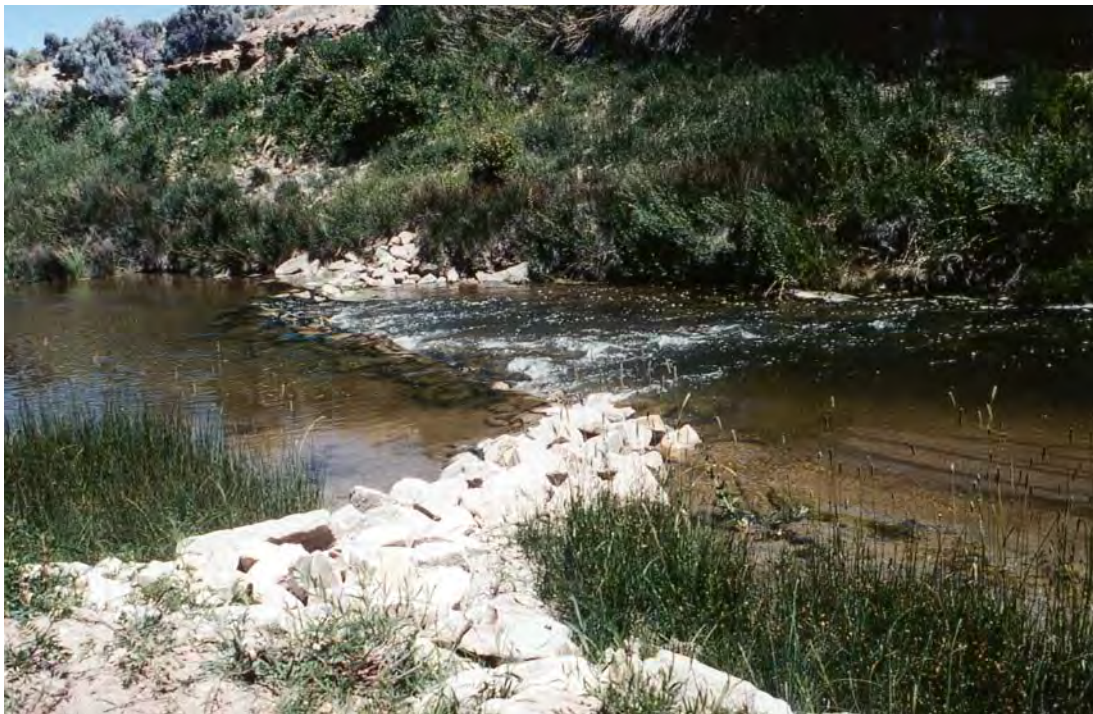
Skimping on materials also caused problems in long-term performance and durability. This was especially true with boulder weirs, e.g., the Big Sandy River. However, the many devices installed statewide have held up surprisingly well over years of floods, some of which were in the 100-year category. A detailed examination of the Beaver Creek project found over 90% of the structures fully functional 18 years posttreatment (Binns 1994). In 1995, 54% of the devices remained functional despite a low frequency flood that caused many changes in the stream channel.

Figure 6-1. Addition of rock weirs to the Big Sandy River increased habitat diversity by creating dam pools, plunge pools, and turbulence. Spaces between the rocks are important shelter for juvenile trout. These weirs also acted as grade controls and raised the local water table, which better subirrigated riparian vegetation near the weirs. The stream narrowed as sediment deposited in new lateral and point bars and riparian vegetation colonized these bars.

First efforts at habitat improvement on the lower Big Sandy were at Bone Draw, a small tributary fed by springs. Hatching boxes for trout eggs and pool diggers were installed in Bone Draw by TU in the 1980s under WGF guidance. When evidence accumulated that trout were present in the river near Bone Draw, interest was generated toward improving habitat in the river proper. Beginning in 1992, habitat improvement devices were systematically built in the river from Bone Draw to below Big Bend. By 1997, 51 boulder structures had been built and 45 of these were rock weirs (Figures 6-1 and 6-2). Installation and rock hauling was done by private contractors. Most of the rocks were hauled from the old iron ore mine on South Pass. Project cost was about \$145,000 (\$7,250/mile).

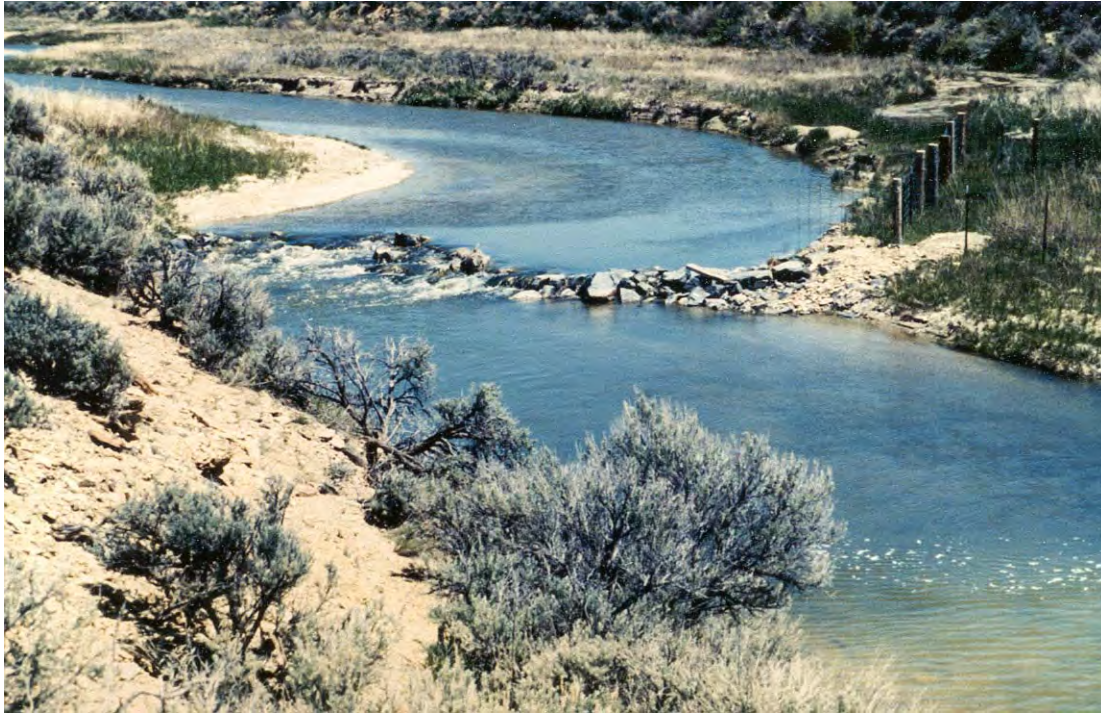
Figure 6-2. A boulder weir on the Big Sandy River turns the flow into a rocky bluff to create better shelter for trout. A livestock exclosure is at top right.

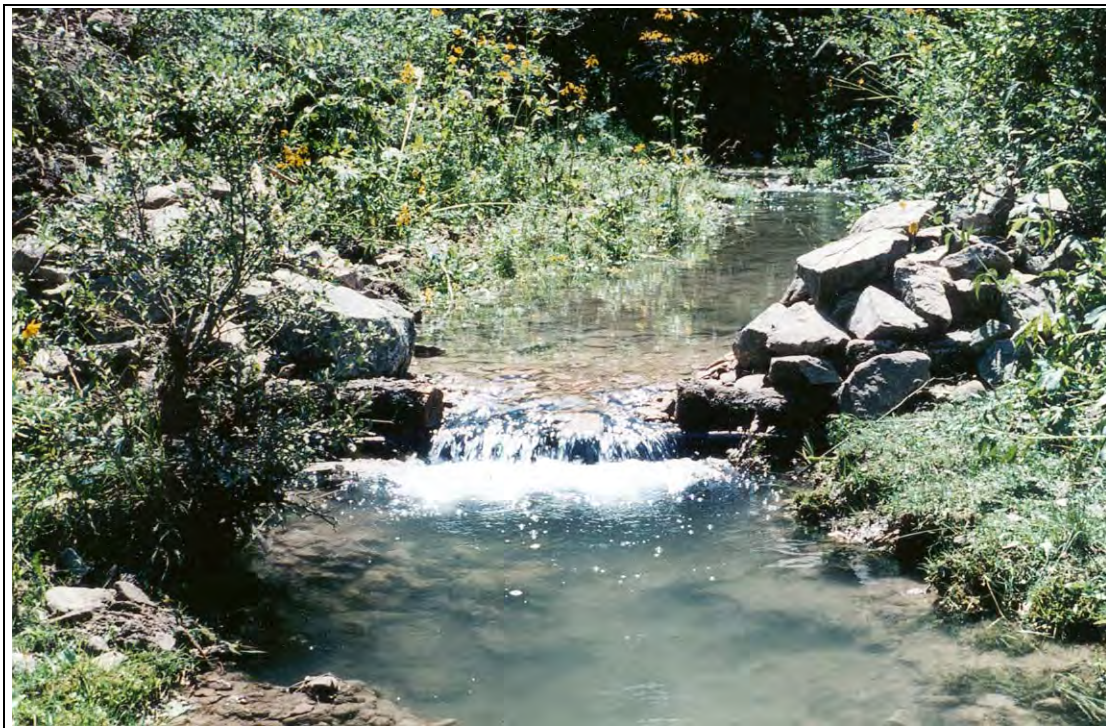
Figure 8-2. Timber plunges installed in Blacktail Creek created deep pool shelter for brook trout and often contained numerous fish for several years posttreatment.

Habitat Structures - A flash flood in 1978 washed out the log plunge and a timber plunge. They were not replaced. Both were located on “S” bends of the stream, a poor location as flood flow continued natural lateral erosion at the bends, thus washing around one end and burying the devices in the newly formed point bar. The other plunges survived the flood and continued to function. But by 1990, all plunge pools were plugged with *Chara* and no trout were seen.

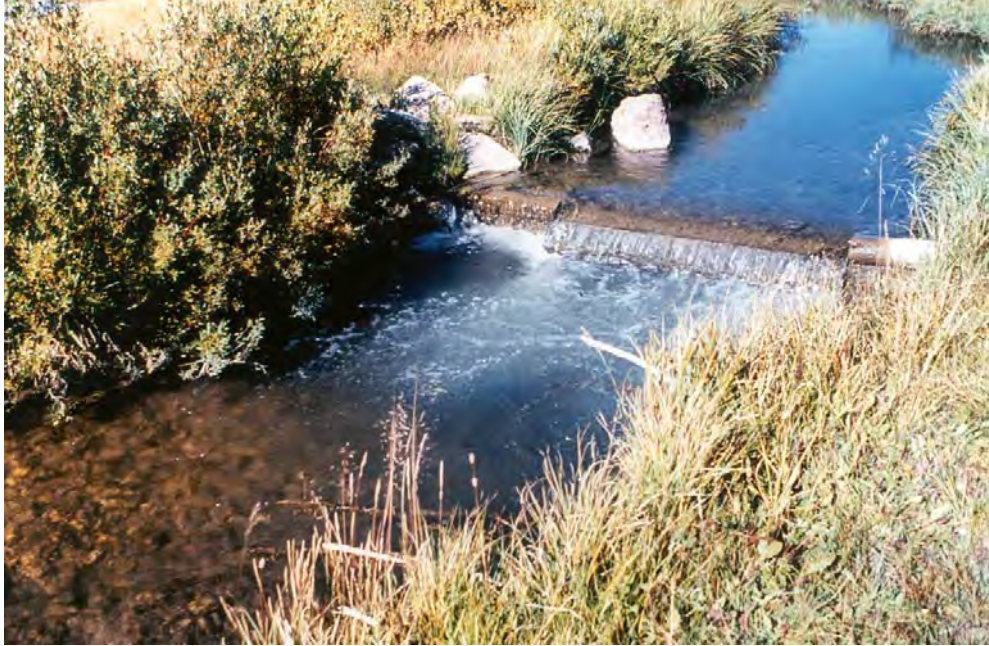
Habitat Structures - Maintenance needs of the plunges were few as they required only occasional resealing. All plunges were rated as being in good condition in 1993.

Figure 10-3. Timber plunges installed in Bull Creek provided both plunge pools and dam pools to shelter trout.

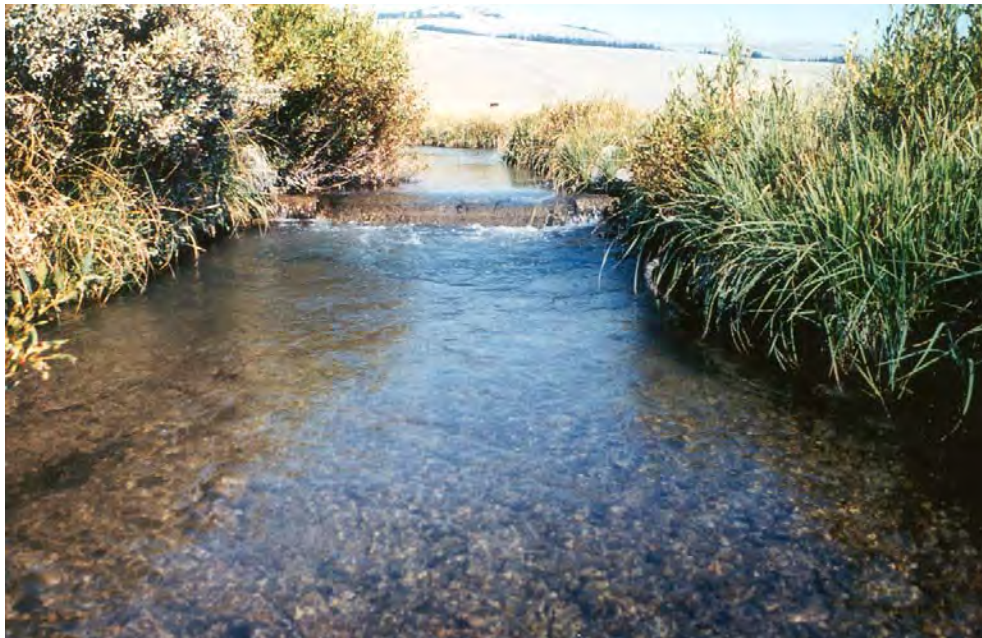
Figure 10-4. In addition to improving shelter for trout with more pool habitat, the plunges aided streamside vegetation by increasing bank storage of water to better subirrigate plants.

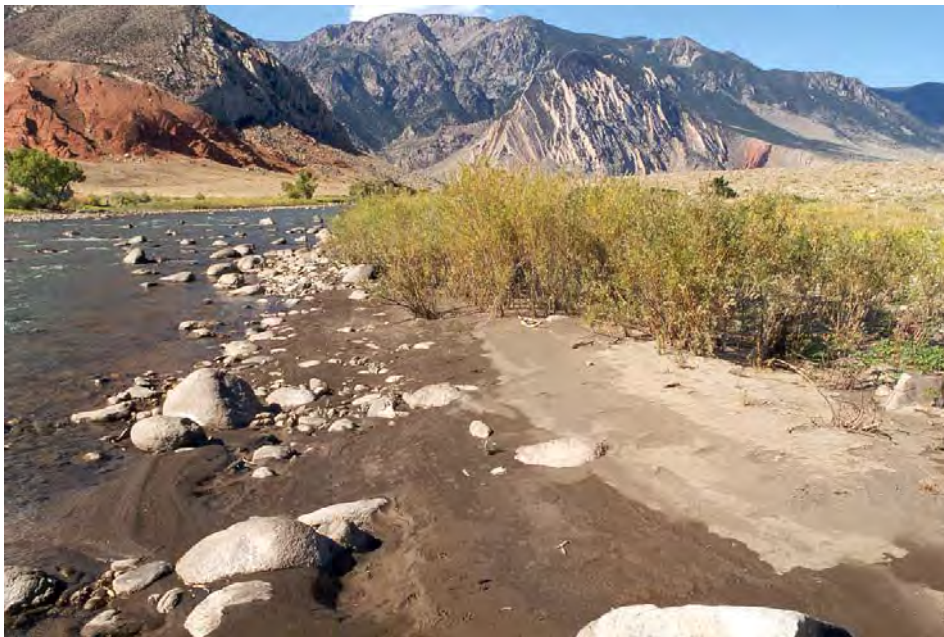
Trout Habitat Response - Much additional pool habitat developed near the boulder structures. Posttreatment, Hogle (1993) reported a 100% increase in HU and 120% increase in cover for trout. During high flows, the devices tended to slow and “pond” the river flow to some extent, which encouraged deposition of sediment along the shoreline. Considerable new willow and cottonwood tree growth developed on these new bars (Figure 12-2).

Figure 12-2. Deposition of sediment along the shoreline near the rock funnels, plus better subirrigation of stream banks caused by ponding behind the devices, allowed establishment and lush growth of riparian vegetation, such as the willows shown here.

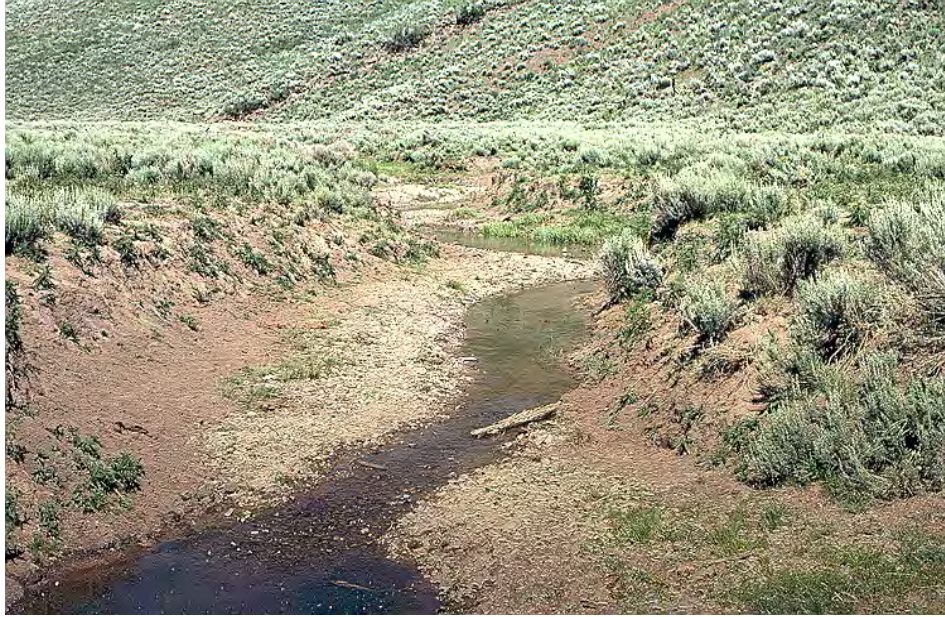
of willow and aspen stands had been reduced by cattle trampling and feeding on young shoots. Beaver activity was consequently much reduced by a shortage of food and materials for building dams. Stream bank erosion was wide spread and vegetative vigor was much reduced along the stream (Figure 13-1). In 1979, a WGF construction crew enclosed about 1 sqmi of creek bottoms and valley sides with a wire and pole fence. No costs were recorded. Then to improve habitat conditions for BRC, instream structures were built within the enclosure. In 1980, a WGF construction crew installed 6 timber plunges (Figure 13-2), 3 single deflectors, 3 double deflectors, and one each of log plunge, upstream “V” plunge, rock plunge, and wire trash catcher. The rough terrain and poor access to the project meant no rocks or trees could be imported. Only rocks found on site were available to armor structures. Aspen tree revetments were built at eight eroding banks and 35 pools were improved in the canyon by rearranging rocks. Project cost was \$4,050 (\$4,050/mile).

Figure 13-1. Pretreatment, stream bottoms at upper Coal Creek had been extensively grazed by livestock for so many years that streamside plant vigor was much reduced and only more tolerant species grew. Watershed health was poor.

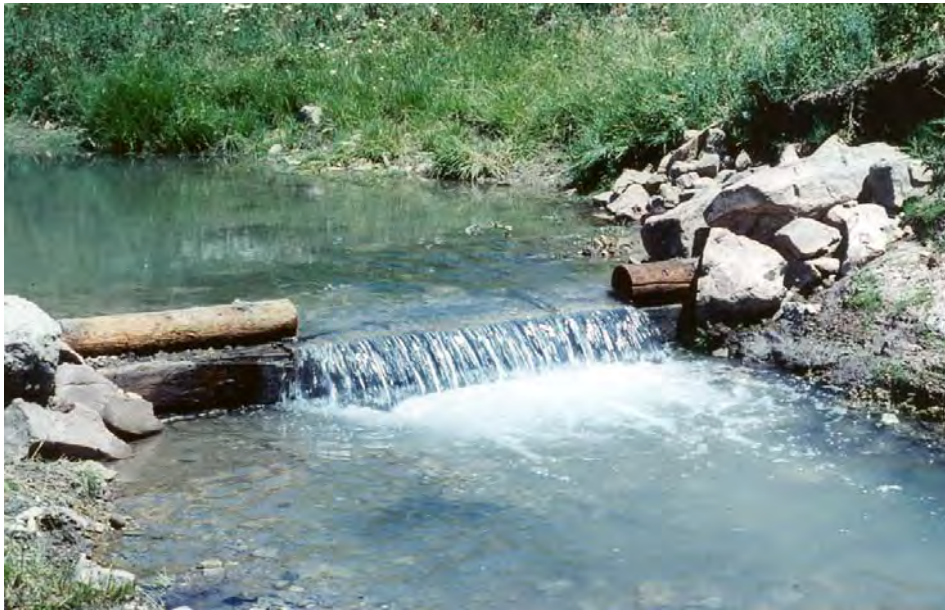
Figure 13-2. A freshly installed timber plunge in Coal Creek already provides pool habitat to shelter trout.

Habitat Structures - By 1995, most of the structures were intact despite being exposed to several major floods, including a 75-100 year flood in 1984. But at least one timber plunge, a deflector, and the log plunge were destroyed within a year or two after installation. Fine-grained soils proved susceptible to erosion and allowed the stream to wash around these structures. Lack of a good rock source definitely limited how well structures could be armored against floods.

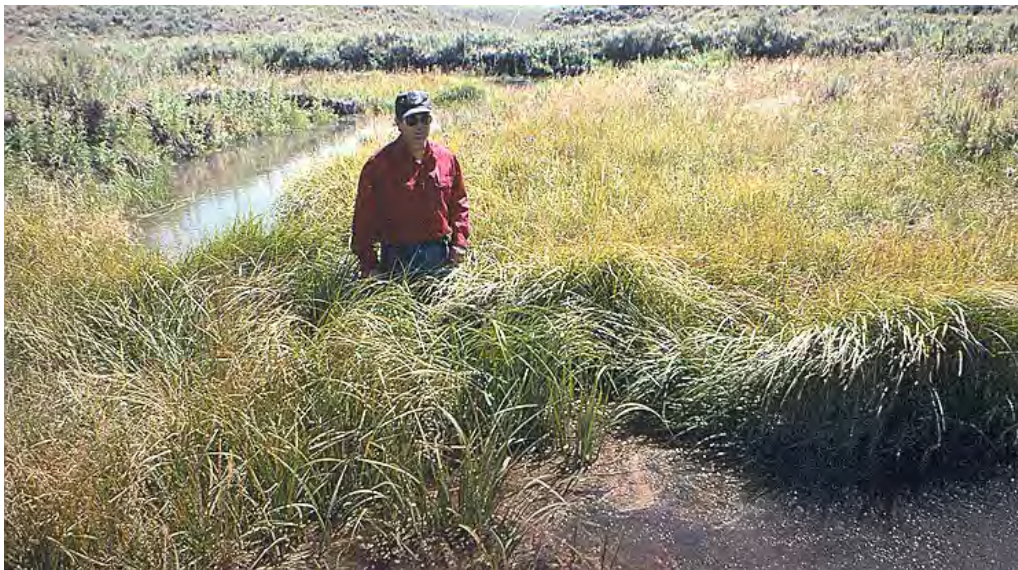
Although maintenance of the enclosure fence by BLM was irregular and some cattle grazed inside at intervals, overall vegetation response was good over the long term (Figure 13-6). Growth of streamside sedges and grasses was noticeably better posttreatment (Figure 13-7). Deep pools were provided by the structures and undercut banks developed as the streamside vegetative cover improved. Use of aspen in the tree revetments was a mistake because beaver immediately took advantage of that new food supply and built a complex of dams, which created new pool habitat for trout and aided riparian vegetation, while drowning out several structures. The overall effect of the beaver ponds were likely positive, but benefits were transient because floods periodically washed out the dams. Building material and food were once again restrictive for the beaver once the imported aspens were depleted. From the standpoint of water temperatures, shoal areas in the pond became warm during summer, but the deep, original channel was cool and water exiting the dam was several degrees colder than water entering the pond.

Figure 13-7. When the enclosure fence was intact and provided protection from livestock grazing, grasses and sedges grew abundantly in the stream bottoms.

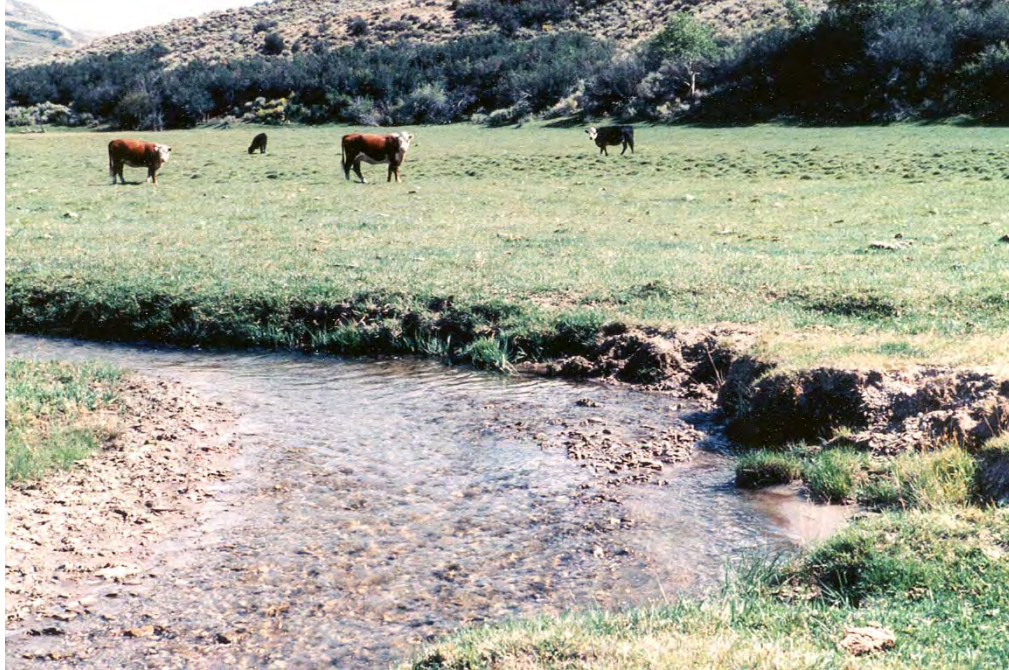
Figure 14-3. Pretreatment, Currant Creek at Janes Meadow was heavily grazed by livestock for many years. Deep pools were lacking and bank erosion was common.

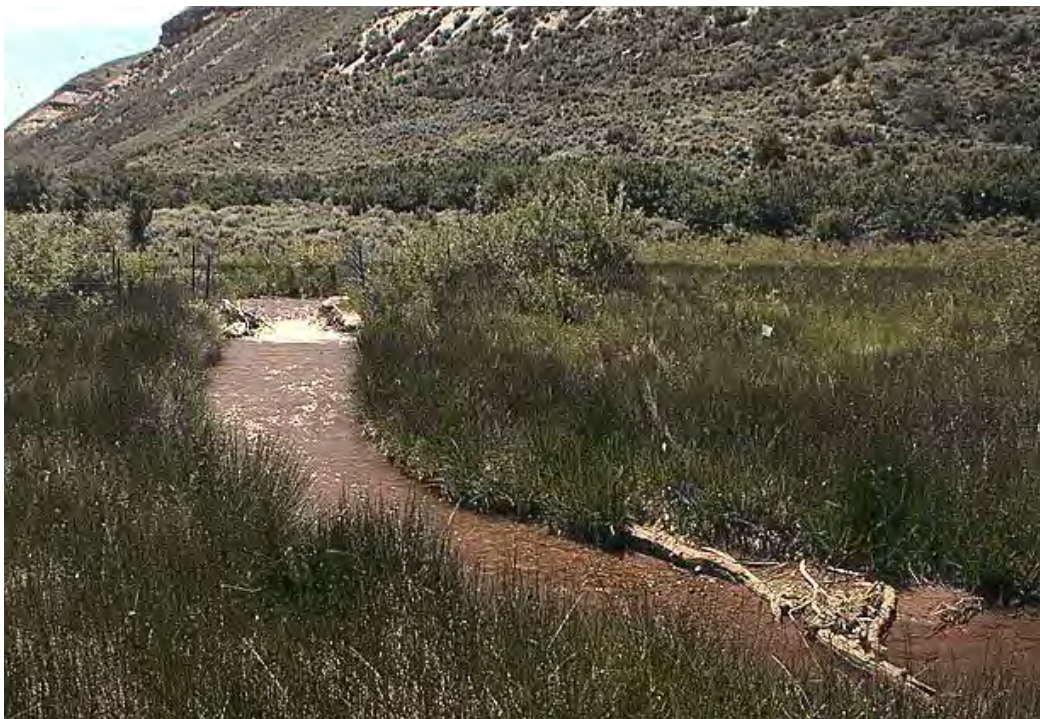
Trout Habitat Response - No formal evaluation was made of trout habitat changes, but the new plunges produced good plunge pools, controlled grade, stopped headcuts, and caused silt to deposit upstream from the plunge. Reduced grazing at Janes Meadow, and better sub-irrigation of the floodplain, prompted good growth of vegetation thereon and that, in turn, led to better instream fish cover. Re-establishment of sedges and other streamside vegetation on sediment deposits soon narrowed the stream. More cover for trout was formed as bank stability improved, undercut banks formed, and bankside vegetation drooped into the water.

Figure 14-4. Reduced livestock grazing and better subirrigation aided recovery of riparian vegetation at Janes Meadow. Deep plunge pools furnished good shelter for trout.

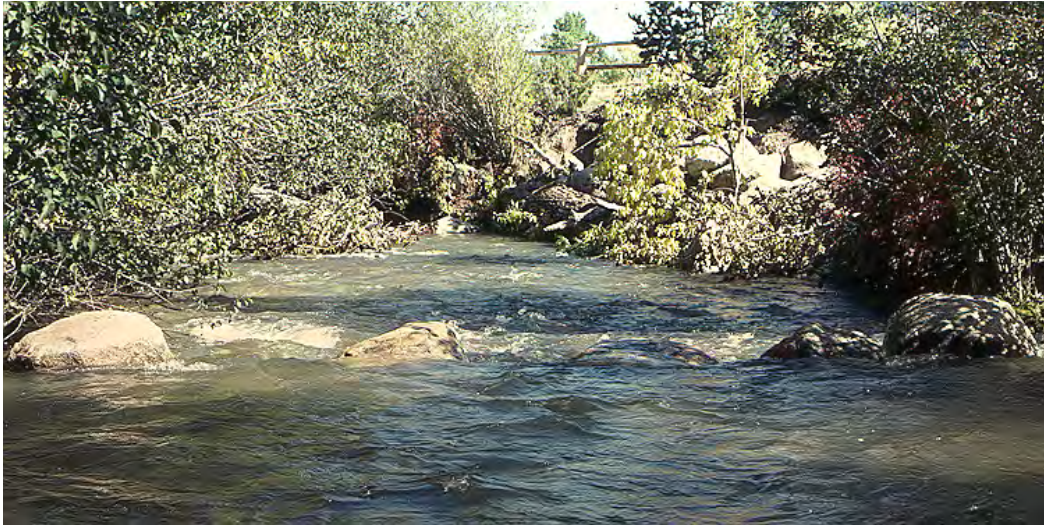
Figure 15-1. Boulder fish rocks (foreground) and a tree/rock revetment (far edge of stream) provided additional shelter for trout in Dead Indian Creek.

Habitat Structures - In June, 1981, intensive and extended rainfall on the snowpack generated a 100 year flood, which washed away at least one camping unit and part of the campground road at the lower end of the campground. Considerable stress was placed on the habitat improvement structures. Clusters of fish rocks were shifted from their original position by the flood, but continued to provide pocket pools usable by trout. Other fish habitat features through the campground were also altered by the flood. Near the damaged camping unit and road, instream trout habitat was further damaged when USFS repaired flood damage by channelizing the stream, armoring banks with large boulders, and removing the deflectors.

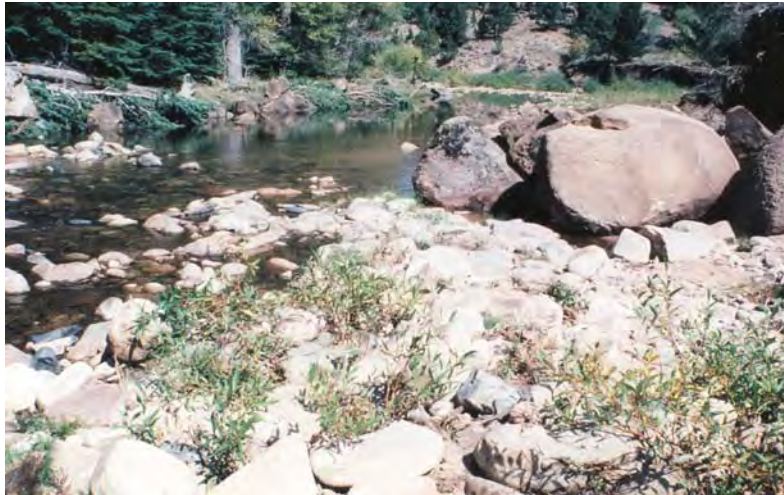
Trout Habitat Response - No formal evaluation was done, but photos were taken and a visual inspection ten years after construction found the deflectors had formed sediment bars where willow growth was better than pretreatment, the stream had narrowed there to scour a deep pool, and the cover trees appeared to still be effective to some extent (Figure 15-2). At the low bank, bank stability was improved, but stability at the cutbank appeared to be only about 75% better than pretreatment.

Figure 15-1. A boulder deflector and a tree/rock revetment (far bank) as they appeared soon after construction in 1986.

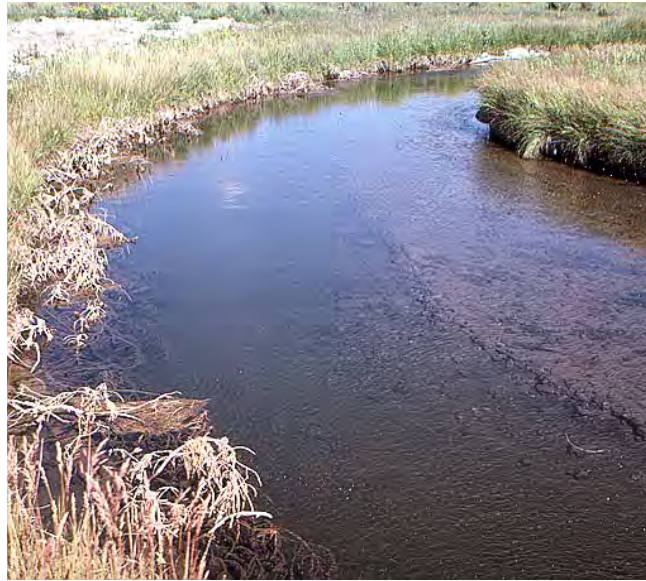
Figure 17-1. A bank protected with a tree revetment as it appeared six years posttreatment. A deep slot was excavated in the channel along the tree edge when the trees were installed.

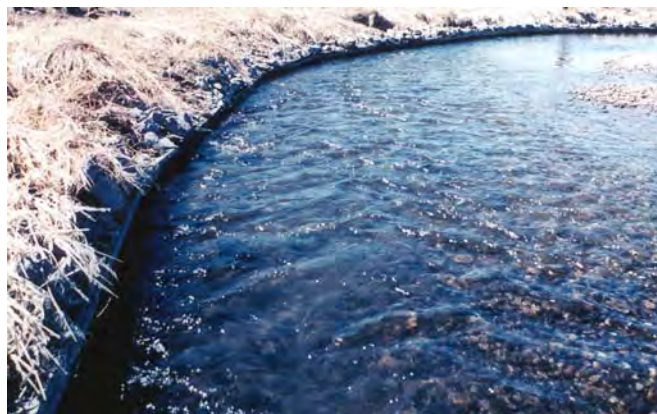
Figure 17-2. Four years posttreatment, a bank protected by skyhook bank panels offers overhead bank cover for trout.

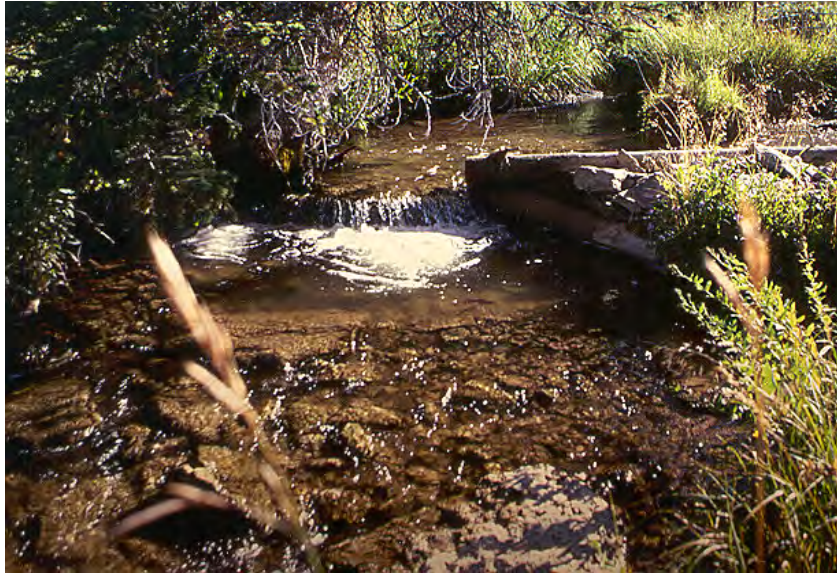
Figure 18-1. Rocks and logs were added to this wing deflector to create a plunge, which is controlling grade and providing plunge pool shelter for trout.

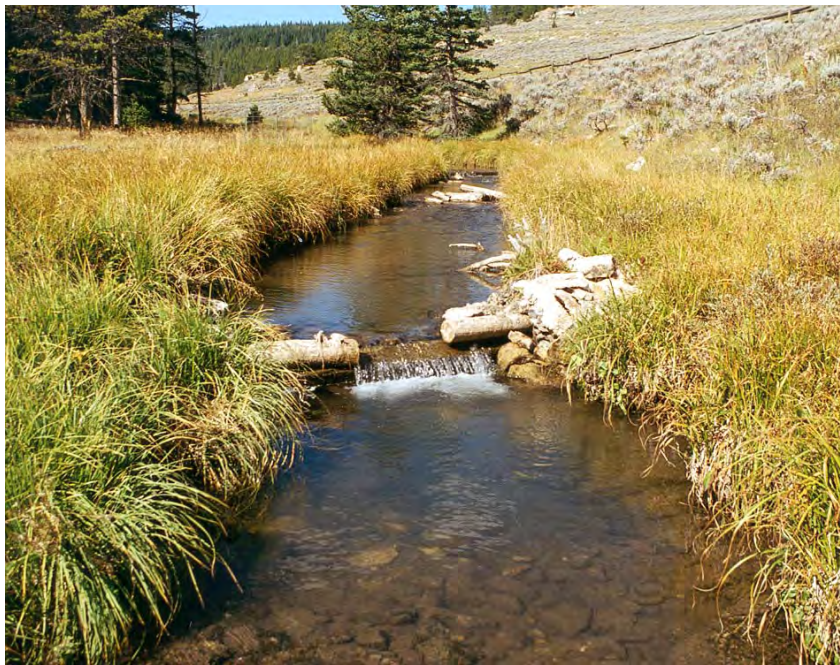
Figure 18-2. This log plunge in a meadow section of Fool Creek is intact and providing pool shelter for trout 19 years after being built.

In 1998, an inspection located 40 wooden plunges built during *Phase I*. One plunge was washed out, one was functioning as a digger log, but the rest were at least partially functional. Mean RPD of the plunge pools was 1.56 ft, but only 53% of the pools had an RPD of 1.5, or greater. Poor pool depth was commonly caused by rocks that had rolled into and plugged the plunge pools, which emphasizes the need for regular maintenance of plunge pools in steep gradient streams.

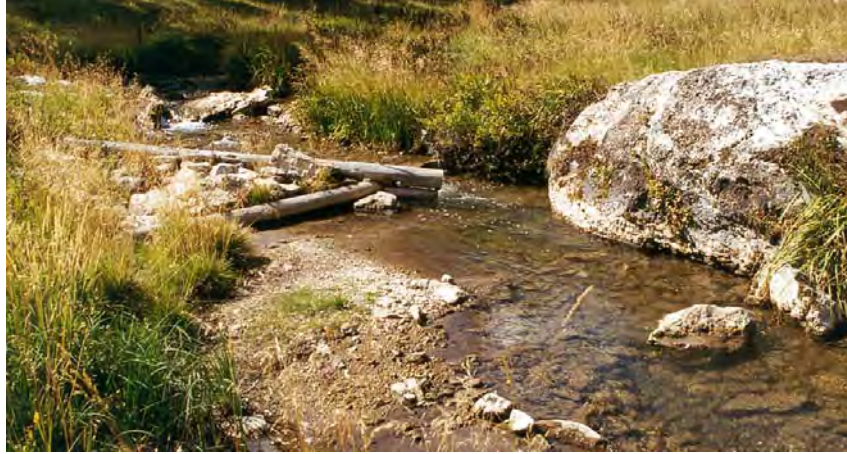
Figure 18-3. A log wing deflector was used to direct flow into a boulder to create scour pool shelter along the edge of the boulder, but no deep pool cover developed.

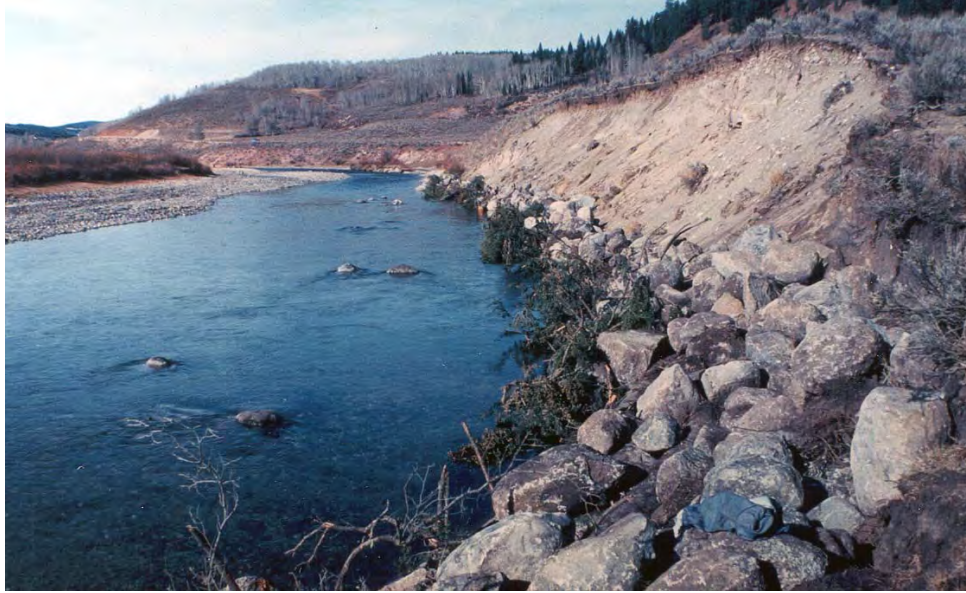
Figure 21-1. Its equilibrium disturbed by channelization downstream on private land, the Green River was actively cutting laterally into this steep bluff located just upstream from the forest boundary. This tree and rock revetment had just been installed when the picture was taken in October, 1988.

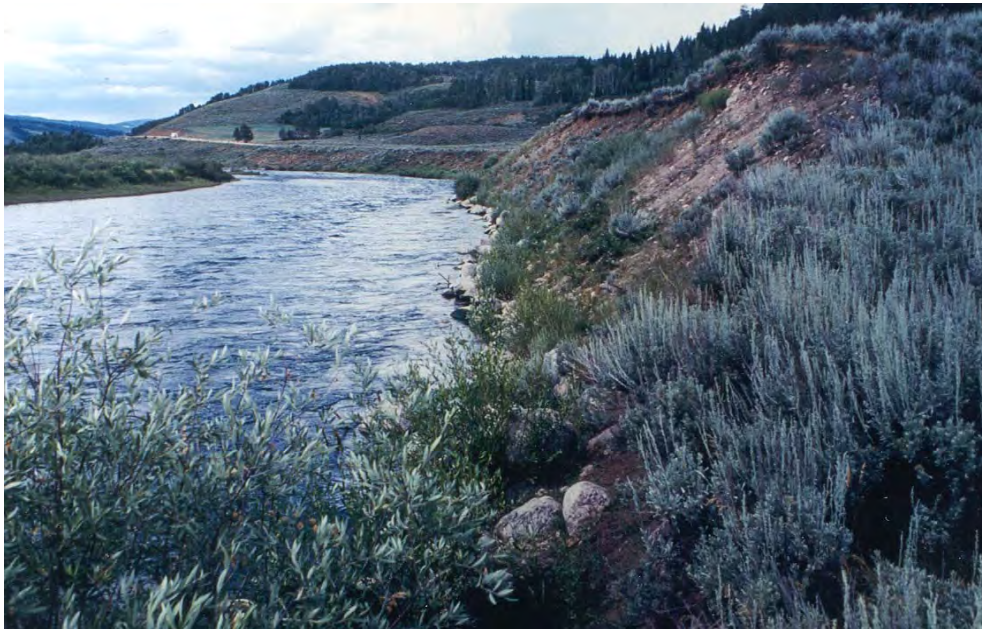
Figure 21-2. The same steep bluff shown in Figure 21-1 as it appeared ten years after treatment. Willows, sagebrush, and various grasses and forbs have actively colonized and helped stabilize the bluff. A deep pool/run has formed along the edge of the revetment. Many of its trees and rocks are submerged and offer cover for trout.

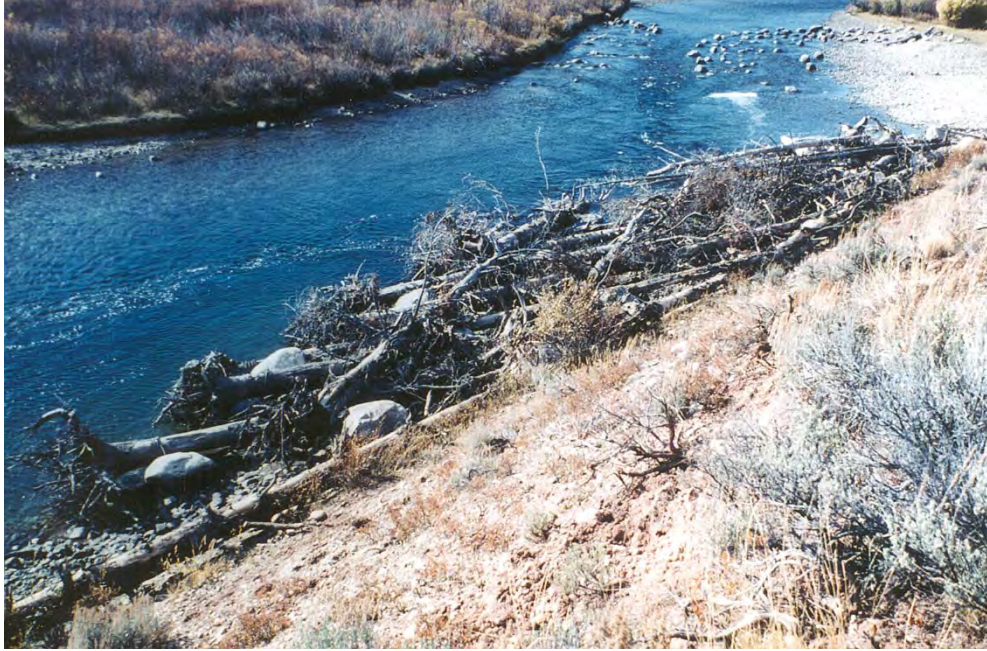
Figure 21-3. A tree jam continues to function and shelter trout despite low flows. At upper right, a rock funnel is visible; its slot concentrates low flow into a narrower channel and the deep pool dug out near the tree jam. Adult trout favor the deeper water along the face of the jam, while juvenile trout often find haven within the jumble of trees.

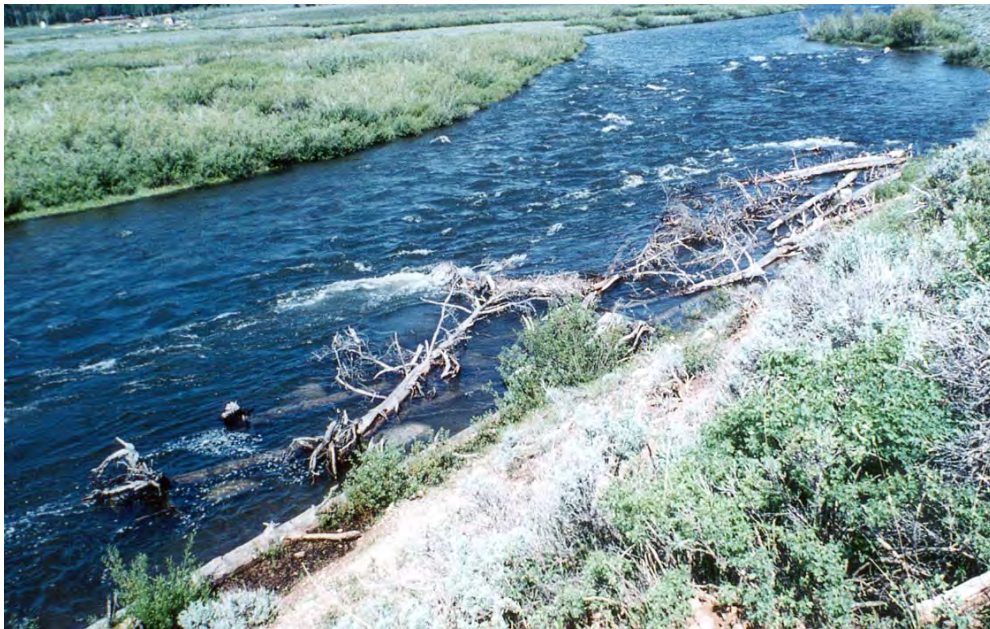
Figure 21-4. The same tree jam as shown in Figure 21-3 during a spring snowmelt runoff. Trout can find shelter within the jam and are able to gain respite from the swift flood flows, from which there was previously no shelter. Juvenile trout have especially benefited from the cover provided by the trees and rocks.
