**A Compendium of Trout Stream Habitat Improvement
Projects Done by the Wyoming Game and Fish
Department, 1953-1998.**

**N. Allen Binns,
Aquatic Habitat Supervisor**

**Fish Division
Wyoming Game & Fish Department
Cheyenne, Wyoming 82006
April, 1999**

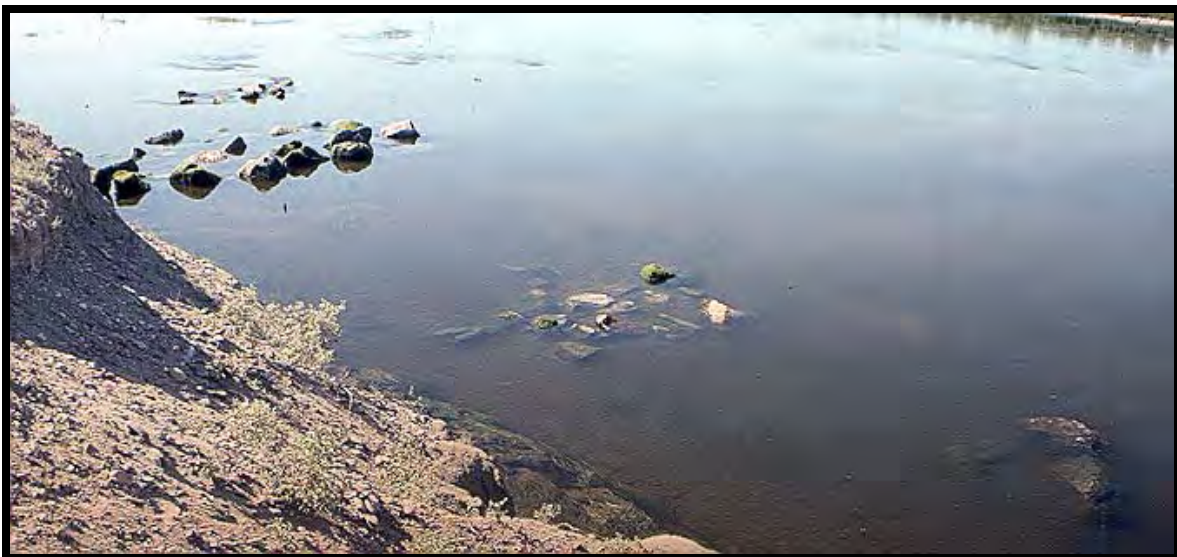
available during 1991 allowed repositioning of scattered fish rocks. Observations had previously noted that large boulders placed in midstream were not effective on rubble glides because a large rock is so massive, trout have trouble feeding around it. Jetties along the bank, with piles of smaller rocks positioned between each jetty, created a more complex habitat for trout and had attracted trout better than the midstream boulders (Figures 22-2 and 22-3). Thus, previously installed boulders were rearranged into groupings so shelter for trout would be maximized.

Figure 22-2. Boulder “jetties and piles” added along edges of the lower Green River increased habitat complexity and were well used by trout.

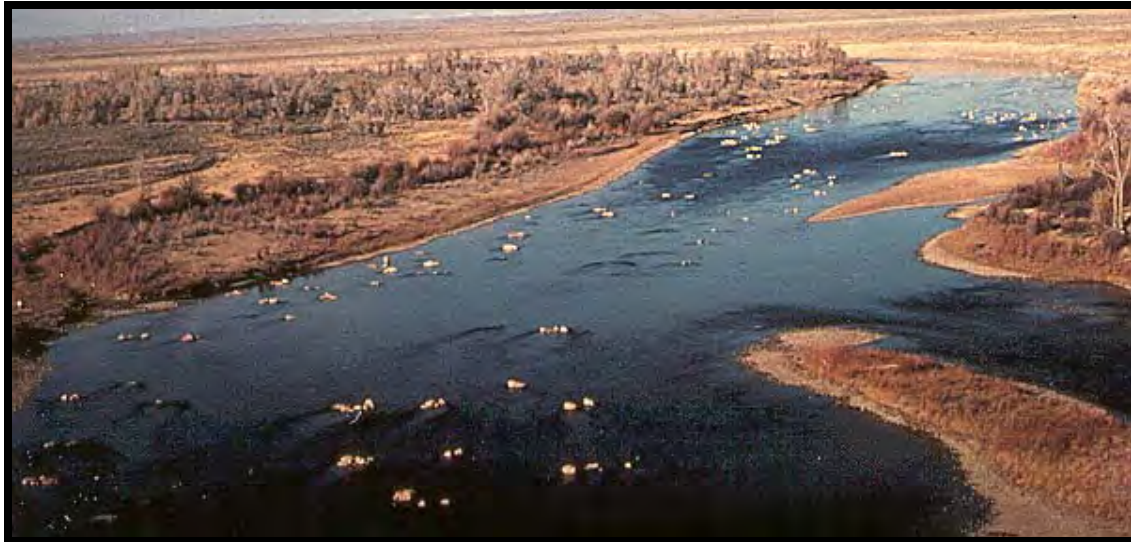
Figure 22-3. Granite boulders were added to the Green River downstream from Fontenelle Reservoir to increase shelter for trout.

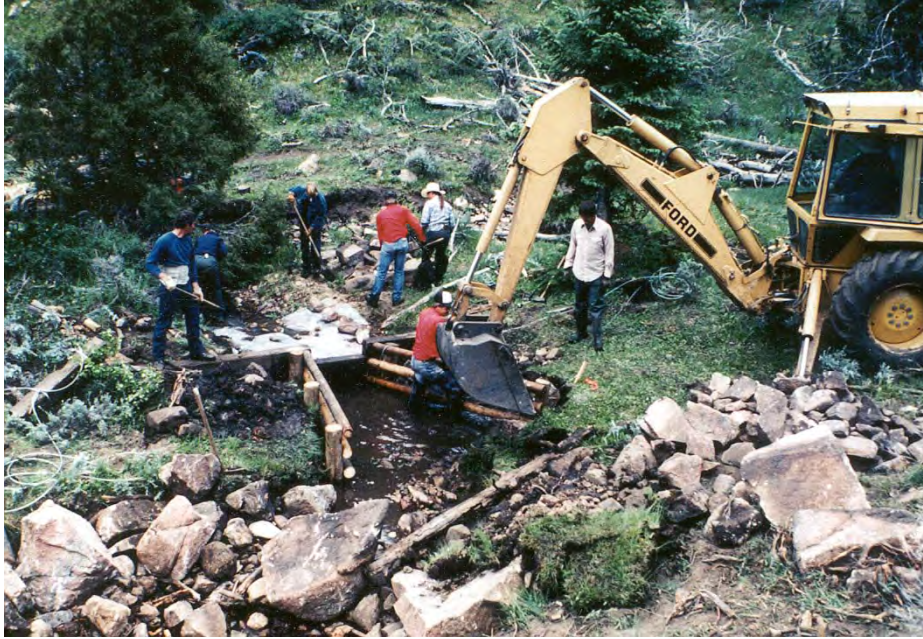
Figure 24-2. A joint WGF and USFS work crew building a timber plunge in 1985 to provide deep pool shelter for trout in the rocky substrate at Hall Creek.

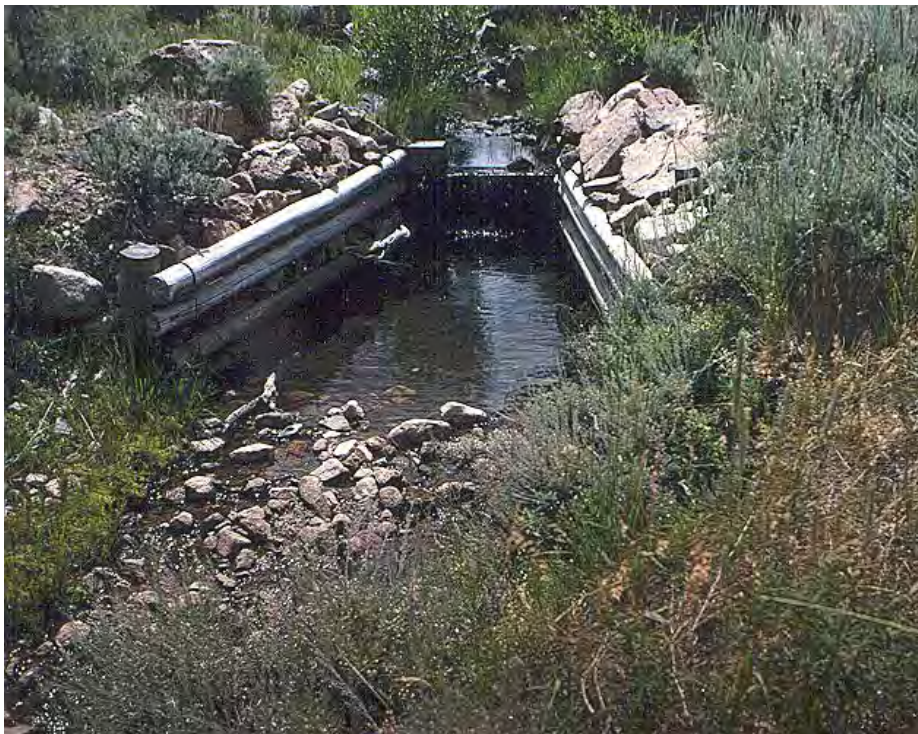
Trout Habitat Response - Plunge pools were dug out to a depth of at least two feet during construction. An evaluation 11 years later indicated the pools had retained their depth, and in some cases, had become deeper. HQI measurements documented a 650% increase in cover and a 86% decrease in eroding banks through the HQI station (Figure 24-4).

Figure 24-3. A timber plunge at Hall Creek continues to furnish deep pool shelter for juvenile trout 11 years after installation.

Habitat Structures - In 1986, a joint agency work crew did a half-day of maintenance work on the plunges. All plunges were visited in 1996 and checked for problems. Six of the plunges were rated in good condition, but one was leaking badly underneath the timbers, and another was washed out around one end. RPD was 1.5 ft, or greater, (range: 1.5 to 3.0 ft) at all plunges and even the damaged ones supported good plunge pools. Effectiveness of the drift fence installed by USFS was debatable, as cattle frequently trespassed into the project area through damaged fence sections.

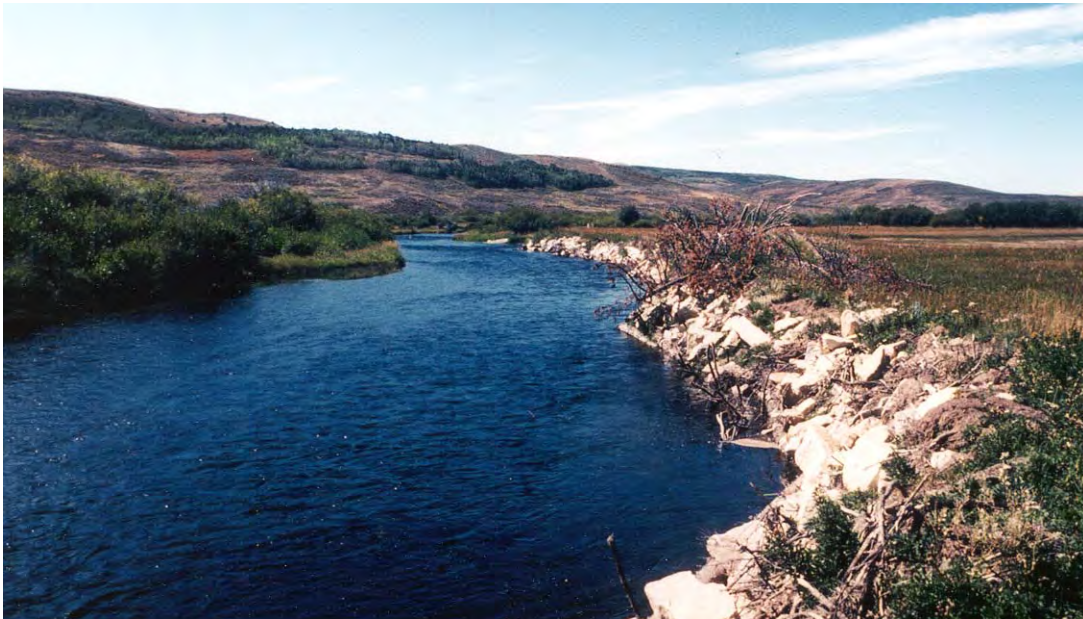
Habitat Structures - About 60% of the structures were inspected in 1997. Other than several pockets of localized scour within revetments, the majority of the revetments were in good condition. At the two slide areas, the rock dikes had improved the stability of banks and channel, but some fracturing of boulders was noted. Good vegetation growth has developed on formerly bare banks now protected by the dikes.

Figure 25-1. Many unstable stream banks on the Peternel PFA were stabilized with tree and rock revetments, which also provide shelter for trout along stream edges.

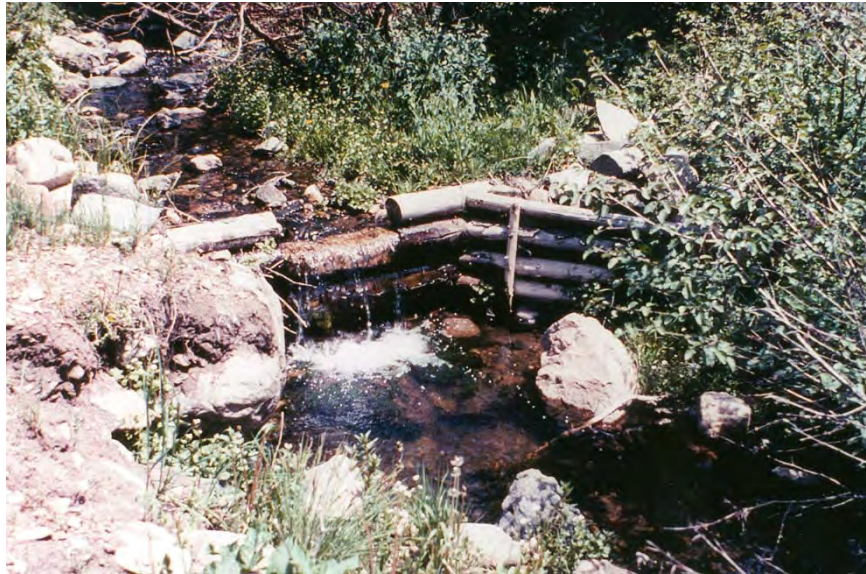
Figure 26-1. A log plunge in Hell Canyon Creek near the forest boundary 14 years after construction is still intact and acting as a grade control. Its plunge pool furnishes shelter to trout and a jumping point for trout seeking to move upstream past the structure.

Habitat Structures - In 1995, six of the seven log plunges on forest were functional. One did not have a plunge pool as the stream bottom had filled in level with the plunge log. It was serving as a grade control. RPD was 1.5 ft, or deeper, at 43% of the seven devices. All seven plunges on forest were intact and their condition graded good (> 80%), despite the lack of a plunge pool at one device. Log deflector condition was good. Sediment deposition and grass growth had incorporated them into the stream banks where they blended in well with the terrain. On the BLM land, condition at 80% of the plunges graded good, but none of the plunges had RPD 1.5 ft, or deeper, (range, 0.5 ft to 1.4 ft, mean, 0.77/plunge). Sediment deposition appeared to be greater at the BLM section.

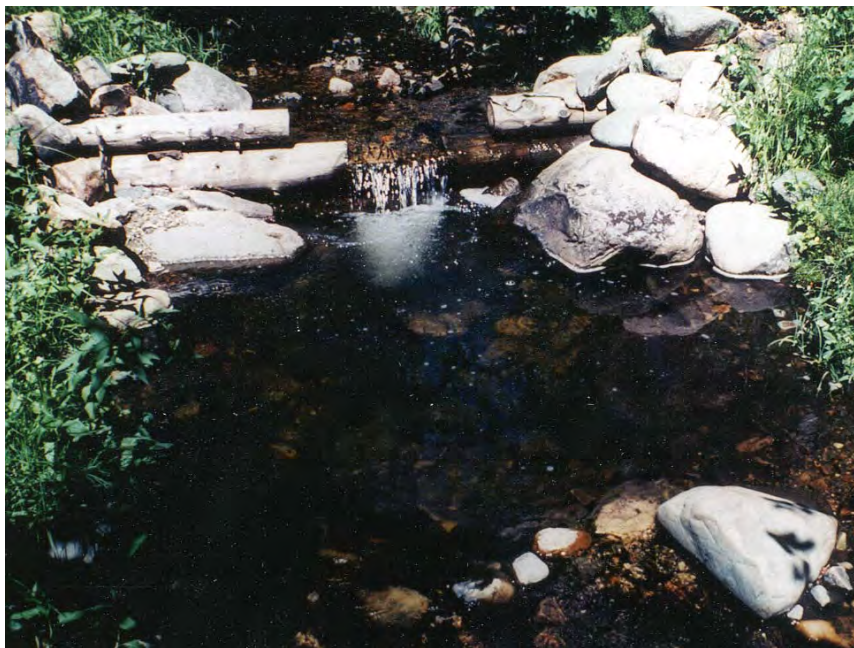
Figure 26-2. This log plunge offers deep, shady pool habitat for CRC.

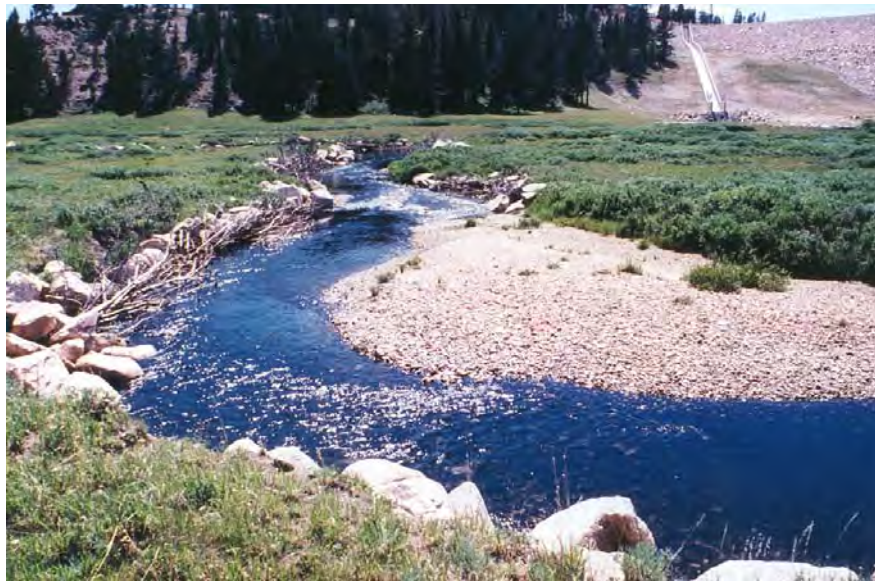
Figure 27-1. Stream banks scoured bare by flood waters were stabilized with tree and rock revetments, which narrowed Hog Park Creek and provided shelter for trout. This picture, taken three years posttreatment, shows riparian vegetation starting to establish on the point bar. By 1997, more vegetation had developed on the bar.

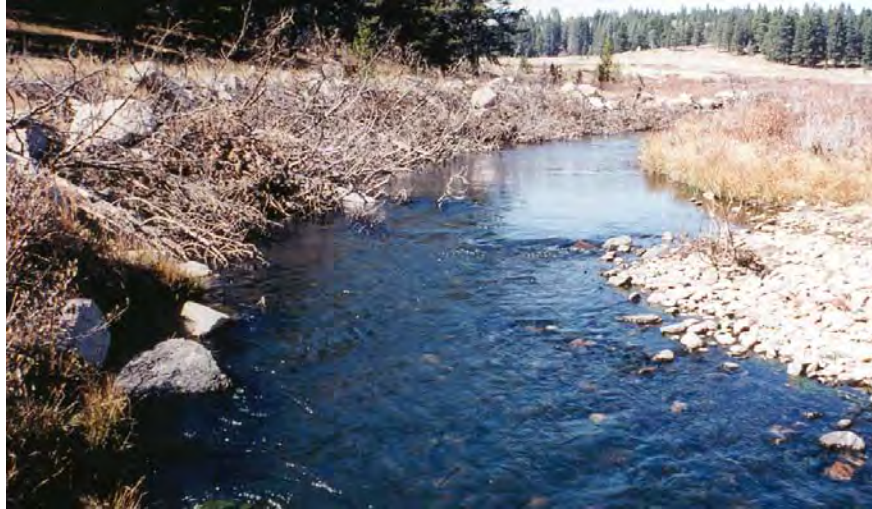
Figure 27-2. Larger conifers and less rock were used in this revetment, seen here three years posttreatment.

Habitat Structures - An examination of the habitat improvement structures in September, 1997 found the structures largely intact and functional. Narrowing and deepening of the stream was very noticeable, as was development of point bars. Many of the point bars had revegetated with grasses, and formerly eroding banks were stable with good grass and willow growth. Some small patches of bank erosion persisted though.

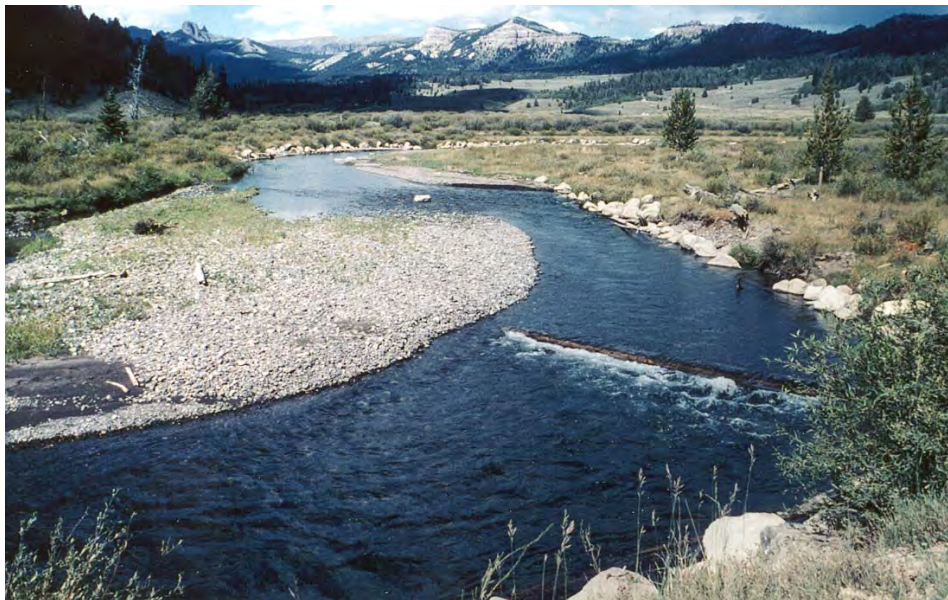
Figure 28-3. Four years posttreatment, instream digger log barbs and tree/rock revetments have reduced erosion of banks and stabilized the channel in the meadow at Horse Creek.

Habitat Structures - By 1997, durability and performance of the habitat improvement structures was good. At one revetment, inadequate rock riprap behind the trees allowed high water to open up a 50 ft segment of eroding bank. But all other revetments were in good condition. The digger log barbs created good pools.

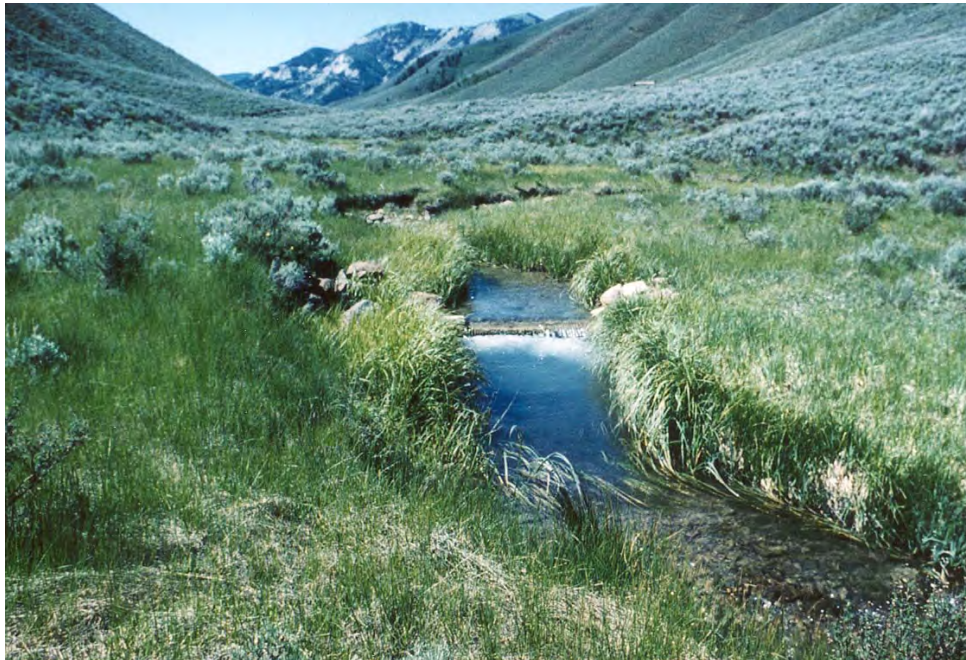
Figure 29-1. A timber plunge remains function 10 years posttreatment. Streamside vegetation has become well established with protection from cattle use and better subirrigation of the riparian zone through elevation of the water table near the plunge. Peaks of the Sublette Range appear in the background.

Habitat Structures - Additional deep-water habitat was effectively provided by the plunge structures. When evaluated in 1991, each timber plunge contained 60 sqft of cover, with RPD 1.5, or deeper, at 58% of the plunge pools. Condition of the devices was rated good. Rock plunge pools had 51 sqft of cover and 80% had RPD 1.5, or deeper. Plunge structures needed little maintenance for several years, but were resealed in 1989 with sandbags to reduce leakage.

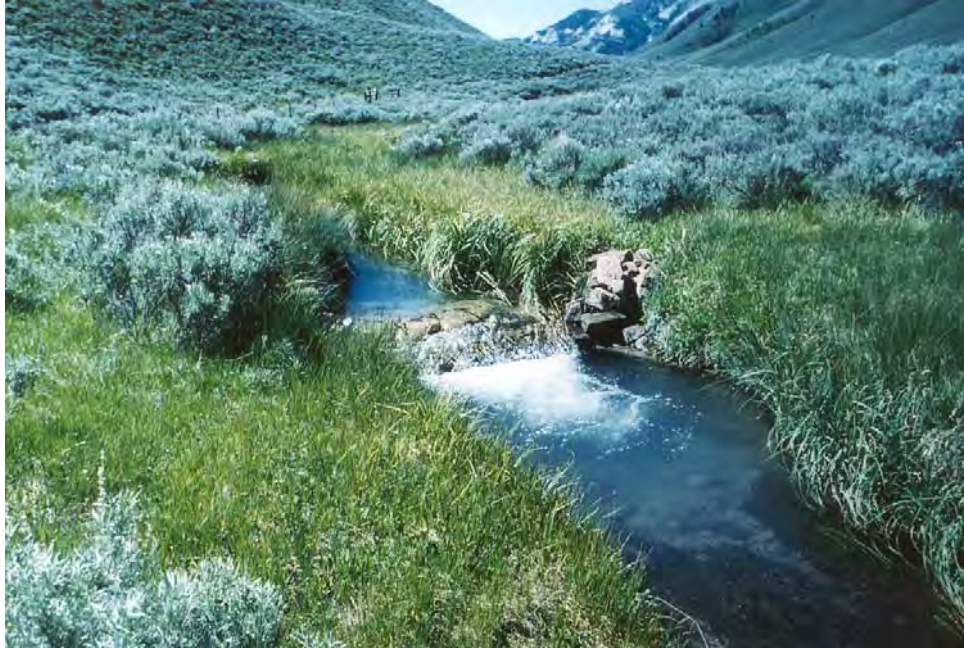
Figure 29-2. A timber plunge still provides a deep pool sheltering trout a decade after it was built. Such pools are crucial to BRC survival as they are pool-oriented fish. Turbulence from the plunge helps aerate the pool when water temperatures become overly warm during summer.

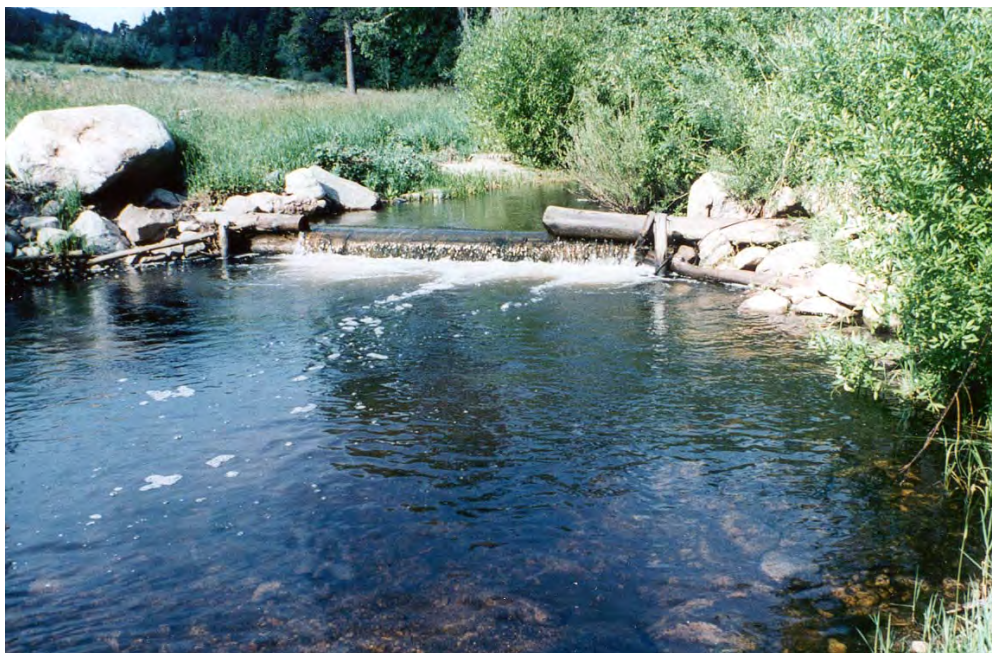
Figure 30-1. A log plunge still provides deep pool shelter for trout in LaBonte Creek 11 years after it was built. RPD was over 4 ft in this pool.

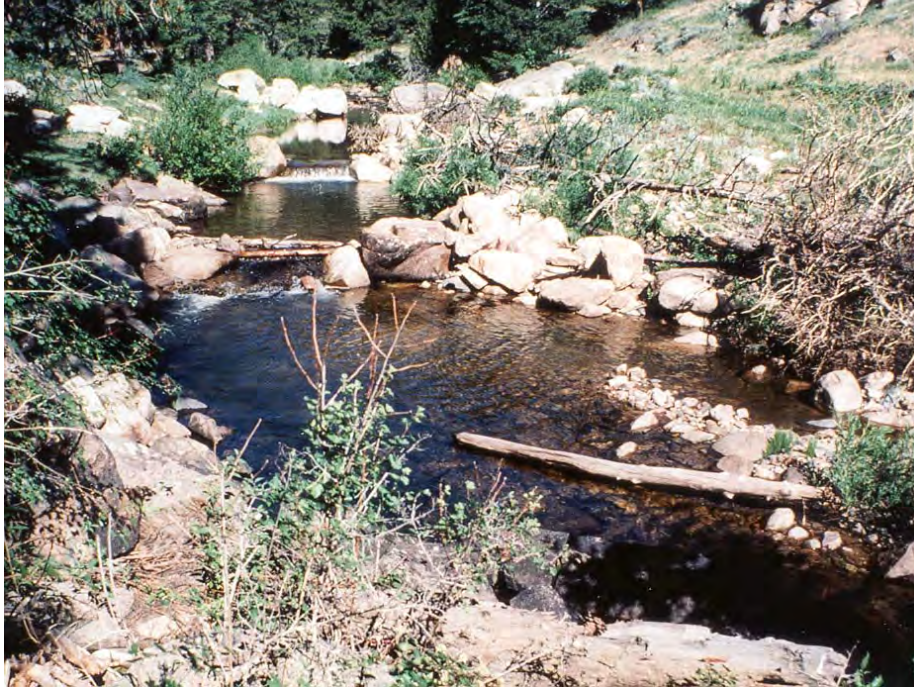
Habitat Structures - In 1995, all 20 of the pool forming structures were located and evaluated. Of the 11 boulder plunges, five had RPD 2 ft, or deeper, and two had RPD over 3 ft (Figures 30-5 and 30-6). Boulder plunge pools with poor depth either had pools filled with rocks or damage to the plunge itself from rocks shifted by river currents. One boulder plunge had disintegrated, but had since formed a deep trench pool with RPD over 2 ft. The remaining boulder plunges were rated in good condition. All six double deflectors were rated in good condition with RPD 2 ft, or deeper, and one was over 4 ft deep. The higher profile structures suffered more rock slippage than did the lower profile devices. Both log plunges had RPD 3 ft, or deeper. One log plunge was in good condition, but the other had been undercut by the stream and was acting as a digger-log. A non-parametric rank sum test indicated significantly more cover was associated with plunge pools at boulder double deflectors (mean, 467 sqft) than at boulder plunge pools (mean, 395 sqft).

Figure 30-5. A pair of boulder plunges (foreground) and a boulder double deflector (top of photo) as they appeared soon after construction.

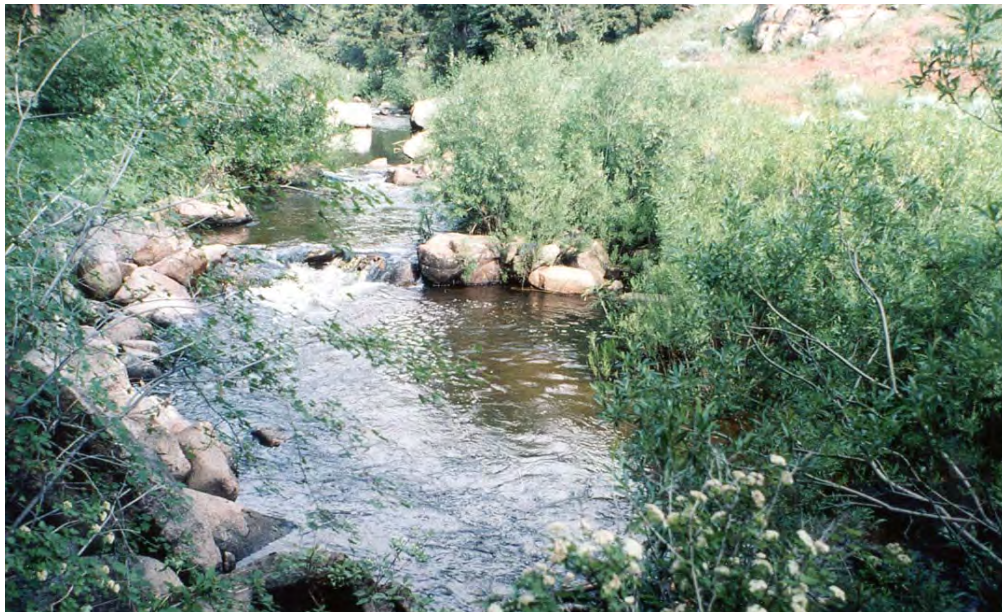
Figure 30-6. The same view seen in Figure 30-5 11 years after the structures were built. Riparian vegetation has responded positively to reduced cattle grazing, sediment deposition, and improved subirrigation of the riparian zone near the plunges.

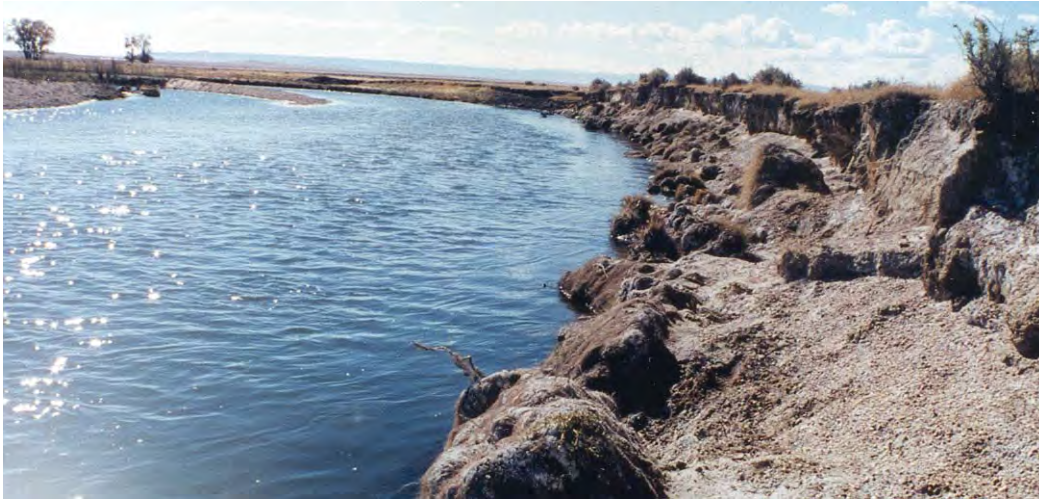
HABITAT MANAGEMENT: Historically, the Laramie River through the Monolith Ranch had been very heavily grazed by cattle. Fish habitat was described as “very grim” and “it can’t get any worse”. Bank erosion was 100%, deep pools were lacking, and the stream was wide and shallow (Figure 33-1).

Figure 33-1. Pretreatment, the Laramie River through the Monolith PFA was wide, shallow, and lacked deep pools. Bank erosion was 100% and was exacerbated by heavy cattle grazing.

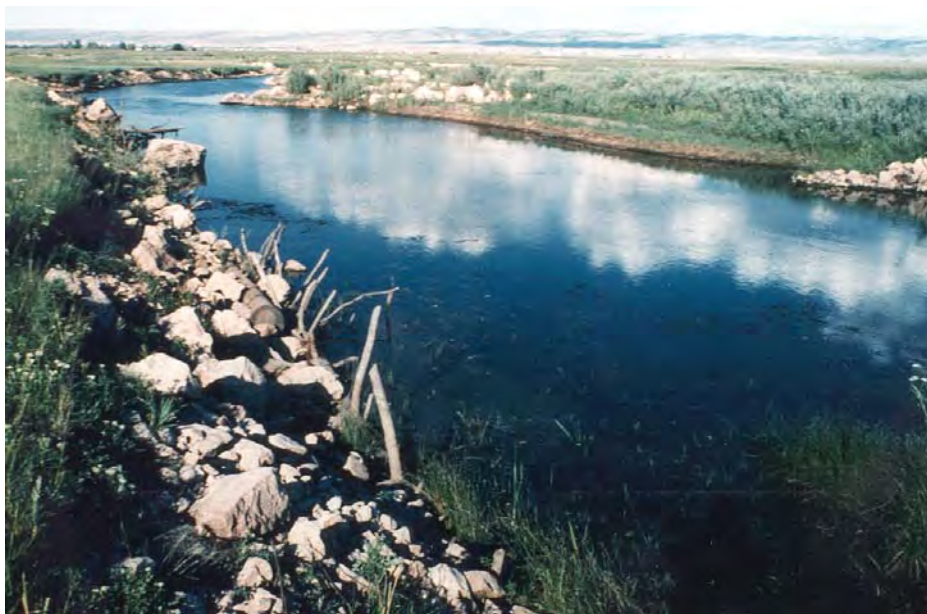
Trout Habitat Response - Many deep pools and runs have developed near the tree/rock revetments, which have added a LWD component to the habitat (Figure 33-3). Habitat diversity has also been increased by the rock sills, which were intended to function both as grade controls and as attachment sites for macroinvertebrate organisms. Pretreatment, cover for trout was very sparse, but after a decade, cover had increased four fold (Figure 33-4). Removing livestock from the riparian zone proved beneficial to stream bank vegetation. By 1997, extensive willow growth had developed along the stream edges, especially on the point bars. Some willows were from cuttings planted by Laramie school children, but much growth occurred from natural root systems that had been repressed by cattle use.

Figure 33-3. Eight years after this tree/rock revetment was built, stream banks are stable and there is cover for trout along the deep interface of trees and water. Willows and other riparian vegetation have established on the point bars and along the banks.

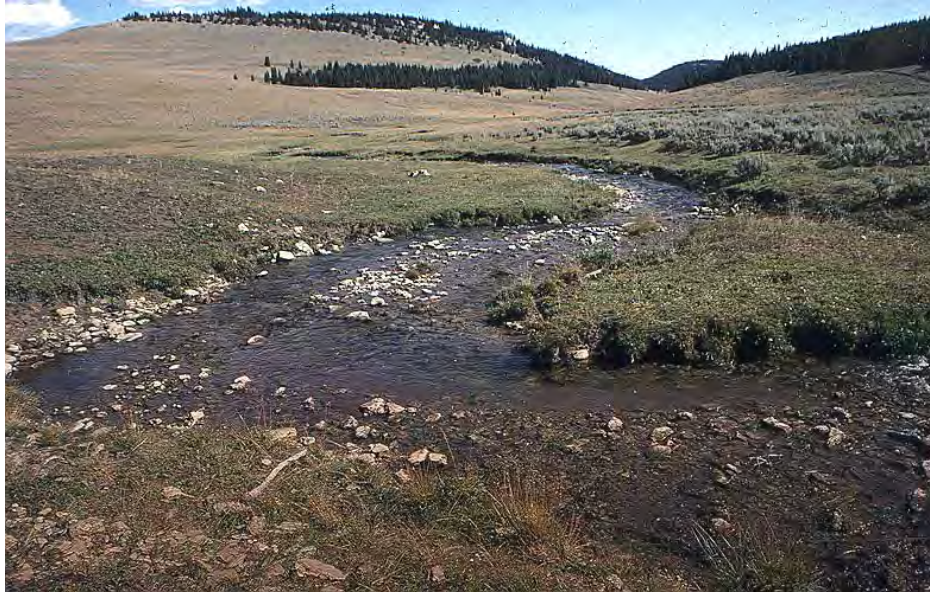
HABITAT MANAGEMENT: An HQI evaluation in 1983 at the proposed habitat improvement project identified lack of cover for trout as a primary habitat shortcoming. Total cover for the station was only 0.8% and shallow pocket pools furnished the only shelter. Overhanging bank cover was virtually nonexistent due to trampling of banks by cattle. Bank stability was poor with 72% eroding stream banks (Figure 34-1).

Figure 34-1. Lick Creek looking downstream across Lick Creek Meadow in 1983, prior to installation of habitat structures. Pretreatment Lick Creek was wide, shallow, and lacked deep pools. The meadow had been heavily grazed for many years.

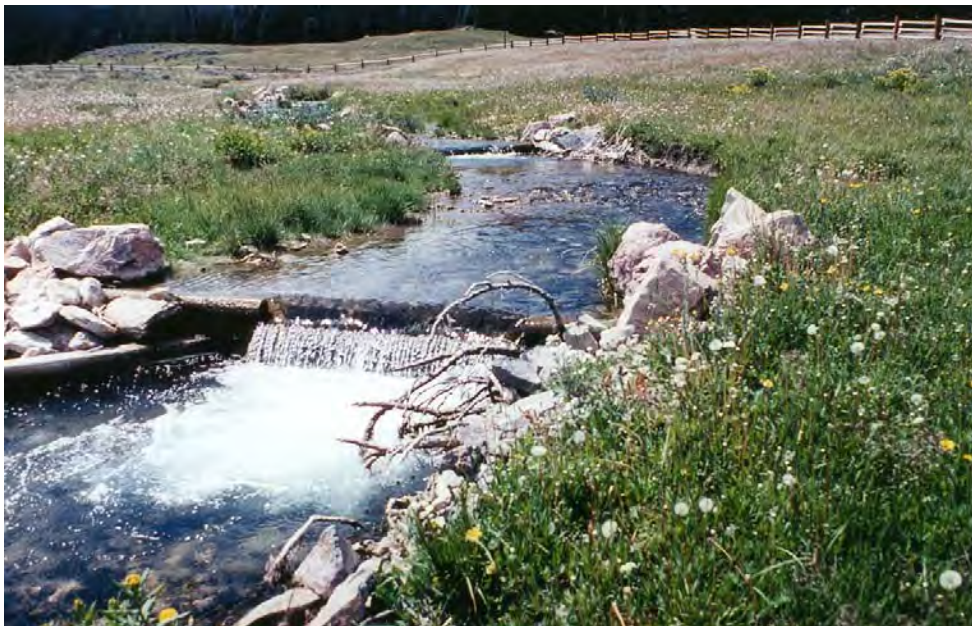
Over a three year period, a WGF construction crew installed 36 timber plunges, 7 rock double deflectors, and one modified upstream “V” plunge (Figure 34-2). Structures were installed at irregular intervals starting where the stream enters the meadow downstream to where the creek changes from meadow to canyon. Cover trees were added to the plunges in 1989 and in 1990-1991, USFS, with Trout Unlimited help, built three pole-fence enclosures to exclude livestock from the stream and its immediate riparian zone through the meadow. In 1998, the water gaps between the enclosures were removed to create one large enclosure. Total WGF project cost through 1989 was \$16,875 (\$20,720/mile).

Figure 34-2. An upstream view of Lick Creek in the same area as Figure 34-1 seven years after timber plunges were added to the stream. The pole fence at the top of the picture is part of the livestock enclosure.

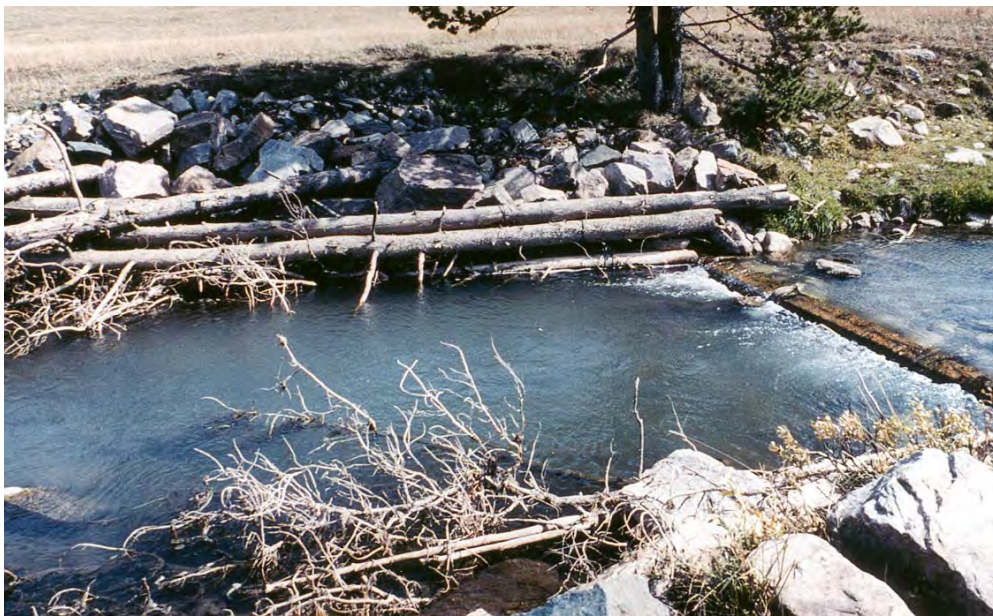
Figure 35-2. This is the same site shown in Figure 35-1 after a timber plunge and a tree/rock revetment were added. Provision of a deep plunge pool adds a key element for overwinter survival of trout.

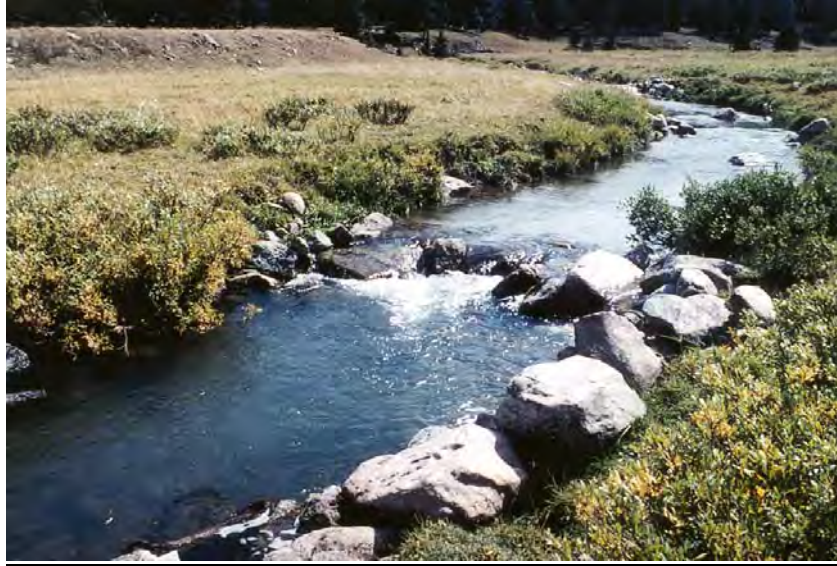
Trout Habitat Response - No formal evaluation of habitat changes was done, but trout could be seen using the many new deep pools (Figure 35-5). LWD shelter was more common and bank stability was better than pretreatment. Angler acceptance of the habitat improvement devices was very good. Pools formed by the structures were heavily fished.

Figure 35-5. A deep pool is provided by a rock plunge, which could also be called a rock vortex weir. Swift stream flows are slowed and ponded by the structure to shelter trout.

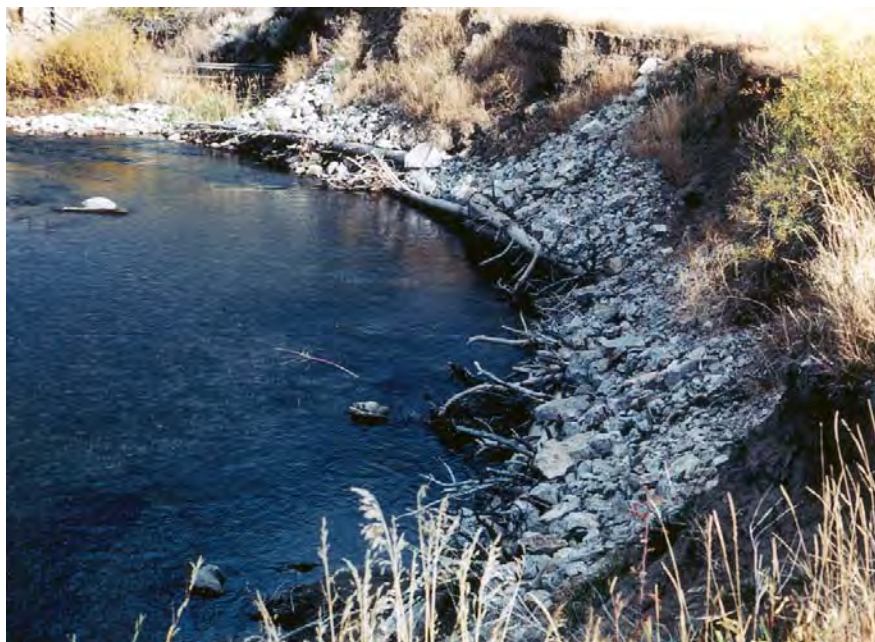
Figure 36-1. Addition of a tree/rock revetment to this steep bank during *Phase I* provided good overhead cover for trout along its base, stabilized the bank, and eliminated it as a source of sediment. Pretreatment, the river was actively eroding all along the base of the bluff, which contributed much sediment to the stream during high water.

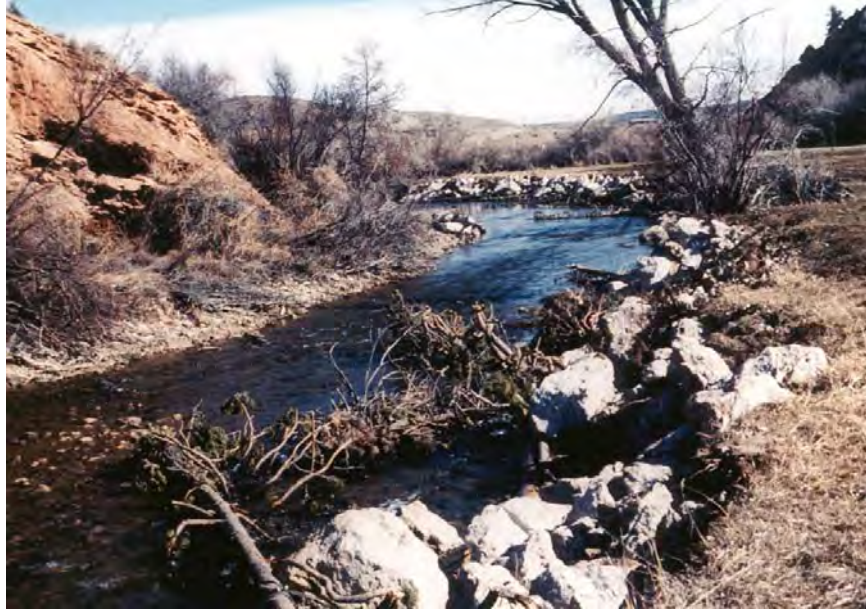
Figure 36-2. This tree/rock revetment was built during *Phase II* to stabilize an eroding stream bank, slow swift currents on an extended riffle, and provide cover for BNT.

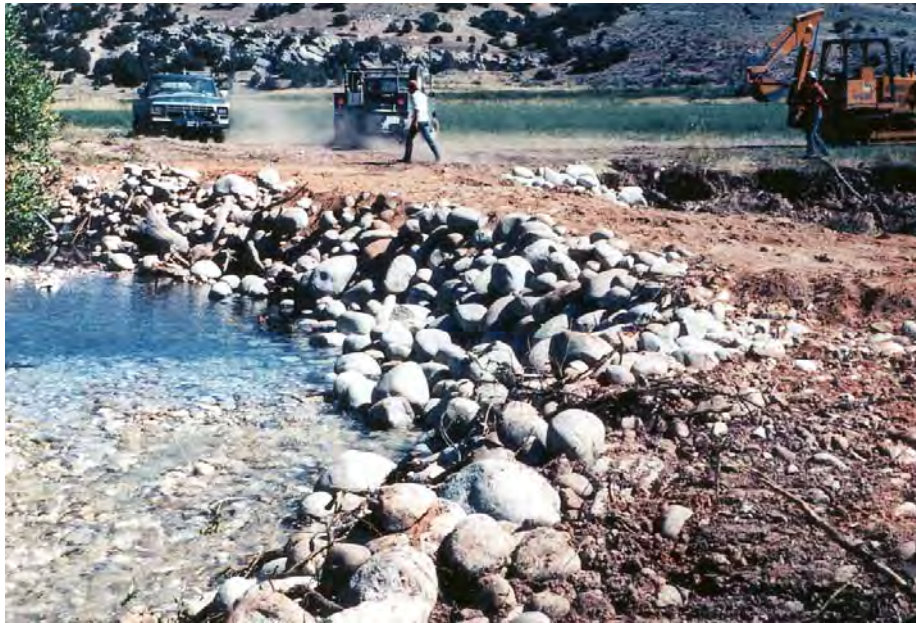
Figure 37-1. A 65 ft dike was constructed to divert all flow away from the channelized section and back into the old stream channel.

HABITAT MANAGEMENT: A WGF construction crew installed 180 ft of bank stabilization at several locations between the bridge and lower unit boundary, using tree/rock revetments or rock riprap. To effect the channel change, a 65 ft dike was built to divert all stream flow back into the old channel (Figure 37-1). No costs were reported.

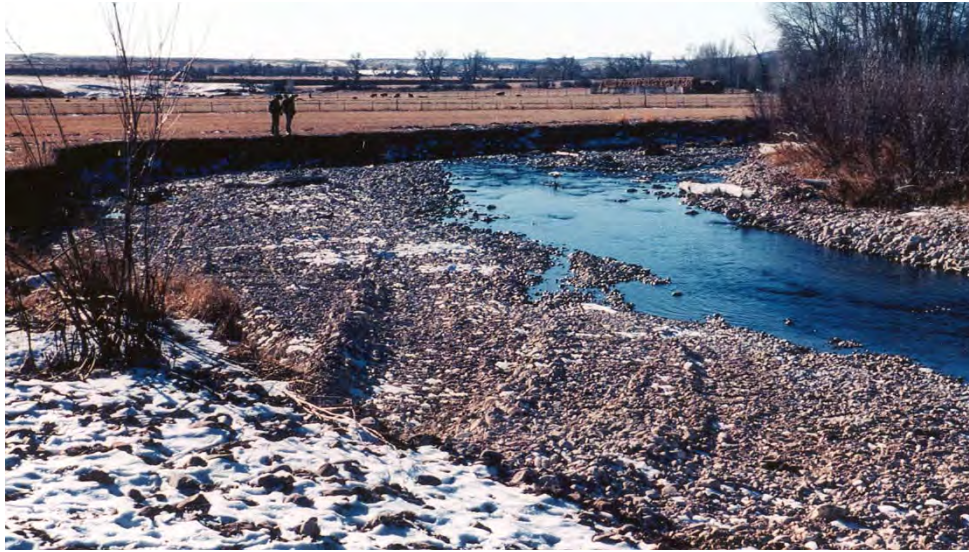
Figure 37-2. A pretreatment view of Medicine Lodge Creek through the channelized section, which contained very little shelter for trout.

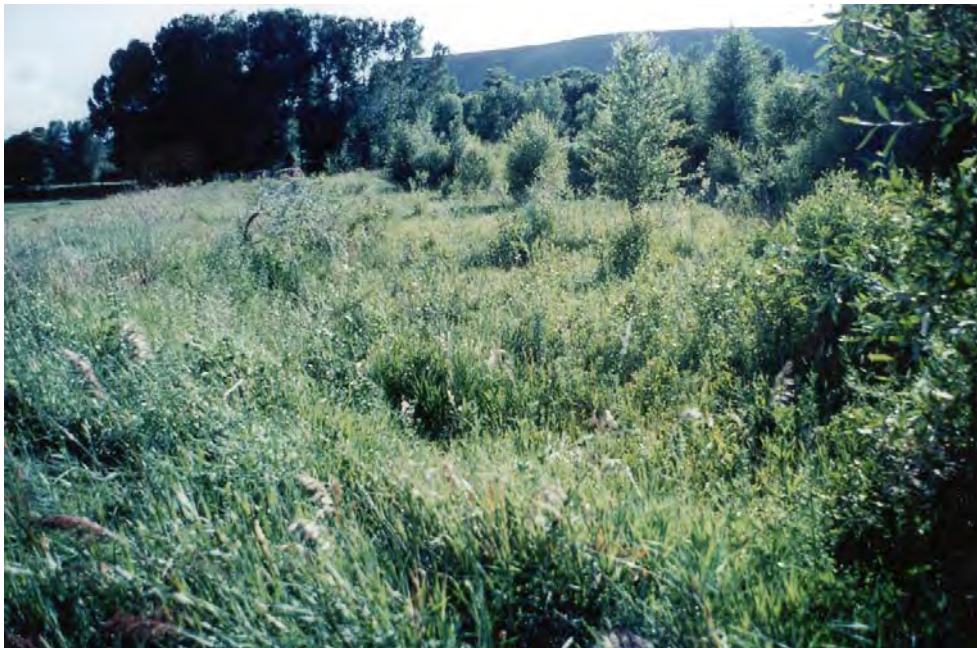
usable by trout. Vegetation growth was good in the old channel (Figures 37-2 and 37-3). Some of the tree revetments had been damaged by fire and several new cutbanks were noted. But those banks stabilized in 1981 were generally stable and furnishing shelter to trout.

Figure 37-3. The channelized section of Medicine Lodge Creek 12 years after flow was diverted back into the old channel.

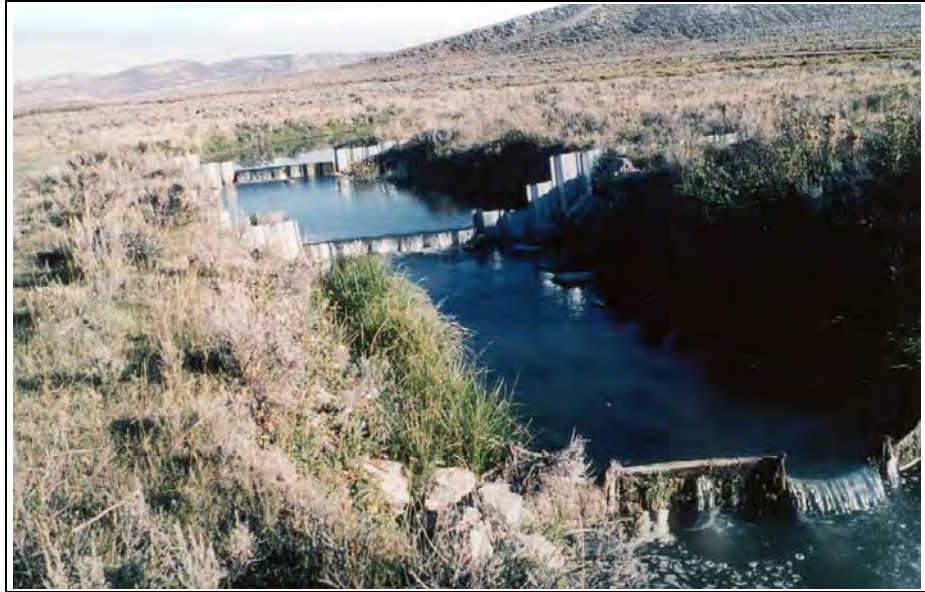
Figure 39-1. A series of three plunges made from C-LOC brand PVC plastic panels provides deep pools for fish, grade controls, and elevated water level to better subirrigate the stream banks on lower Muddy Creek.

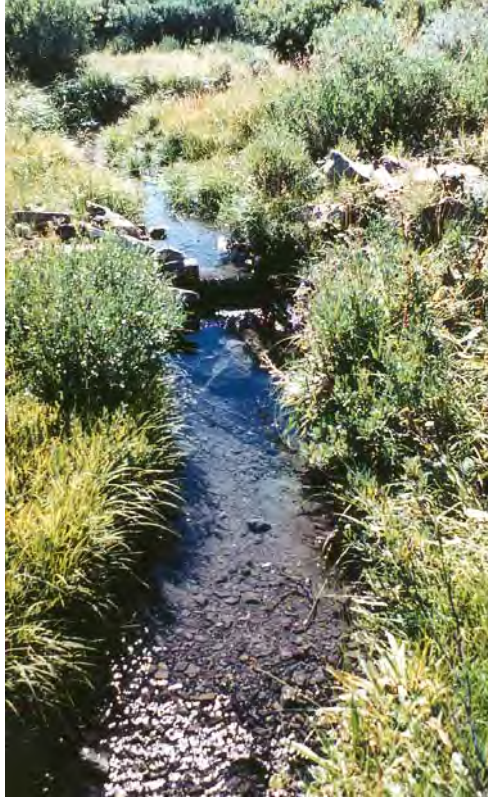
Habitat Structures - By 1995, 94% of the plunges were rated as being in good condition (Figures 40-2 and 40-3). But many of the plunge pools were filled with rocks that had rolled into the pools during high water events. Periodic cleaning these rocks out of the pools would easily restore pool depth to levels more useful to CRC.

Figure 40-2. Timber plunges built in tiny Nameless Creek acted as grade controls and provided additional shelter for CRC trout.

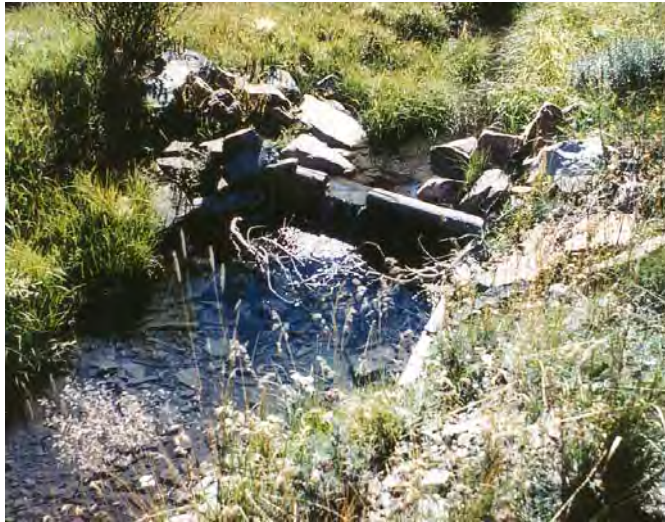
Figure 40-3. A close-up view of a timber plunge in Nameless Creek.

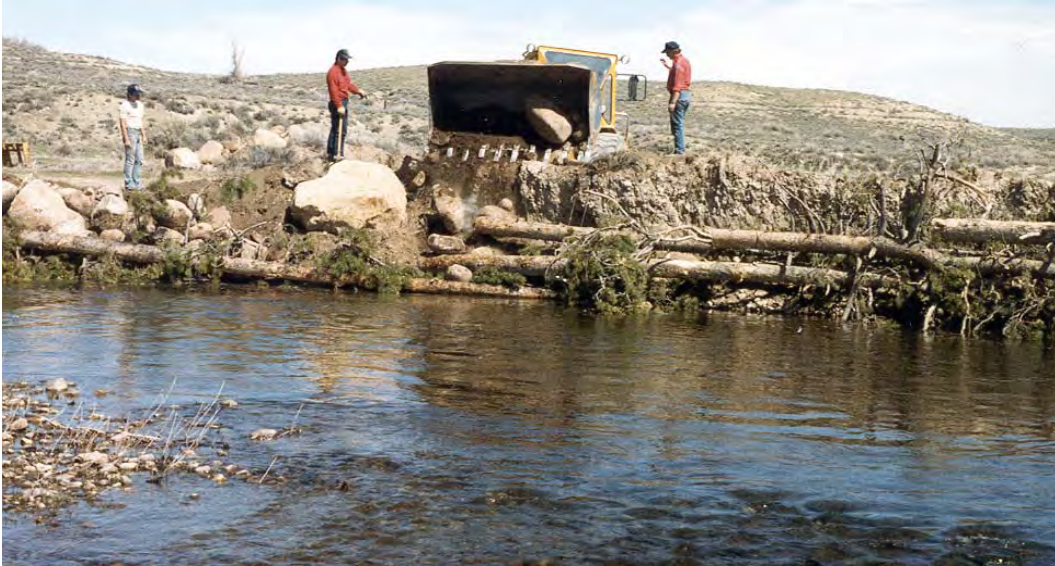
Habitat Structures - Structures endured minor flood damage annually, but continued to function until an exceptional flood in 1991 essentially wiped out all habitat improvement devices. Although flood magnitude was likely great enough to demolish the devices by itself, extensive cattle grazing in and along stream banks, farming to the edge of the stream, and allowing irrigation return flows to run unchecked over the banks to further erode them caused structure integrity to deteriorate and thus contributed to their demise. In spring, 1997, rock riprap was added to several eroding banks to repair flood damage.

Figure 41-2. A construction crew adds rock riprap behind tree revetments at the PFA on the North Fork Popo Agie River.

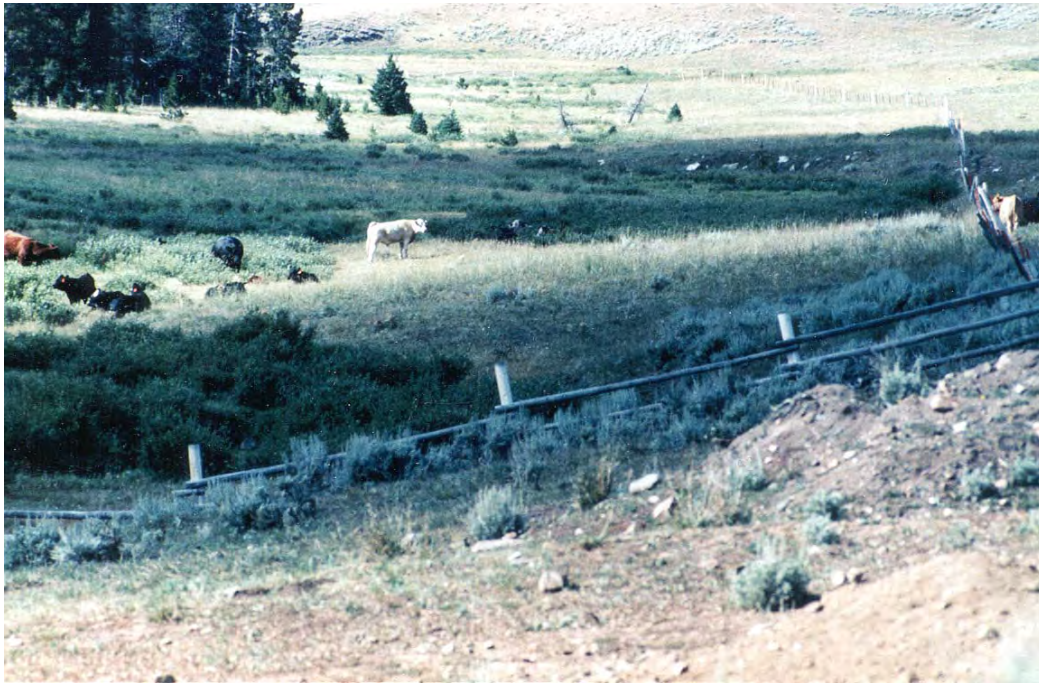
Habitat Structures - Trespass cattle continued to use the enclosed area because either the fence was not maintained, or the wires were deliberately cut. Without regular maintenance or prompt removal of trespass livestock, such enclosures cannot function at optimal levels.

Figure 42-4. Trespass cattle inside the exclosure at North Fork Powder River.

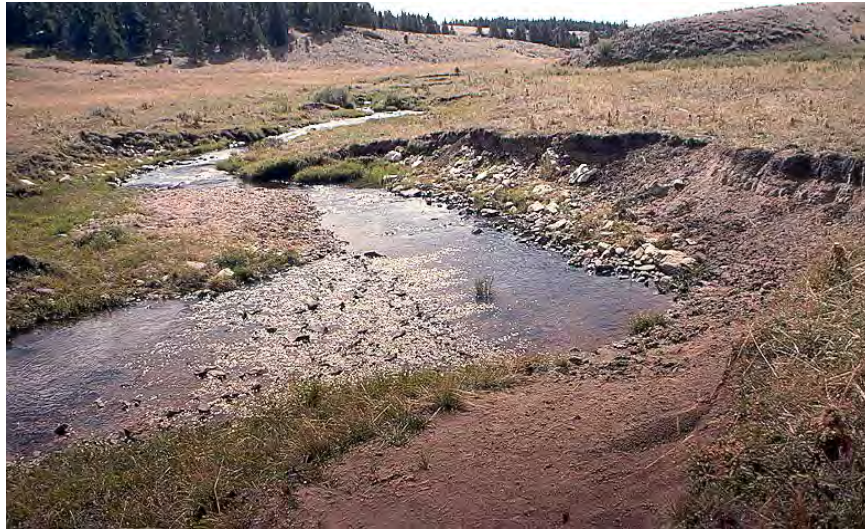
Figure 42-5. Eroding stream banks and cattle trails along the stream were common outside the livestock exclosure at North Fork Powder River when the exclosure was evaluated in 1989.

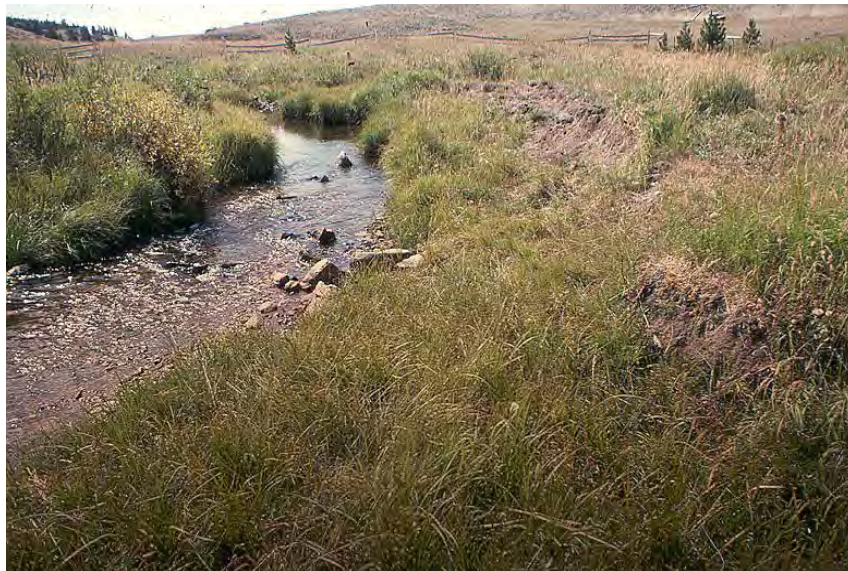
Figure 42-6. Healing is well underway at a formerly eroding bank inside the livestock exclosure at North Fork Powder River 21 years after the area was fenced.
