**A Compendium of Trout Stream Habitat Improvement
Projects Done by the Wyoming Game and Fish
Department, 1953-1998.**

**N. Allen Binns,
Aquatic Habitat Supervisor**

**Fish Division
Wyoming Game & Fish Department
Cheyenne, Wyoming 82006
April, 1999**

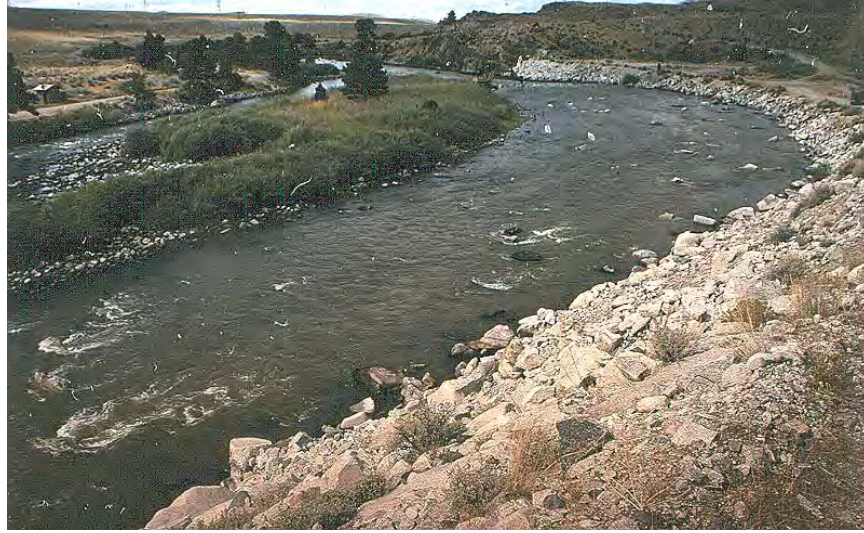
Figure 45-1. Large boulders were added to a swift section of the river to supplement fish cover provided by several existing boulders.

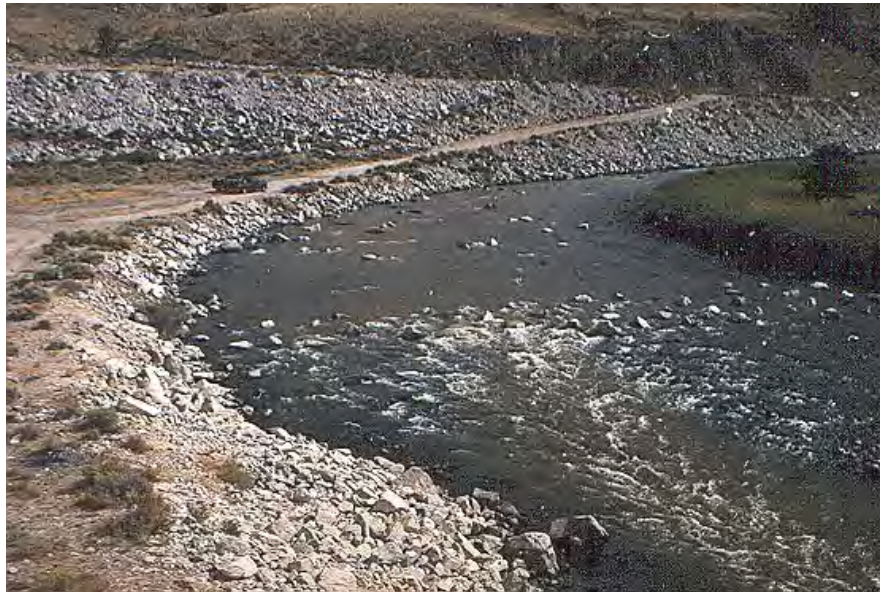
Figure 45-2. A loose rock sill was constructed to act as a grade control, raise water levels in the upstream river, and provide additional shelter for fish.

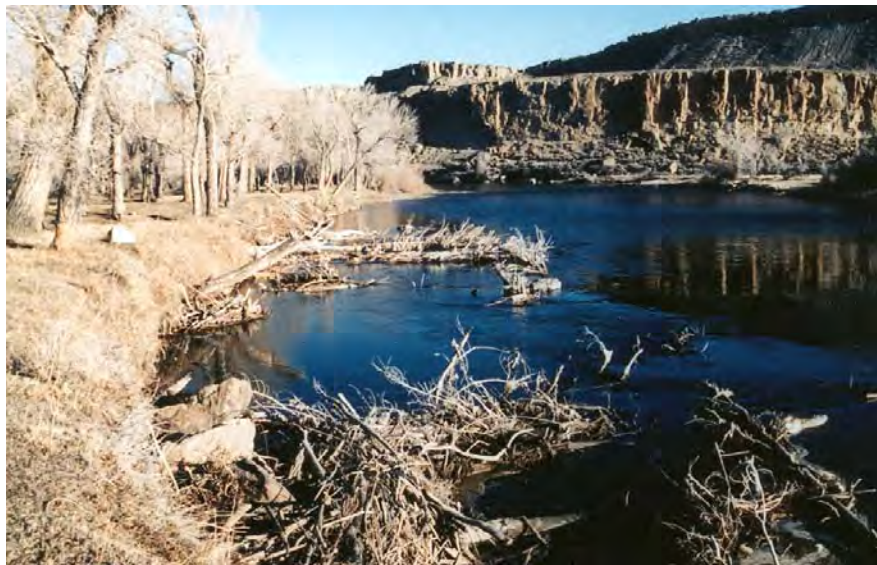
Habitat Structures - At higher flows, the tree jams functioned to provide shelter for trout, but at lower flows, they acted as deflectors to push the thalweg away from the trees.

Figure 46-1. Tree jams were constructed in the North Platte River at Pick Bridge as an experiment to determine if this type of structure was feasible for this river.

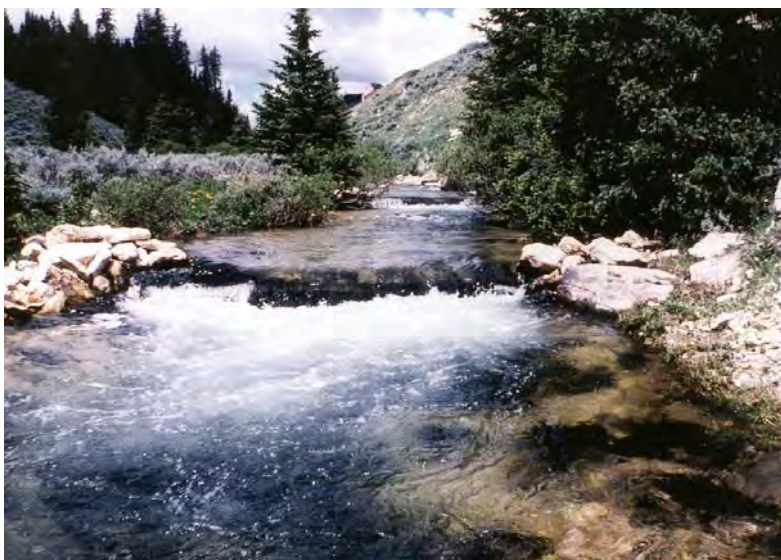
Figure 47-1. Two timber plunges near the confluence with Trail Creek slow swift currents, dissipate energy, and provide deep water to shelter trout.

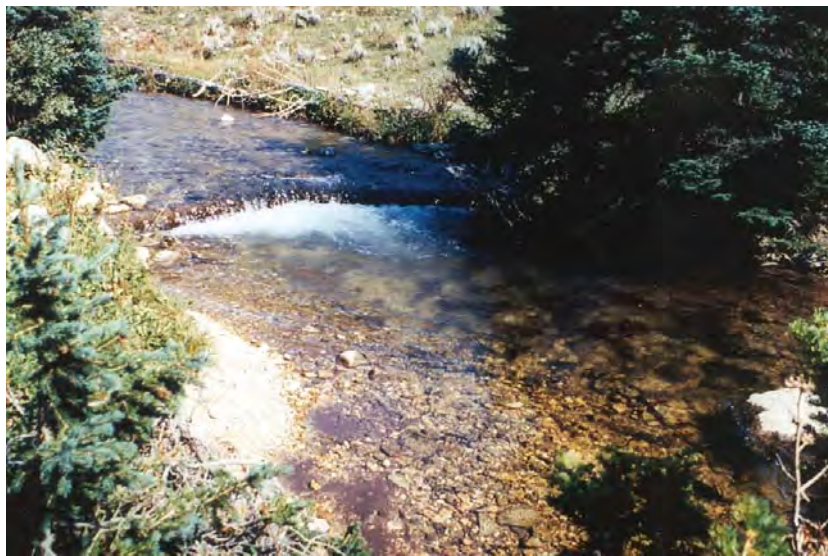
Figure 47-2. A log vortex weir (upstream “V” plunge) acts as a grade control to slow stream flow and furnishes valuable pool shelter for trout.

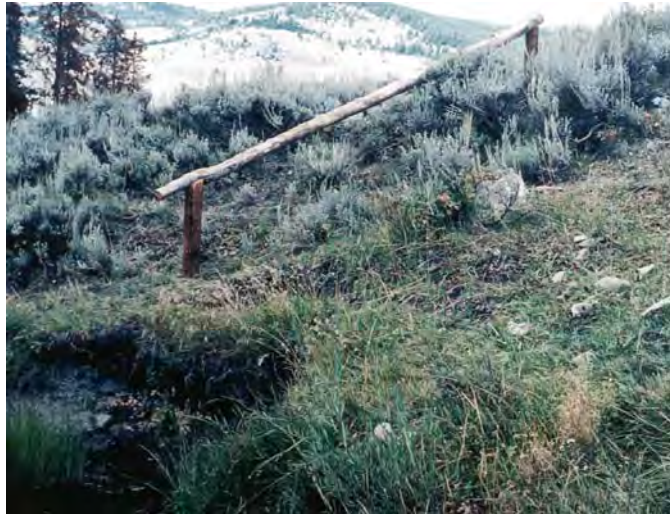
Figure 48-1. A pole deflector system was erected along Pass Creek by USFS to discourage cattle movement parallel to the stream.

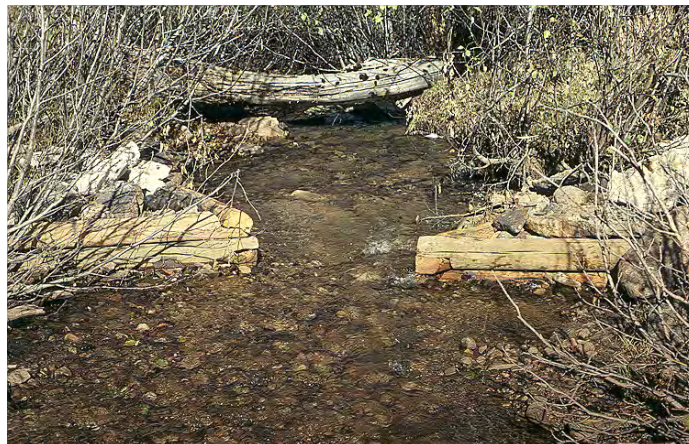
Figure 48-2. Double deflectors were installed in Pass Creek to narrow the stream flow and encourage scouring of pools for trout shelter.

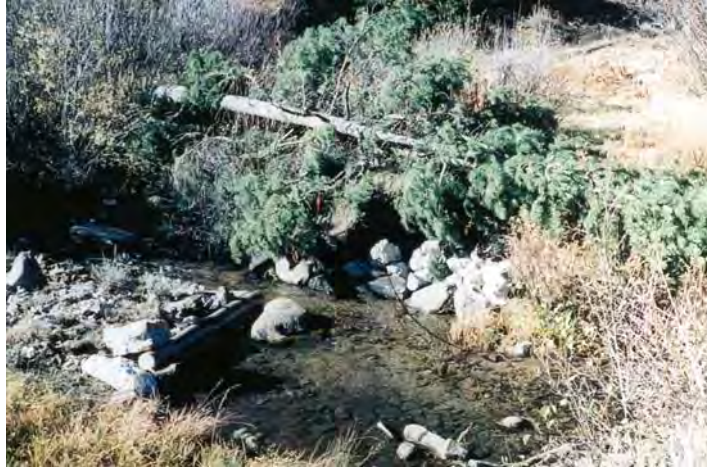
Figure 48-3. Here a combination structure was used in Pass Creek. After the eroding bank was protected with rocks, a conifer was laid over the top to discourage cattle use along that bank. The wing deflector narrows and deepens flow along the face of the rocks, thus increasing cover for trout.

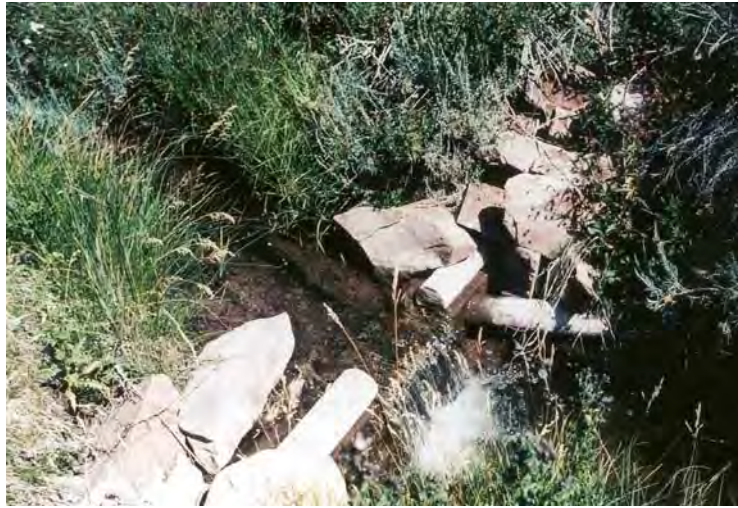
Figure 49-1. Timber plunges installed in Pinegrove Creek have provided shelter for trout, grade control for the stream, and subirrigation for the riparian vegetation.

Habitat Structures - An inventory in October 1997 located all 12 timber plunges. Condition of the plunges was rated good at 83% of the devices, but only 8% of the plunge pool RPD were 1.5 ft, or deeper. This lack of depth was likely due to the filter cloth installed under the structures, which would prohibit the stream from digging a deep plunge pool. However, pool depth was usable for CRC at the flow observed. And, over the long term, the grade control provided by the plunges may be more valuable than the plunge pools.

rebuilt by a WGF construction crew and impervious filter cloth was installed to ensure the devices sealed properly (Figure 49-1). Total WGF cost for the 1985-1986 work was \$2,040 (\$4,080/mile), and the 1990 work cost \$4,310 (\$8,620/mile). There is no cost record for the BLM exclosures.

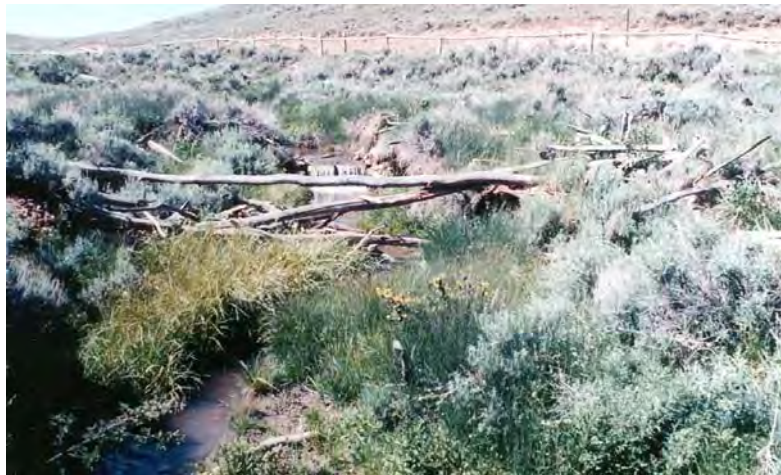
Figure 49-3. Riparian vegetation has grown denser following protection from grazing and better subirrigation. Prior to treatment, the stream in this section had begun to down cut and form a gully. Posttreatment, this trend has been reversed.

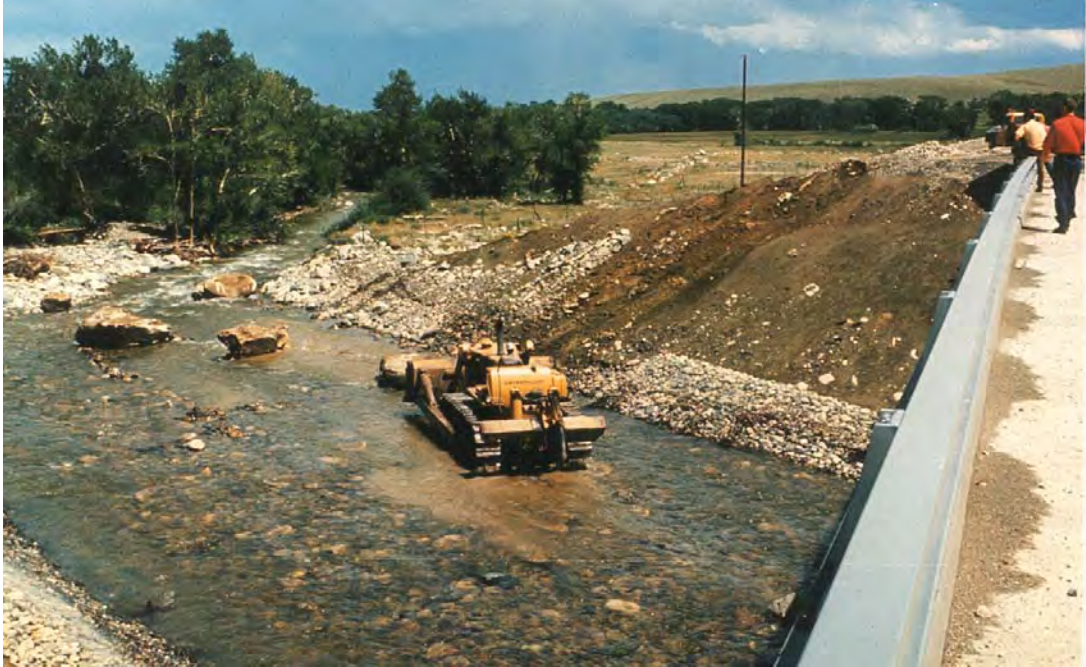
Figure 50-3. As mitigation for channelization done during construction of I-80, 76 large boulders were placed in Rock Creek under the east bridge and upstream from the west bridge crossing. Rock placement extended upstream into the tree-lined section shown in the photo.

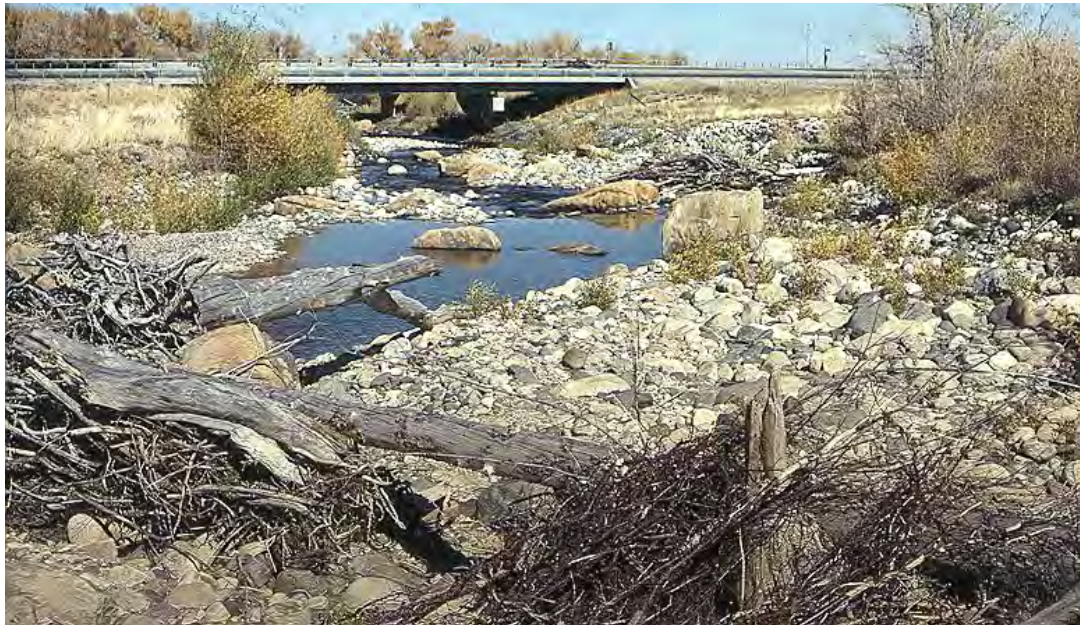
Trout Habitat Response - Excellent pool habitat developed around many of the boulders after only two spring floods. Logs and other LWD that hung up on the boulders to create debris jams provided additional fish habitat. An inspection of the project in 1997 found the stream had built large cobble and rubble bars in response to the channel roughness provided by the boulders and LWD (Figures 50-3 and 50-4). Many boulders had pools associated with them and some of these pools were providing very good trout habitat. The thalweg meandered naturally within the channel and the stream had a natural appearance. In contrast, the boulderless section under the west bridge retained a monotonous, channelized appearance.

Figure 50-4. Rock Creek as it appeared 27 years posttreatment. Photo view is looking downstream toward the west bridge and covers the same area occupied by the bulldozer and boulders in Figure 50-3.

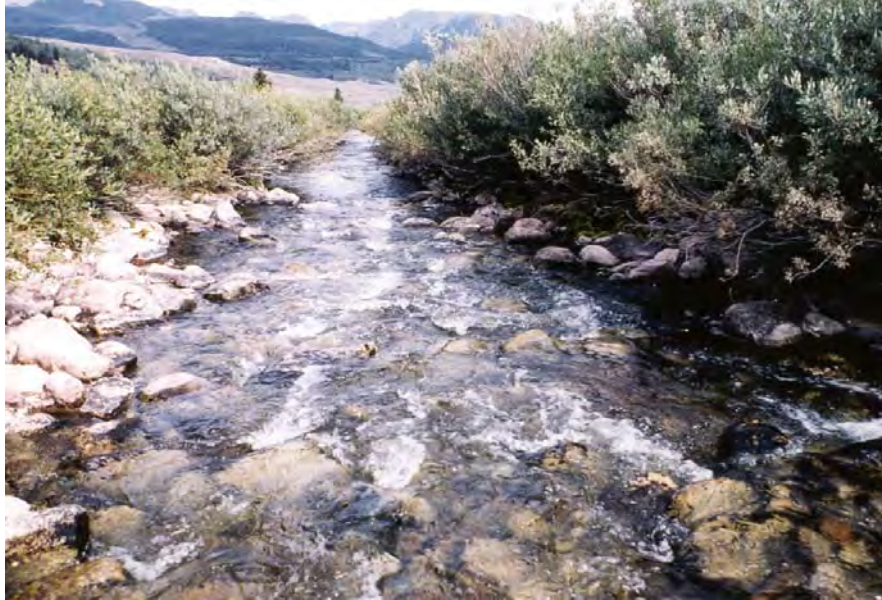
drives. Water velocities through the section were high and there was little shelter for trout of any size. Habitat type was swift rapids and pocket pools, with virtually no deep pools (Figure 51-1). A WGF construction crew installed 6 log plunges (Figure 51-2), 5 rock plunges, and 275 ft of tree and rock revetment. Project cost was \$5,028 (\$35,397/mile). Trees and rocks were obtained locally.

Figure 51-1. Pretreatment, Rock Creek through the project area was characterized by swift rapids and a straight channel. Only shallow pocket pools were present.

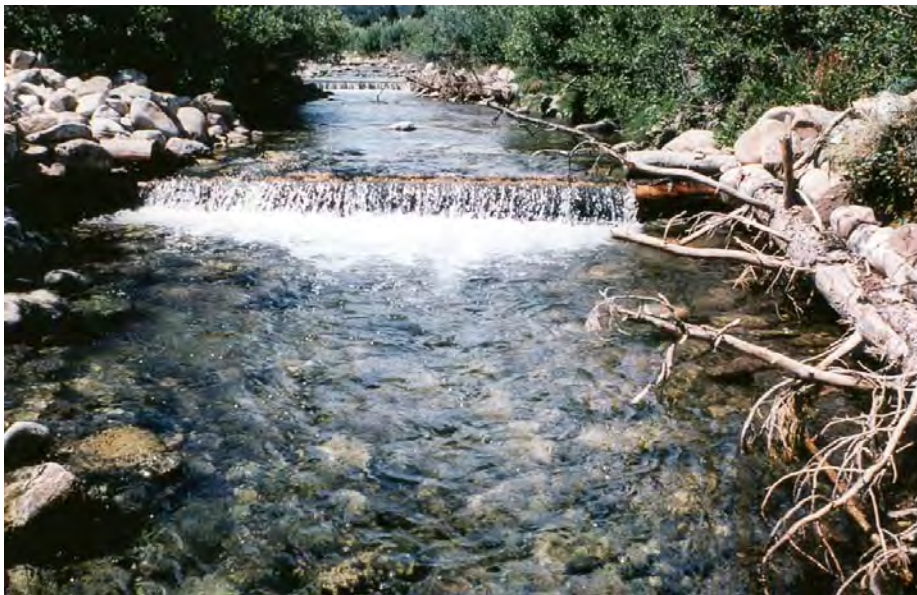
Figure 51-2. Log plunges were built in Rock Creek to provide grade control and furnish pool shelter to trout. Cover trees placed along the sides of plunge pools added both cover and structural stability.

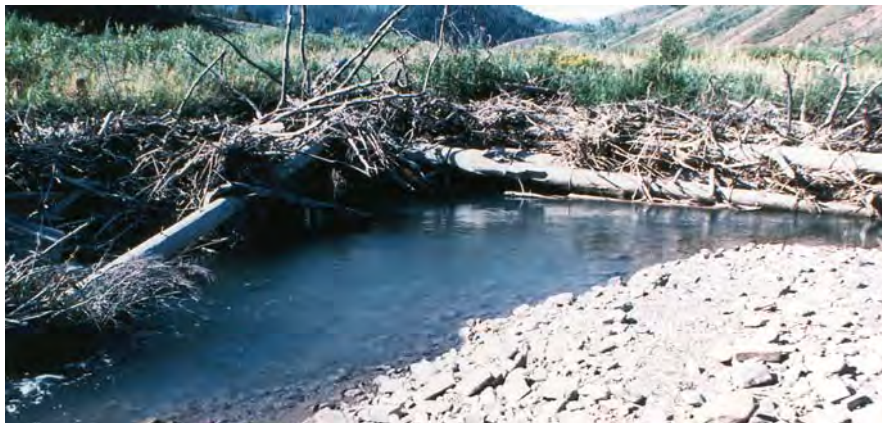
Trout Habitat Response - Installation of the tree/rock revetments stabilized stream banks and added large amounts of LWD to the stream channel (Figure 52-3). Deep pools developed in association with the revetments, while spaces under the trees provided overhead cover for trout. Deep pools also developed at many of the plunges (Figure 52-4). All of which led to a 107% increase in shelter for trout and a 148% increase in HU 14 years after treatment (Figures 52-5 and 52-6). Plunge pool cover at the log plunge was 210 sqft in 1995, compared with 84 sqft at the upstream “V” log plunge, and 300 sqft at the gabion plunge.

Figure 52-3. Tree and rock revetments stabilized corner pools and added woody debris to the stream. Many trout were attracted to deep pools containing overhead cover furnished by the woody debris.

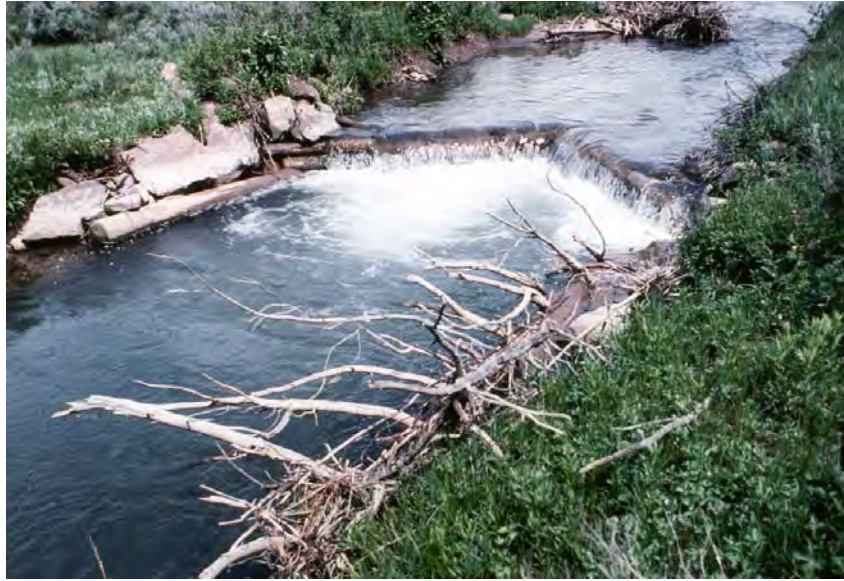
Figure 52-4. A deep plunge pool developed at this upstream “V” log plunge, furnishing valuable deep water cover for trout.

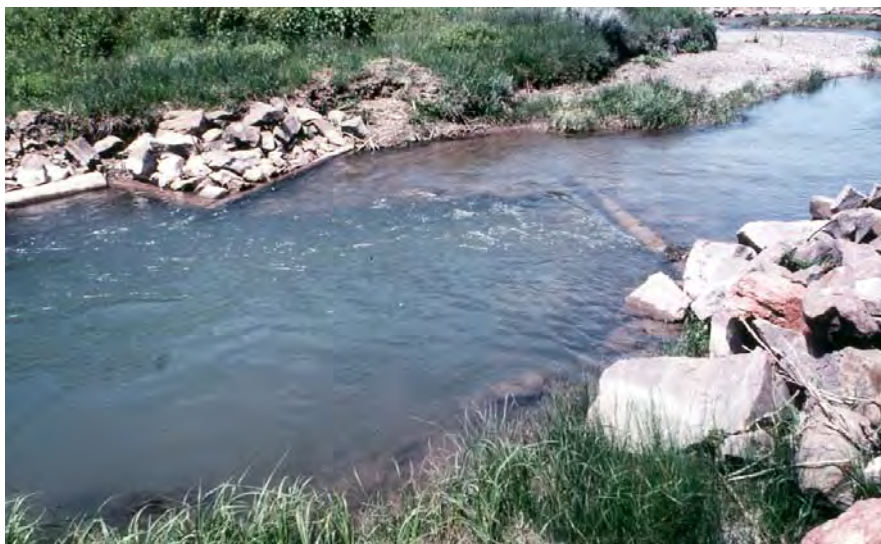
Figure 53-2. An upstream “V” log plunge (log vortex weir) produced a deep plunge pool that provided excellent shelter for trout in Salt Creek.

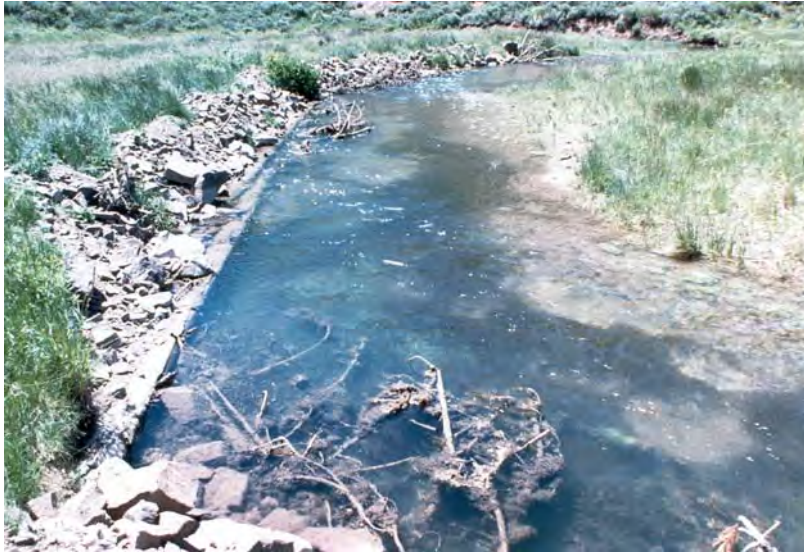
Trout Habitat Response - Installation of the tree/rock revetments stabilized stream banks, narrowed the stream channel, and added large amounts of LWD to the stream (Figure 53-5). Deep pools (RPD, 2 ft, or greater) developed near the revetments, while spaces under the trees provided overhead shelter for trout. By 1991, HU had increased 50%, cover was up 33%, and eroding banks had become stable (Figure 53-6).

Figure 53-5. Tree and rock revetments stabilized eroding banks, provided deep pool habitat, and many of the logs furnished overhanging bank shelter for trout.

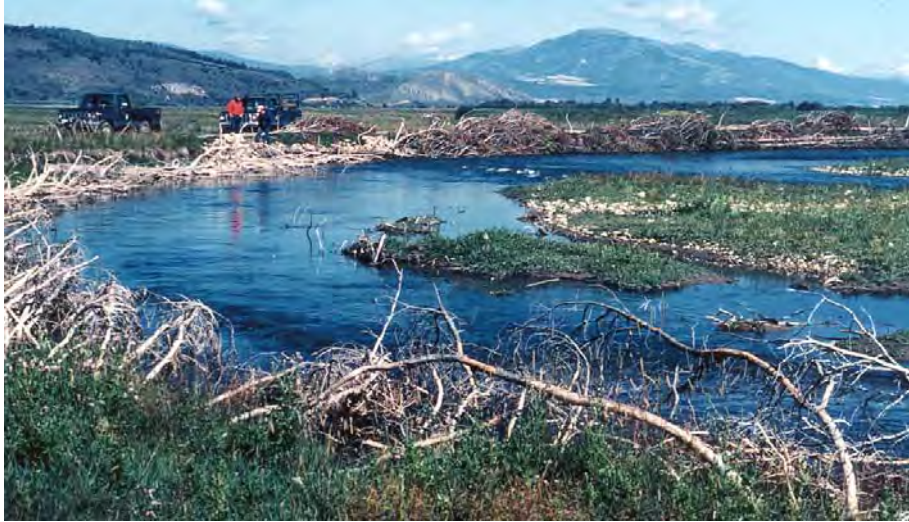
Figure 54-1. Tree revetments were installed in the Salt River to protect eroding banks.

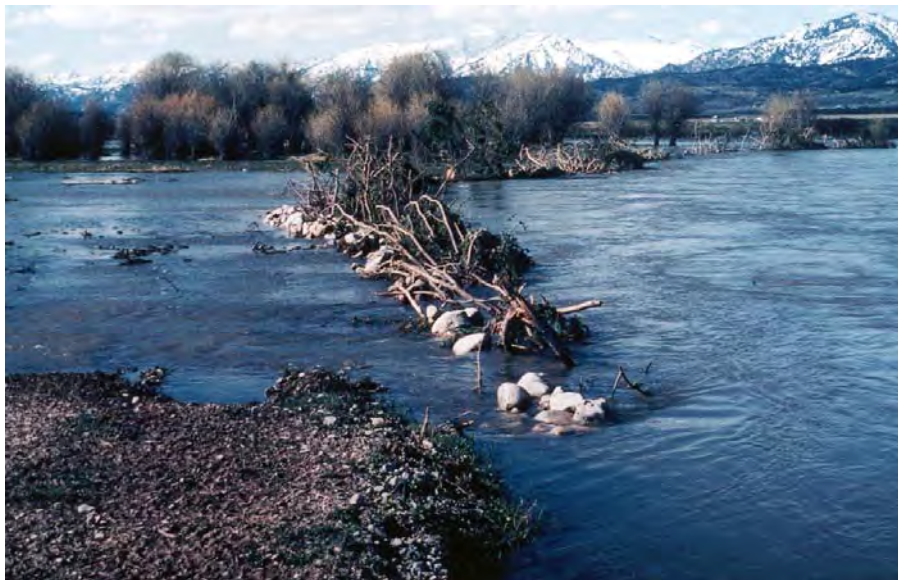
Figure 54-2. Due to the large volume of water and a degraded channel, spring snowmelt floods often flooded river bottom areas and threatened to cut through oxbows. Here a tree revetment is protecting a bank by reducing pressure on the bank from over bank flood flows.

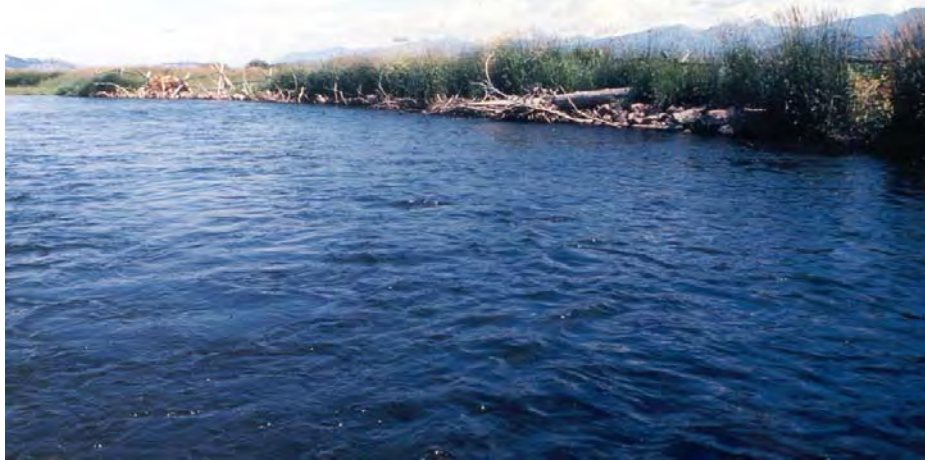
Habitat Structures - Estimated life of the tree revetments was 10 years when the Phase II project was initiated. Prior to the exceptional flood in 1986, 40% of the tree revetments were still intact. After the flood, inspection found only 25% intact. But many of the surviving structures were reported functional in the 1990s (Figure 54-4).

Figure 54-4. Several years after a tree revetment was installed, this formerly eroding bank is very stable. Note the dense growth of willows that has developed along the bank behind the trees.

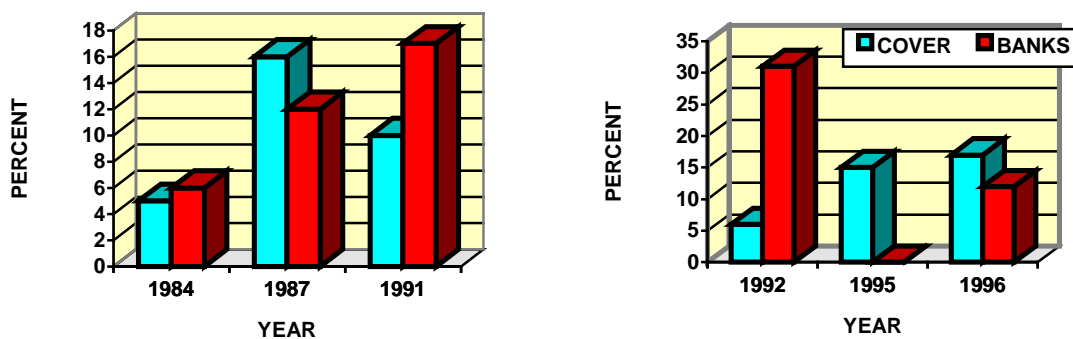
Trout Habitat Response - In the *Phase I* project, mean posttreatment cover was 160% better than pretreatment (Figure 55-3). Deep pool cover increased most. Habitat quality increased from 58 HU to 106 HU, an 83% improvement. Hogle (1993) also reported 106 HU, indicating the improved habitat was persisting. Eroding banks were not treated aggressively during *Phase I* and by 1987, bank erosion had doubled to 12% at the HQI station.

Figure 55-3. Cover and eroding stream banks before (1984 left, 1992 right) and after habitat improvement at South Cottonwood Creek (*Phase I* project, left) and (*Phase II* project, right).

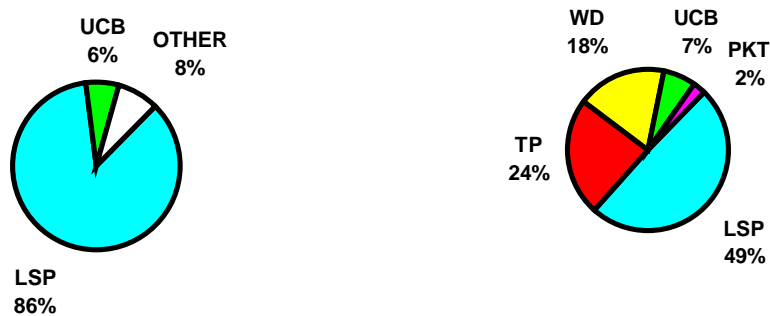
In the *Phase II* project, mean posttreatment cover was up 167% after two years. Lateral scour pools comprised 85% of the cover in 1992, but in 1996, lateral scour pools, trench pools, and large woody debris were the main cover components (Figure 55-4). After two years, HU had increased 26% and eroding banks had decreased 80%.

Figure 55-4. Cover types at *Phase II* project before (1992, left) and after (1996, right) habitat improvement at South Cottonwood Creek. Other cover types include runs, backwater pools, pocket pools (PKT), and woody debris (WD). UCB is undercut banks, LSP is lateral scour pool, and TP is trench pool.

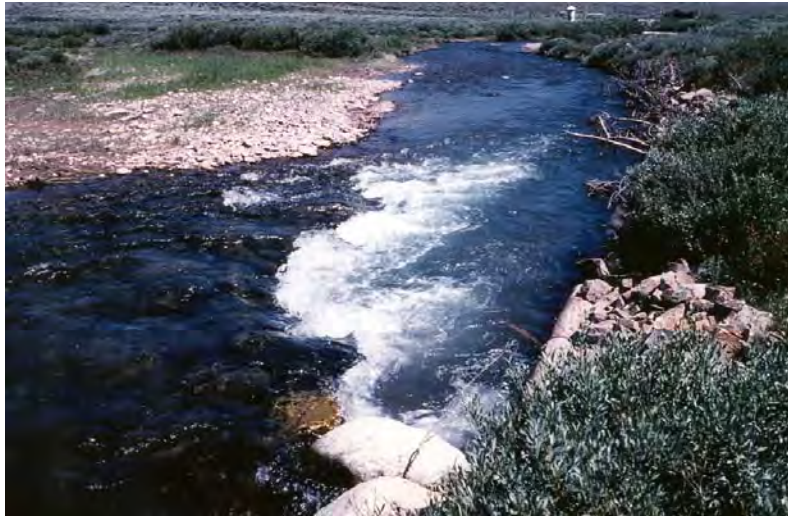
Habitat Structures - For the entire *Phase II* project, mean pretreatment RPD for all pools with RPD 1 ft, or deeper, was 1.6 ft, but three years after treatment, it had increased to 1.9 ft. At one pool modified by a diagonal weir (Figure 55-5), RPD increased from 1.15 ft to 2.0 ft (up 73%), while RPD remained constant (1.74 ft) at a natural, untreated LSP. Mean RPD for all log plunges in both *Phase I and II* was 2.05 ft in 1997.

Figure 55-5. A diagonal rock weir was coupled with a tree/rock revetment to provide a deep pool having considerable woody debris shelter. Electrofishing always found many trout in this patch of cover. The weir extends from the large light colored rocks in the foreground across the stream into the point bar.

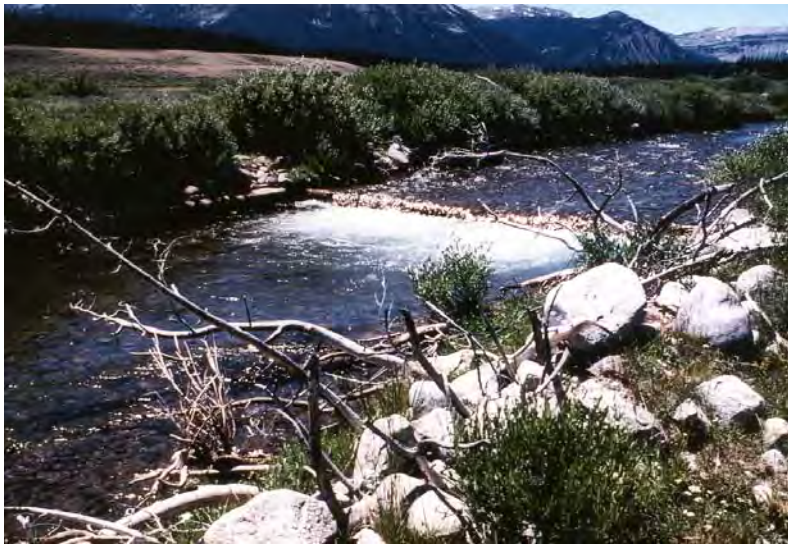
In the *Phase I* project, 71% of the log plunges were rated as being in good condition in 1997 and both log plunges in the *Phase II* project were in good condition (Figure 55-6). In the 1980s, beaver built a large dam on a log plunge within the *Phase I* project, rendering the plunge inoperable, but providing a deep beaver pond. Neither plunge nor dam was functional in 1997 after the snowmelt flood breached the dam and washed a new channel around one side.

Figure 55-6. A log plunge constructed during Phase I provides both pool habitat and grade control to slow swift flows. Cover trees were installed on both sides of the plunge pool to furnish cover for trout and to make fishing the pool more challenging to anglers.

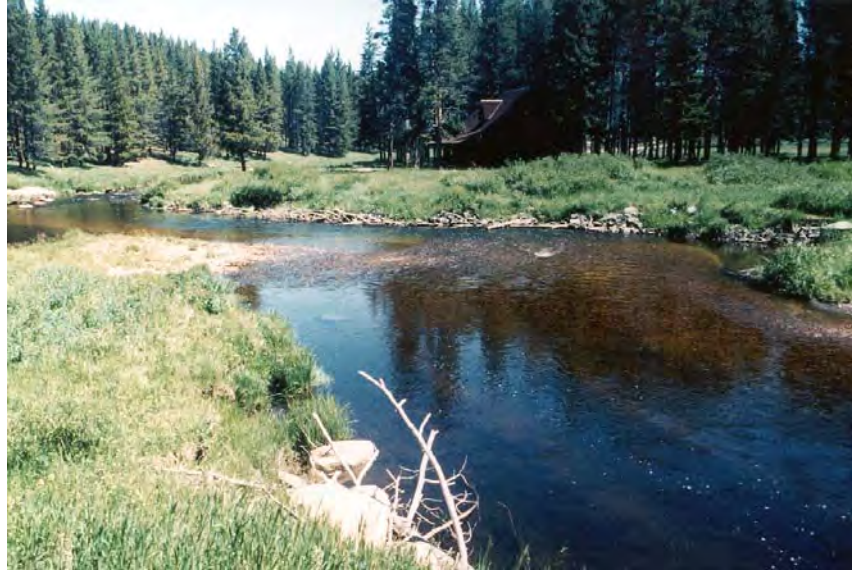
Trout Habitat Response - No formal evaluation of trout habitat was done, but photos documented improved bank stability, narrowing of the river channel, and creation of more shelter for trout (Figure 56-3). Many fish were taken with electrofishing gear from pockets of cover located at the various structures (Figure 56-4).

Figure 56-3. A decade after an unstable bank in front of the cabin was treated with a tree/rock revetment, the river has adjusted to form a natural diagonal bar and a deep, trout-filled run along the revetment.

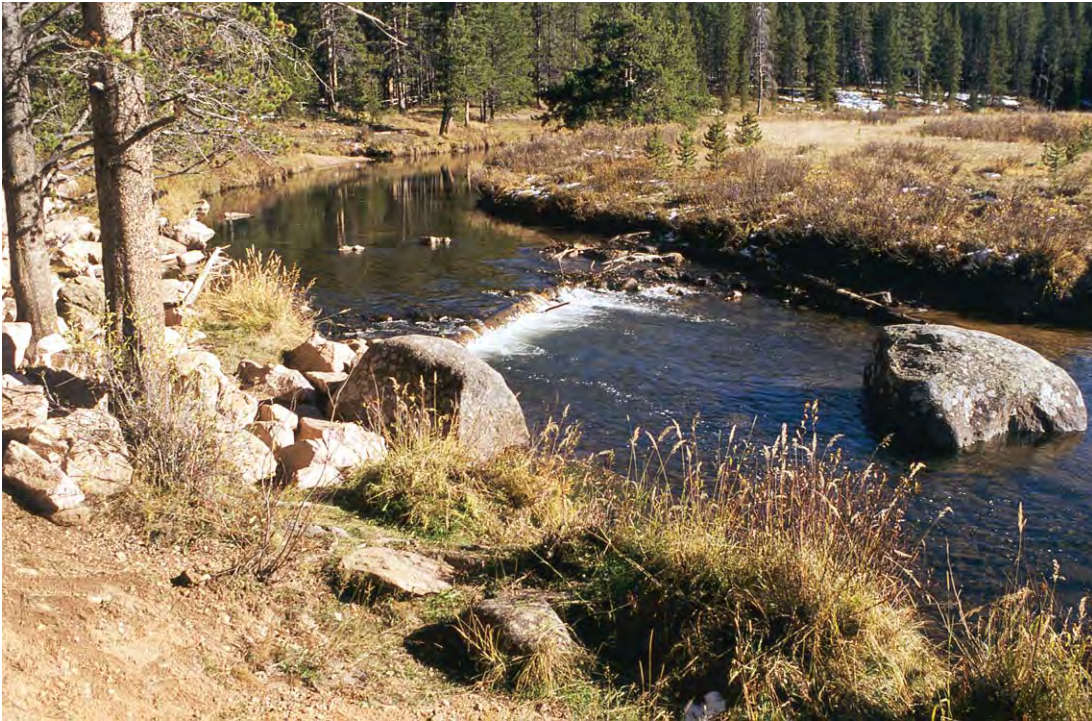
Habitat Structures - Durability and performance of the various devices was generally good. Two years after installation, most structures were in good condition. But firewood scavengers at the campground damaged one revetment soon after installation and an exceptional snowmelt flood in 1997 caused minor damage to some revetments. Deep pools persisted at both the diagonal rock weir and the digger log (Figures 57-3 and 57-4). And both pools have proven popular with both trout and anglers.

Figure 57-3. A diagonal digger log weir was built to provide deep pool habitat in a shallow run.

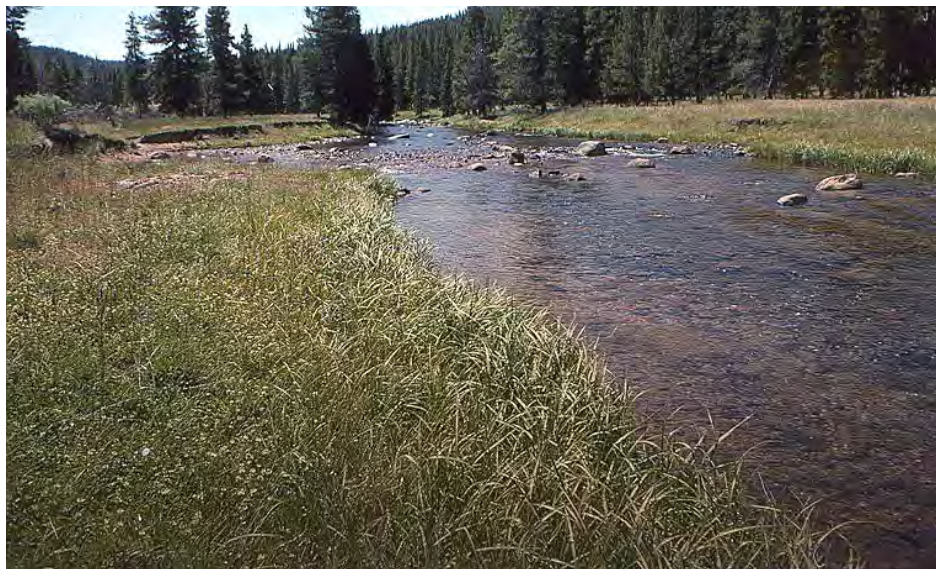
Figure 58-1. Pretreatment, South Tongue River at Shutts Flat lacked deep pool habitat through this section. Many eroding banks were also present.

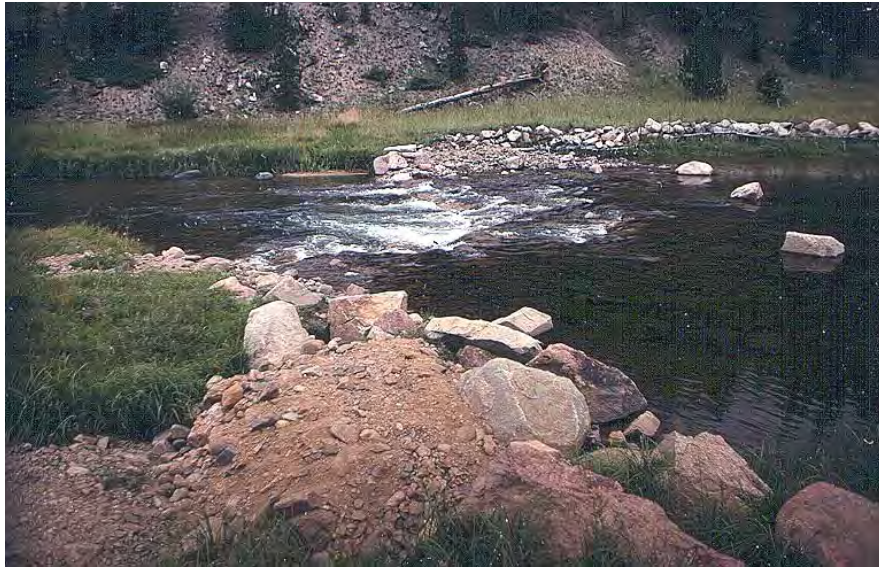
Figure 58-2. Where long shallow runs were present at Shutts Flat, as in Figure 58-1, several rock vortex weirs were constructed to provide deep pool shelter for trout. In addition to providing pools, these weirs act as grade controls and encourage sub-irrigation of downstream riparian vegetation by raising water tables in the floodplain.

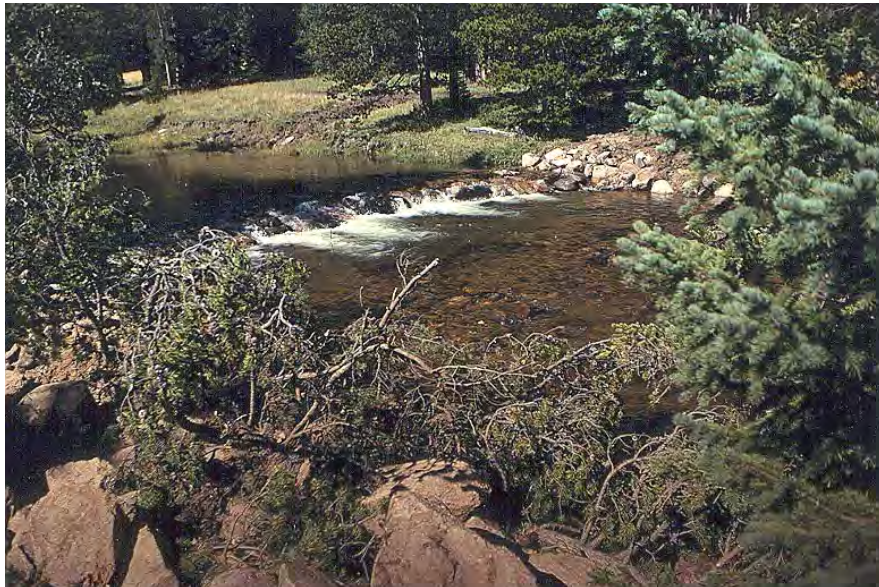
Figure 58-3. Diagonal rock weirs were also constructed to create deep pools and control stream grade.

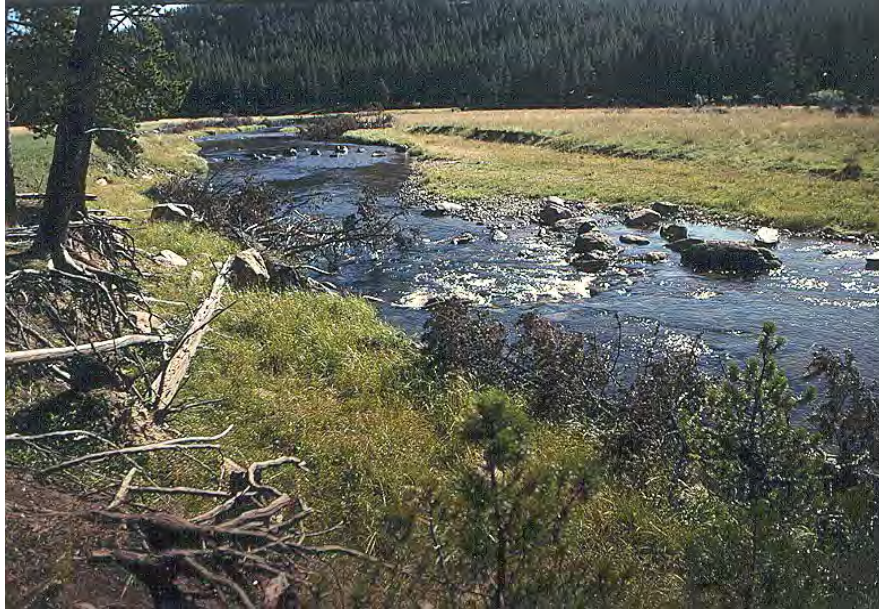
Figure 58-4. Cover trees were anchored next to rock vortex weirs (foreground) to provide shelter for trout using the pools. In this instance, a large trout moved in under the trees before construction was complete, thus demonstrating the need for such habitat. Tree/rock revetments on eroding banks can be seen downstream.

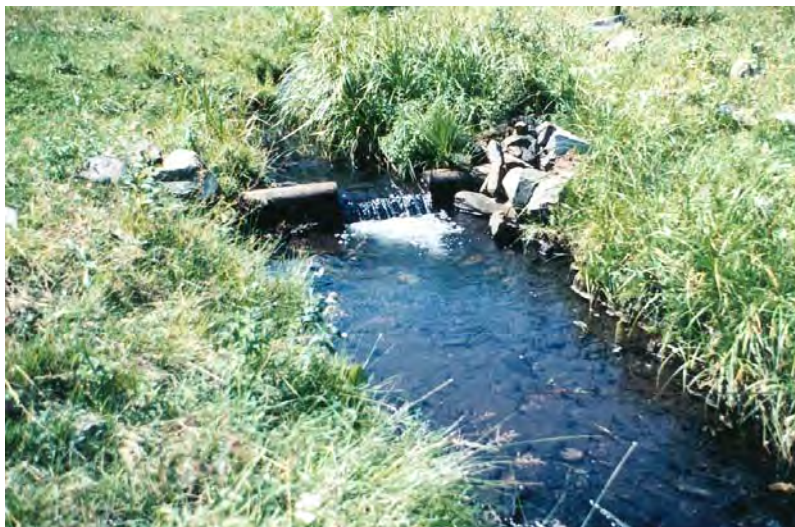
HABITAT MANAGEMENT: Pretreatment, Spotted Tail Creek was shallow and lacked deep pools. A few small step pools, undercut rocks, pocket pools, and undercut banks provided the only cover for trout. To provide deep pool habitat, a WGF construction crew installed 36 timber plunges (Figure 59-2), eight rock plunges, and one log plunge in 1,840 ft of stream. Plunge pools were dug out by backhoe to ensure deep pool development in the rocky substrate. WGF labor, materials, and equipment time cost was \$4,990 (\$14,260/mile). Cost per plunge was \$111.

Figure 59-2. Building timber plunges in Spotted Tail Creek created deep plunge pools, and in some cases, dam pools. An additional benefit was increased sub-irrigation of the riparian area as the plunges raised water tables in the floodplain.

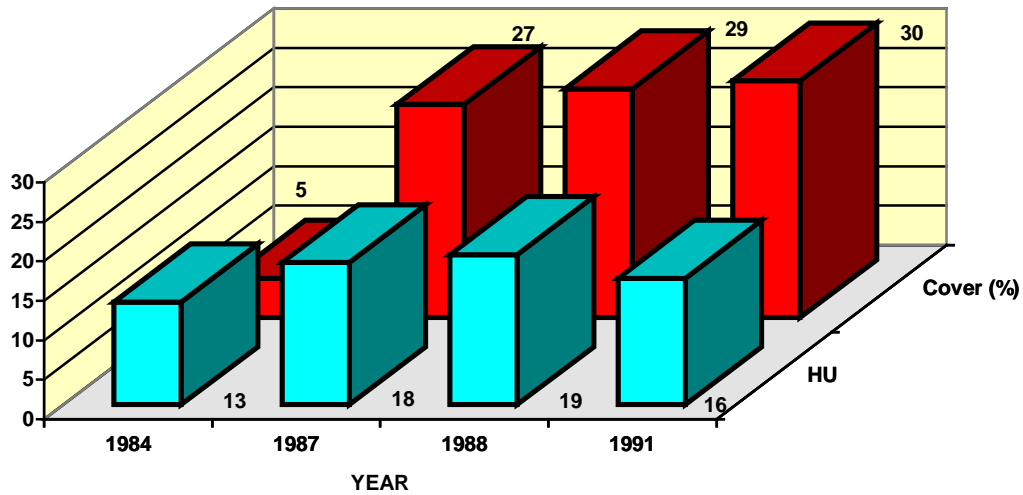
Trout Habitat Response - Cover for trout was poor (5%) pretreatment, but by 1991, cover had improved six-fold (Figure 59-5). Plunge pools were the most common cover type posttreatment and averaged 39 sqft of cover/plunge in 1988. In 1987, RPD was 1.40 ft, or greater, at 60% of the timber plunges and 50% of the surviving rock plunges. RPD at the lone log plunge was 1.42 ft. At the treated station, HQI score improved 46% from 1984 to 1988, and was 8% better in 1988 than at the reference site. By 1991, HQI score had dropped 16%, but was still 23% better than in 1984 (Figure 59-5).

Figure 59-5. Cover for trout and HQI score (HU) in Spotted Tail Creek before (1984) and after (1987-1991) habitat improvement.

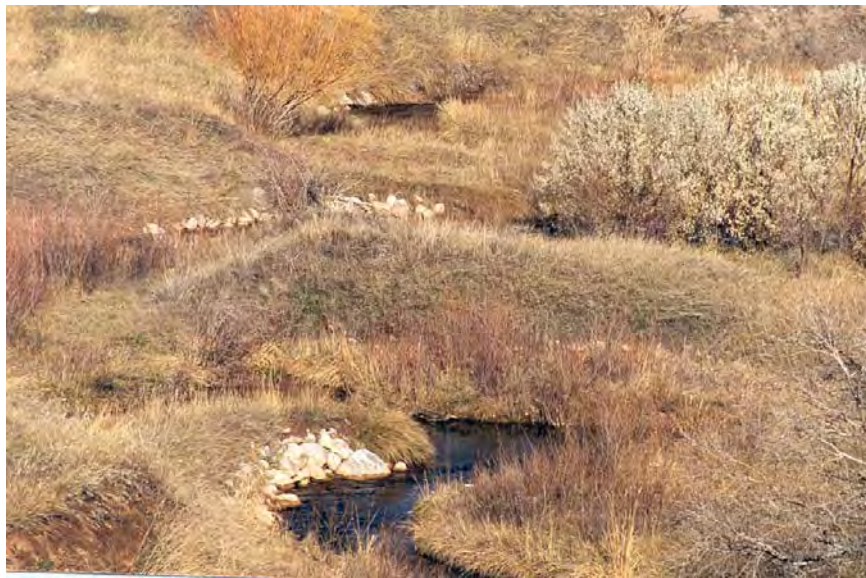
Figure 60-5. Reduced grazing and stabilization of stream banks with rock revetments allowed riparian vegetation to return and resume its stabilizing role in stream ecology. This area is the same area shown in Figure 60-4.

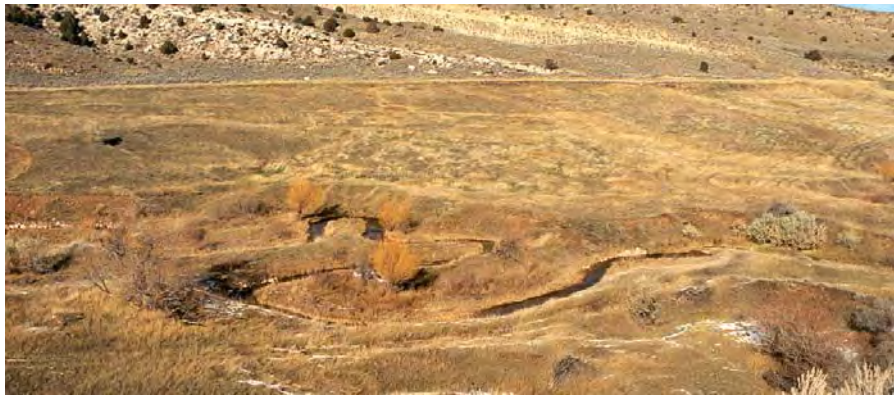
Figure 60-7. Posttreatment, the stream channel is much more stable. This is the same area as shown in Figure 60-6.

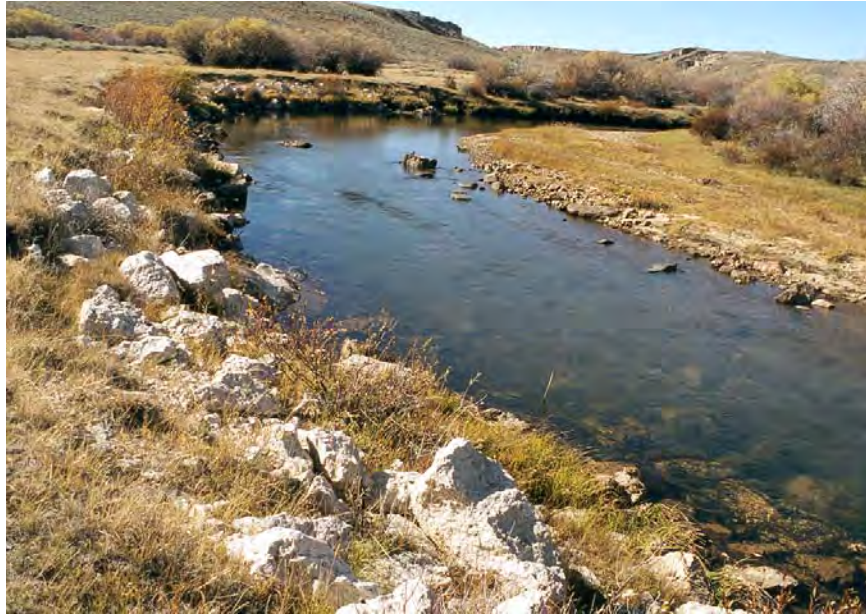
Phase III - Habitat changes were not monitored after the structures were installed. When checked in 1998 though, both banks treated with riprap were stable with good grass and willow growth (Figure 62-3). A deep pool was present along the upper bank, where good trout shelter was

Figure 62-3. A formerly eroding bank as it appeared 25 years after it was stabilized with limestone chunks. Willows have become established along the bank behind the riprap to further stabilize it. Compared to surrounding willow clumps, the new willow growth is still short, even after 25 years, which points out the long period of time sometimes necessary for riparian vegetation to become reestablished after severe disturbance.

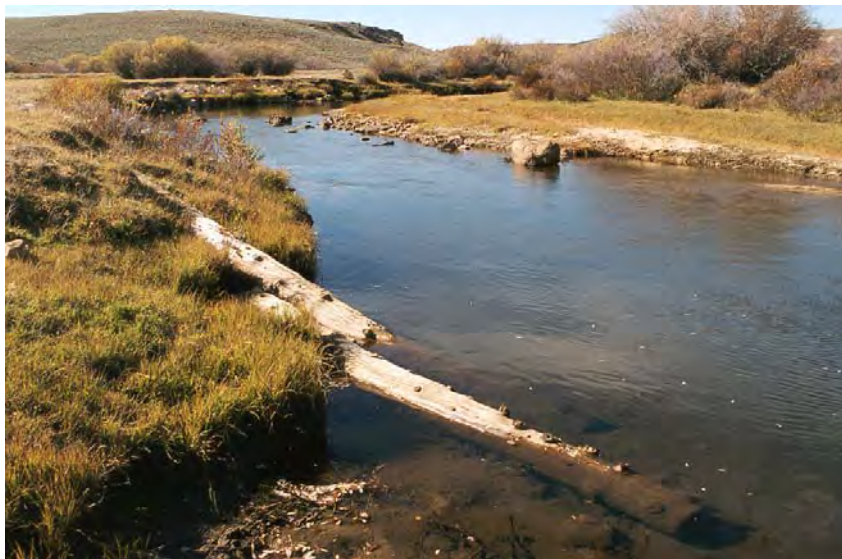
Figure 62-4. Two logs are all that remain of a log deflector installed 27 years previously. Attracting deflectors, like this one, were built to protect the bank on the left, but are still causing erosion (picture foreground, left). This type of structure is not

recommended in Wyoming for bank protection because it deflects flow into the bank instead of away from it.

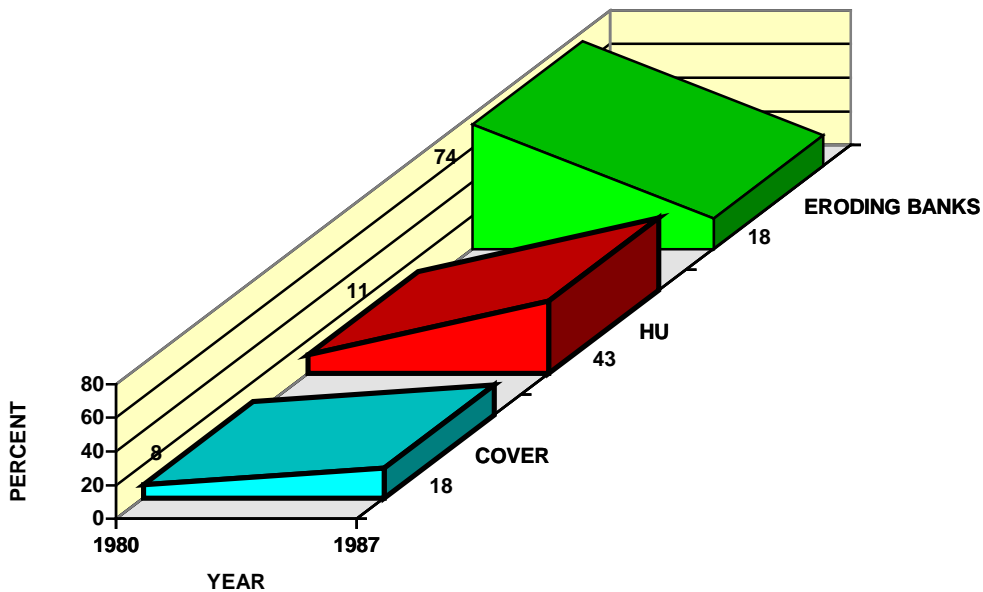
Trout Habitat Response - Change in trout habitat was not formally monitored in the tree revetment section, but more shelter for trout was obviously present in and around the trees. In several instances, the trees formed artificial overhanging banks that yielded many trout to electrofishing samples. Seven years after livestock were excluded from the enclosure, trout cover had increased 125%, HU were up 291%, and eroding banks had decreased 82% (Figure 63-4).

Figure 63-4. Posttreatment changes in trout cover and eroding banks within the enclosure at Tepee Creek 1980-1987.
