**A Compendium of Trout Stream Habitat Improvement
Projects Done by the Wyoming Game and Fish
Department, 1953-1998.**

**N. Allen Binns,
Aquatic Habitat Supervisor**

**Fish Division
Wyoming Game & Fish Department
Cheyenne, Wyoming 82006
April, 1999**

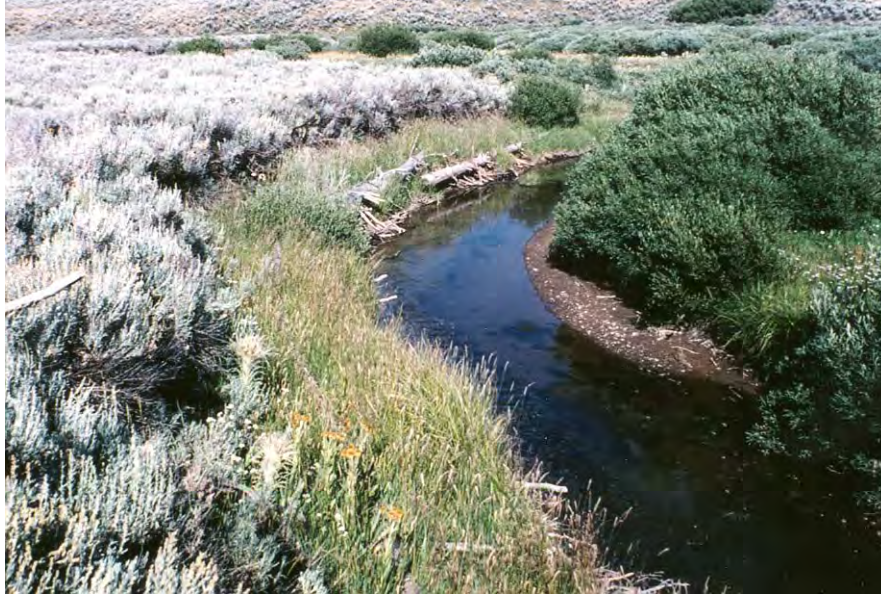
Habitat Structures - Stream banks were protected by the tree revetments for several years, and in several instances, sediment deposition within the revetments formed a grassy berm below the original cutbank (Figure 63-5). And good shelter for trout formed along the interface between tree line and stream. At other sites though, lack of rock behind the trees was the primary reason for continued bank instability. After several floods, trees began to wash loose, or were left out of the water when the thalweg changed.

Figure 63-5. A decade after tree revetments were installed, this stream bank is stable. Although some trees near the stream curve are out of the water, the trees in the foreground (note branches protruding from the grass) have formed a grassy berm and offer overhead cover for trout.

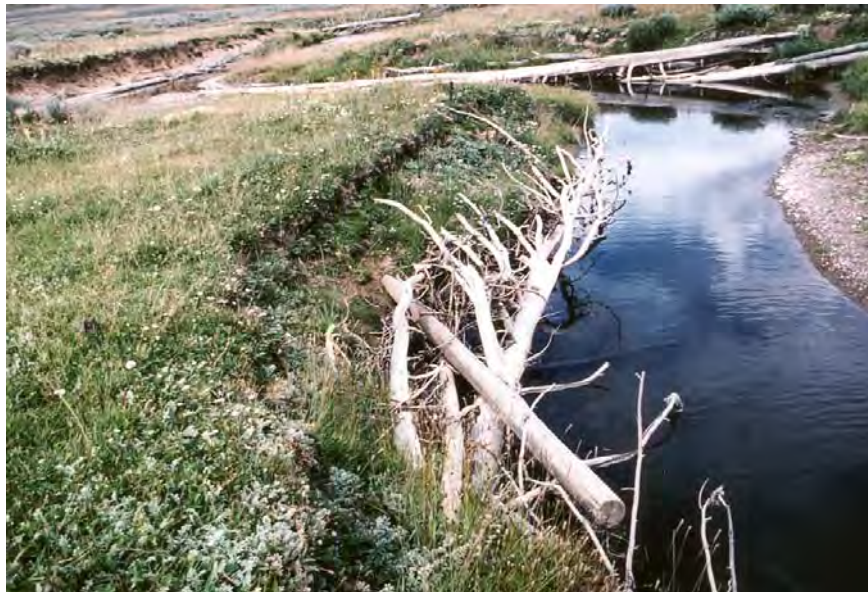
On a beaver dam washed out and the creek formed a new channel. When the revetments were examined in 1994, several tree revetments resembled toothpicks and offered about as much cover (Figure 63-6). Others were effective LWD cover. Tree blocks along the bank tops helped control cattle trampling of

Figure 63-6. This photo shows the contrast in effectiveness of the tree revetments. In the foreground, the bank is stable with woody debris shelter offered trout by the trees. However, at the top of picture, left, the bank there is still unstable and the trees were not effective at preventing bank erosion.

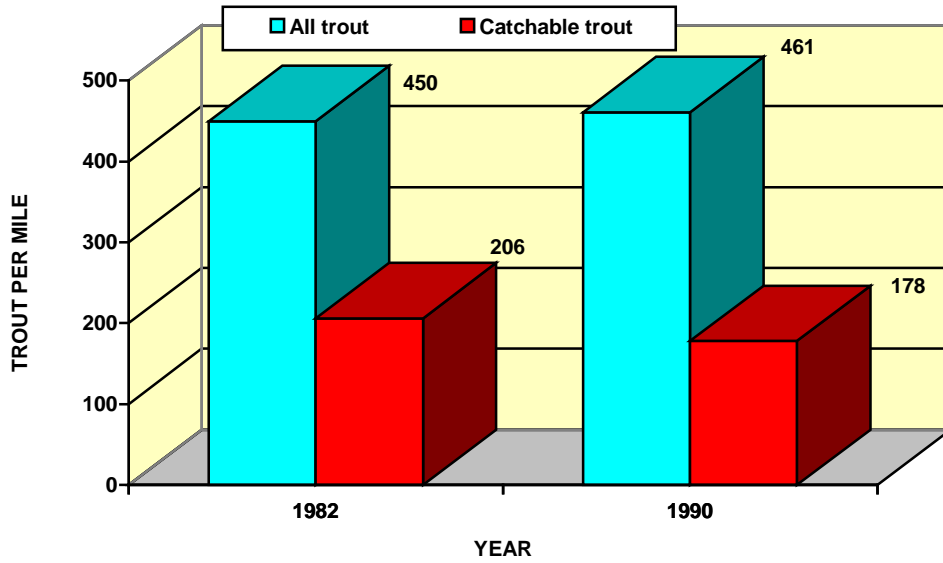
Fishery Response - Pretreatment electrofishing records for the project area are lacking, but the population is believed to have been low. An electrofishing sample in 1982, a year after the structures were installed, found both BKT and CRC at a station that included one plunge. A control station without any habitat improvements contained no trout. When the treated station was sampled again in 1990, the trout population was virtually unchanged from 1982. Trout evidently moved into the new habitat soon after construction and the population has stabilized. Fewer catchable trout (6 inches, or longer, total length) occurred in 1990 (Figures 64-1 and 64-2, Table 64-1), but trout biomass had increased 29% over the 1982 level.

Figure 64-1. Abundance of trout in Tosi Creek one and nine years after habitat improvement. Catchable trout are 6 inches, or longer, total length.

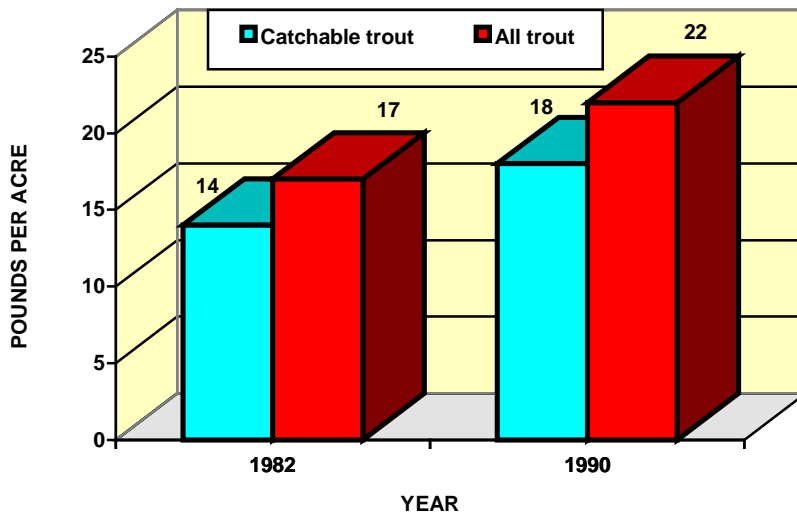
Figure 64-2. Biomass of trout before, and eight years after, installation of habitat improvement devices at Tosi Creek. Catchable trout are 6 inches, or longer, total length.

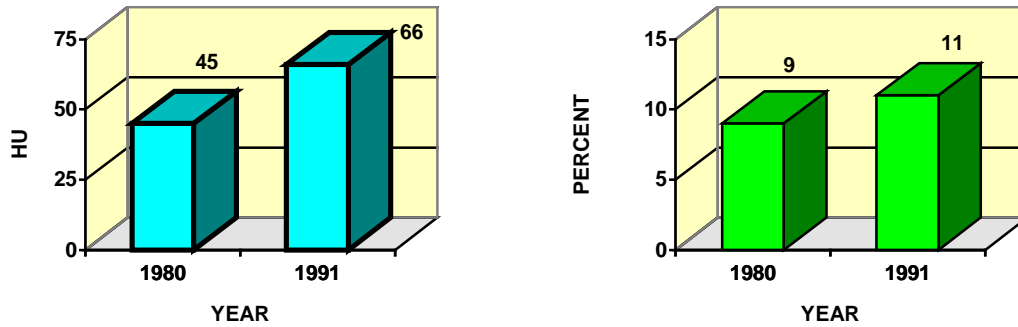
Trout Habitat Response - All three plunges initially furnished good pools. A decade after treatment, HQI score had increased 47% and cover was 22% better (Figure 64-3). By 1994, RPD was still 1.5 ft, or deeper, at the two surviving plunge pools and cover per plunge pool was 671 sqft. Including dam pools formed upstream from the plunges, 1,480 sqft of cover had been added to the stream.

Figure 64-3. HQI score (left) and cover for trout (right) in Tosi Creek before (1980) and after (1991) habitat improvement.

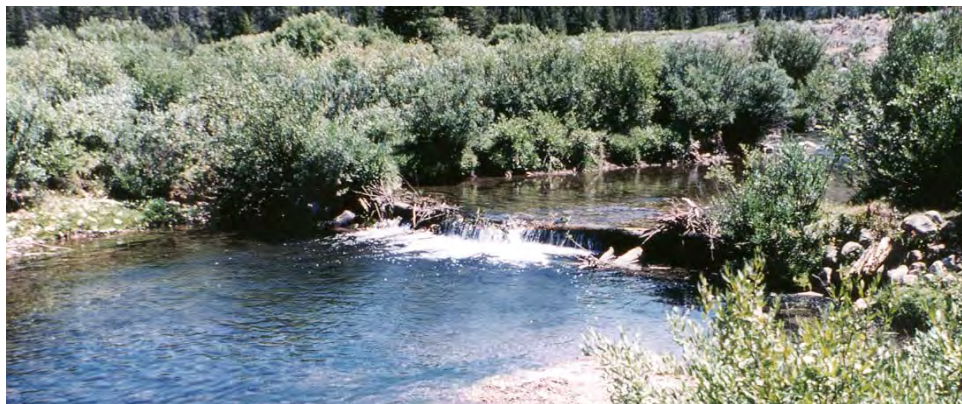
Figure 64-4. A CCC rock crib dam built in 1935 on Tosi Creek was still functional in 1994 and furnishing deep pool habitat for trout.

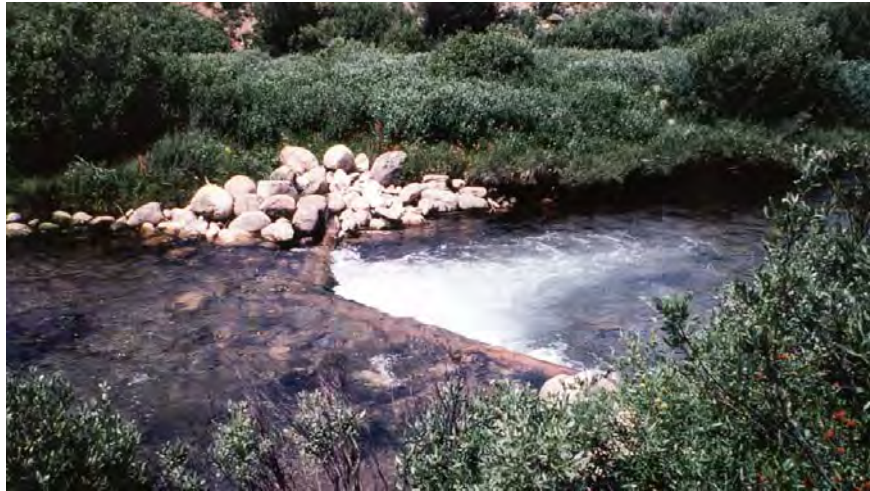
Figure 64-6. An upstream "V" plunge built by WGF was in good condition 12 years after construction. It was furnishing both shelter to trout and a grade control to slow swift stream flows in this section.

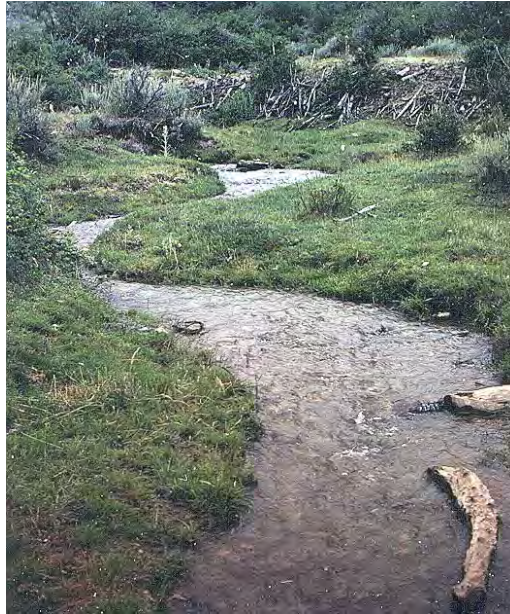
HABITAT MANAGEMENT: Prior to treatment, long, shallow riffles were prominent and few pools were present (Figure 65-1). Cover for trout was limited to small holes under banks or overhanging brush. Decadent, silted-in beaver ponds were common drainage-wide, but a few active ponds provided vital living space for trout. Livestock, especially sheep, had heavily grazed much of the watershed. WGF Fisheries Management personnel installed 58 structures by hand: 16 log or trash deflectors, 7 digger logs, 6 rock dams, 4 rock deflectors, 3 triangle log deflectors, 2 rock-filled wire cribs, 1 double deflector, brush

Figure 65-1. Pretreatment, Trout Creek contained mostly riffles and few pools. Its watershed was degraded from many years of extensive livestock grazing.

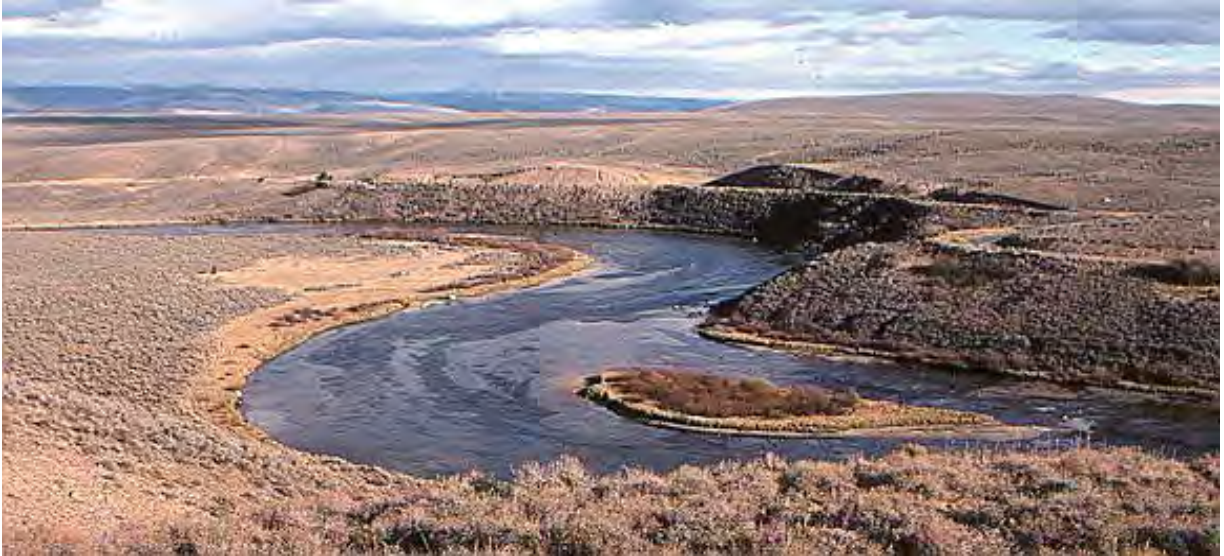
woody debris to shelter trout (Figure 66-1). Excessive areas of the river are typified by wide, shallow gravel and cobble riffles, which offer little holding water for trout (Figure 66-2). Sandbars are common in sections having slow flow. Some of the habitat shortcomings are due to past tie drives and abuse of the riparian area by agricultural interests. Lack of cover was identified as a primary factor limiting the trout population, so addition of LWD was prescribed to increase shelter for trout. In 1999, a joint WGF and BLM work crew, using a tracked excavator and a front-end loader rented from a private contractor, toiled to build five tree jams and one rock barb. In addition to funds from WGF and BLM, mitigation money from the Central Utah Project helped finance the project. As work is ongoing, no project cost information is available.

Figure 66-1. In the area where tree jams were built in October 1999, the Green River is a wide, meandering stream with few deep holes and virtually no woody debris.

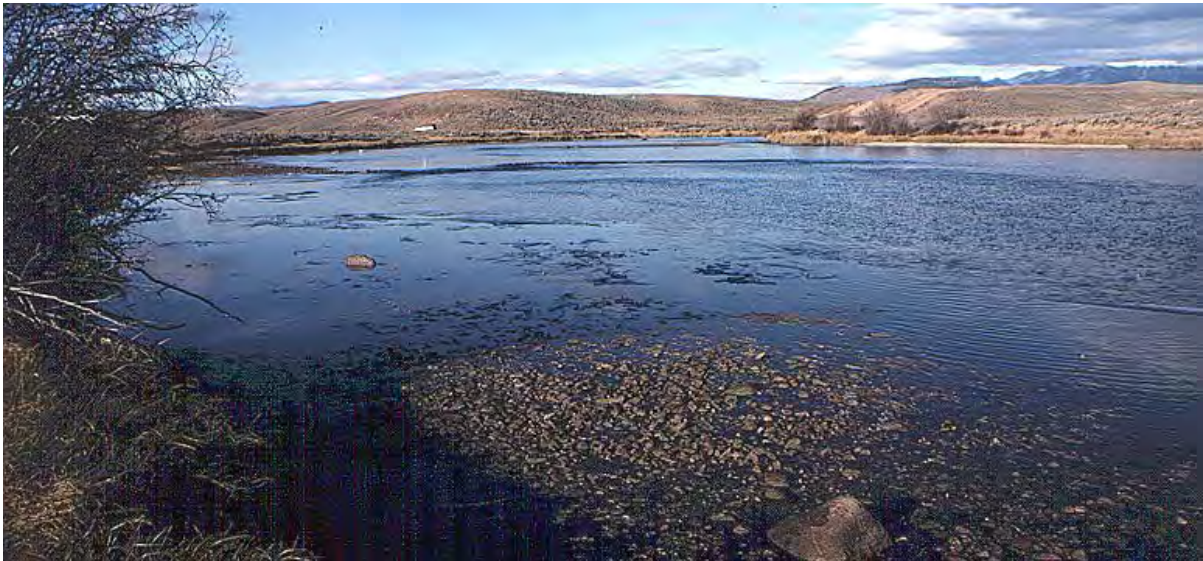
Figure 66-2. Wide, shallow gravel and cobble riffles typify the Green River at the Warren Bridge PFA through the section where tree jams were installed in 1999. Sand deposits are common on the stream substrate where flow is slow in this section.

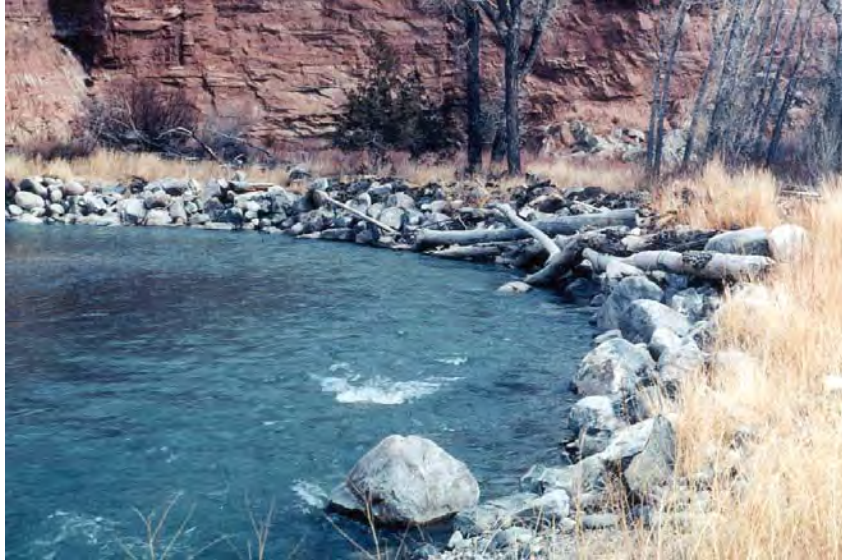
Figure 66-1. A formerly eroding stream bank has been stabilized with rock riprap. Woody debris visible in the picture washed in naturally during floods.

HABITAT MANAGEMENT: Installation of the rock riprap was an attempt to correct past abuses of the river channel, stabilize the channel, and provide more cover for trout. Work was done each spring when flow was low between ice-out and the spring runoff. Cost of the four-year project was \$11,076 (\$22,152/mile).

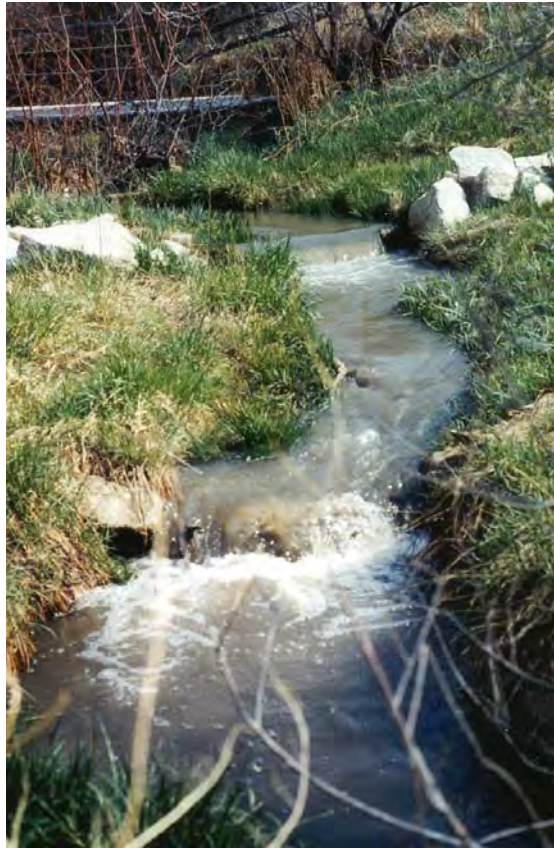
Figure 68-1. A timber plunge (top of photo) and a rock plunge (foreground) slow flows in Wolf Creek and provide pool habitat for fish.

Habitat Structures - Structures were still functioning four years after installation.
